SWBSS
2011 19 - 22 October
Limassol, Cyprus

Salt Weathering on Buildings and Stone Sculptures

The salt-damaged wall paintings in Stroeby Church, Denmark

Larsen P.K.^{1*} and Brajer I.¹

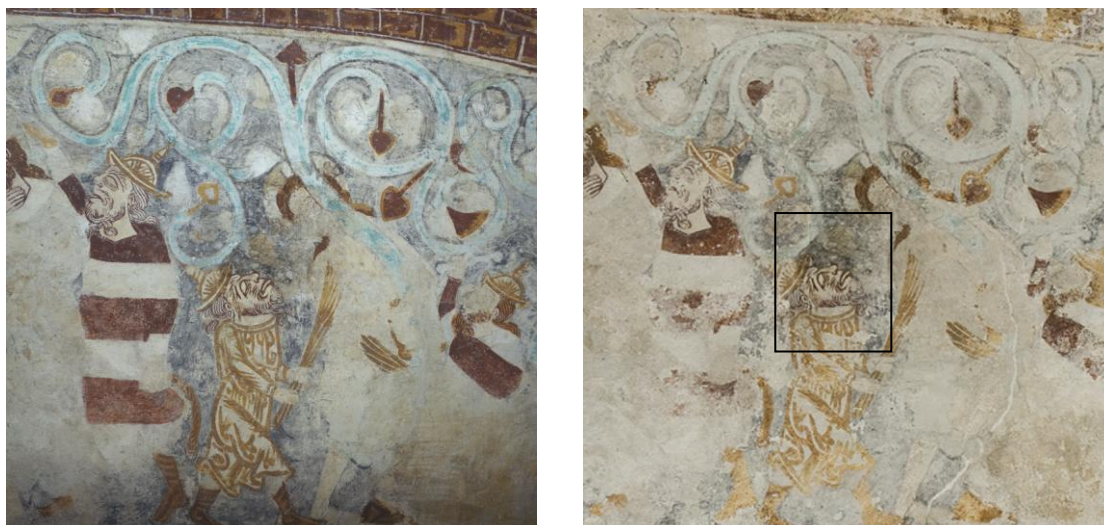
The decoration in the chancel is a result of a superimposition of paintings from two periods. A simple non-figurative embellishment of the ribs and upper part of the webs from the mid-13th century, executed directly on the vault's rendering, was augmented approx. a decade or two later when limewash was applied to the remaining surface of the webs and decorated with figurative scenes. The decoration was covered with limewash at an unspecified time after the onset of the Reformation in Denmark in 1536. The limewash crust comprising numerous historical limewashings was removed in 1920 revealing paintings, which displayed evidence of a long history of salt and moisture problems: only the depictions of scenes from Christ's Passion on the north web had survived relatively intact to the 20th century. Furthermore, the paintings continued to deteriorate in the centrally heated interior after they were uncovered (fig. 1a and 1b).

Figure 1a and 1b. Condition of the north web of the chancel vault in 1984 (a) and 2009 (b). Rectangle on 1b marks area consolidated with acrylic dispersion in 1984. Photo: Roberto Fortuna.

dispersion of an acrylic-acid-ester-copolymer containing carboxyl groups. As this was considered to be an experimental treatment, its use was limited to about 40 cm² (central area on figure 1b). It is currently the best preserved area on the vault.

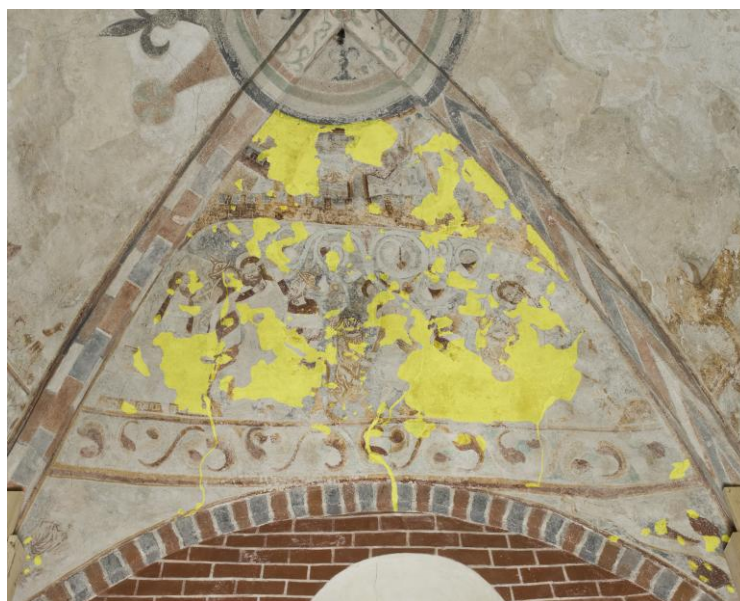
The goal of the 2009 investigation was to carry out a condition survey and analyses enabling a diagnosis of the problems concluding with a proposal for treatment. Mapping of the losses determined that ca. 65% of the pictorial content of the most important scene on the north web was missing (fig. 2). The scenes on the other webs are even more fragmentary. What remained of the paint layer was seriously damaged, either completely lacking cohesion or detached, kept only in place by cobwebs and dust. Although one can question whether the decoration is at all salvageable, an attempt will be made in 2012 to reattach the flaking paint. The condition of the paint layer was deemed to be so fragile that it probably cannot withstand more cycles of salt deliquescence and precipitation. Immediately after the investigation was completed, the wooden scaffolding raised for this purpose was converted into a climate chamber for the waiting period during which funds were raised for treatment. The ca. 5 cm gap between the wooden scaffolding floor and the wall was tightly plugged with rolled up bubble plastic effectively cutting the painting off from the heated interior.

Figure 2. Areas of the north web where the pictorial substance is missing are mapped in yellow.

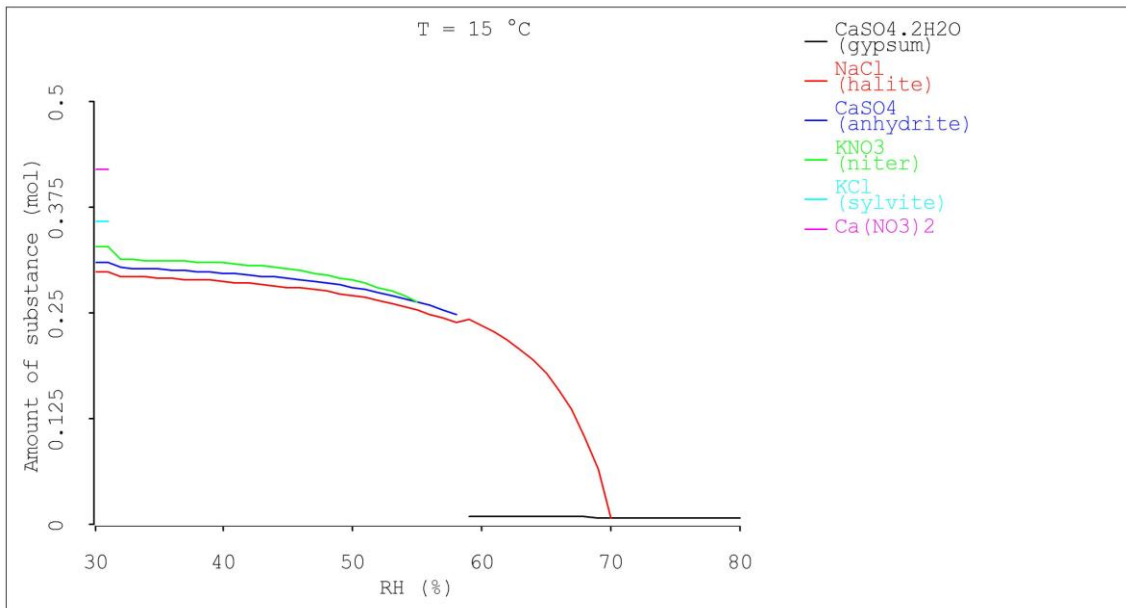
Twenty-four samples were extracted from various depths of the vault for analysis of the content of soluble salts. The dominant ions were sodium and chloride, and minor components were potassium and calcium, nitrate and sulphate. The range of precipitation was estimated with the ECOS-Runsalt software (fig. 3). Sodium chloride will precipitate at RH below 70%, and potassium nitrate at RH below 60%. Gypsum will always be precipitated, but will undergo a phase change to anhydrite around 60% RH. This result may not be valid, since the program does

not always treat mixtures with calcium and sulphate ions correctly. Nevertheless, it seems that the safe range for RH to avoid salt precipitation is above 70%

Fig. 3. Estimation of the range of precipitation for the salt mixture found in the vault. Sodium chloride is the dominant salt, which will precipitate at RH below 70%.

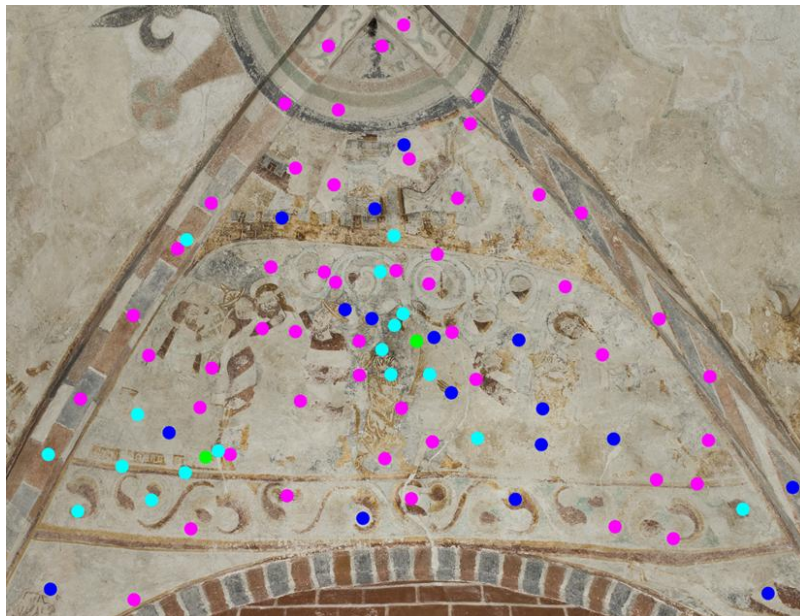
Fig. 4. Mapping of the surface salt distribution on the north web. Colour coding: pink – very low; blue – low; aqua – moderate; green – high.

surface of the vault for 30 seconds, immediately after which the electrical conductivity was measured by a Protimeter (GE Sensing). The individual readings were grouped into categories and mapped (Fig. 4). Distribution of salts on the surface, disappointedly, did not relate to visible damages on the painting. For example, the readings from areas where the paint layer was lost, adjacent to areas with severe flaking, were low. This may be due to the fact that detachment of paint also resulted in loss of surface salts, and gave a first indication of the limitations of the method. The high readings in the center of the web corresponded to the area consolidated with synthetic adhesive in 1984, indicating that variations in surface porosity also produce unreliable readings, which was confirmed when the method was tested again during a condition survey in Gjøøl Church in 2010 (Brajer 2010).

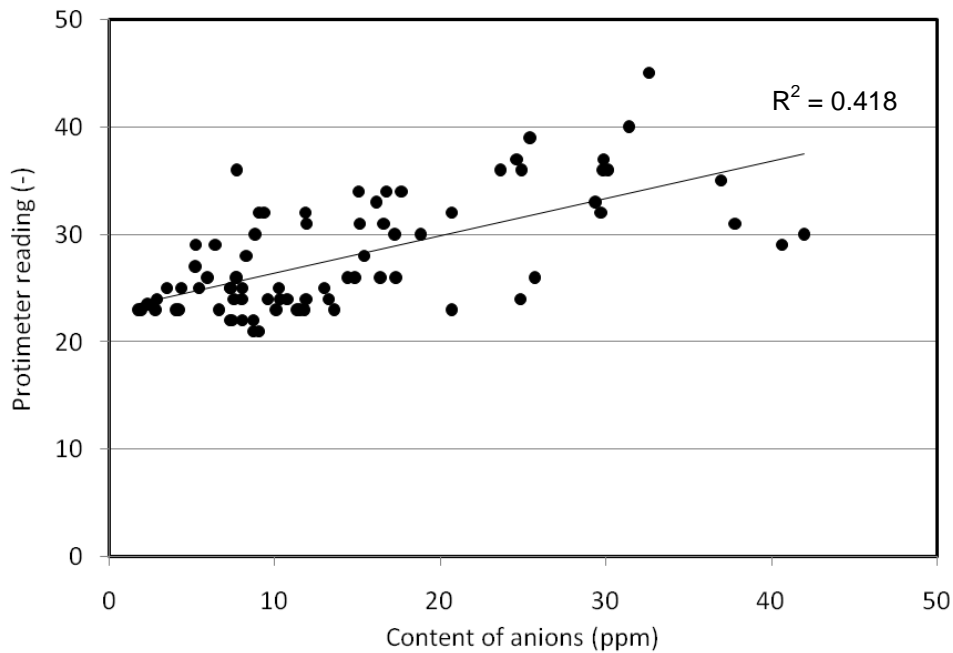
The surface salt mapping in Stroeby was repeated after two years, in February 2011. The procedure was the same as in 2009, but the sampling positions were slightly altered to avoid the effect of surface desalination from the previous sampling. This time the filter papers were collected for salt analysis at the laboratory. The soluble anions were extracted in 10 ml distilled water and measured by ion chromatography. The total content of chloride, nitrate and sulphate is plotted against the Protimeter readings in figure 5. There is a linear correlation between the actual ionic content of the filter papers and the Protimeter readings, but the scattering is quite large. This method, therefore, does not reliably indicate surface salt contamination on the wall paintings. But the surface sampling method itself could perhaps replace destructive sampling, where pieces of mortar or scrapings are taken to the laboratory for salt analysis.

Fig. 5. Surface salt sampling on the north web. Aionic content measured by ion chromatography versus Protimeter reading.

as a quick on-site procedure to replace destructive sampling for the diagnosis of salt damage on wall paintings. However, in this case, the electrical conductivity readings did not correspond to the damage observed on the painting, and furthermore poorly correlated to the actual ionic contents of the filter papers when analyzed by ion chromatography.

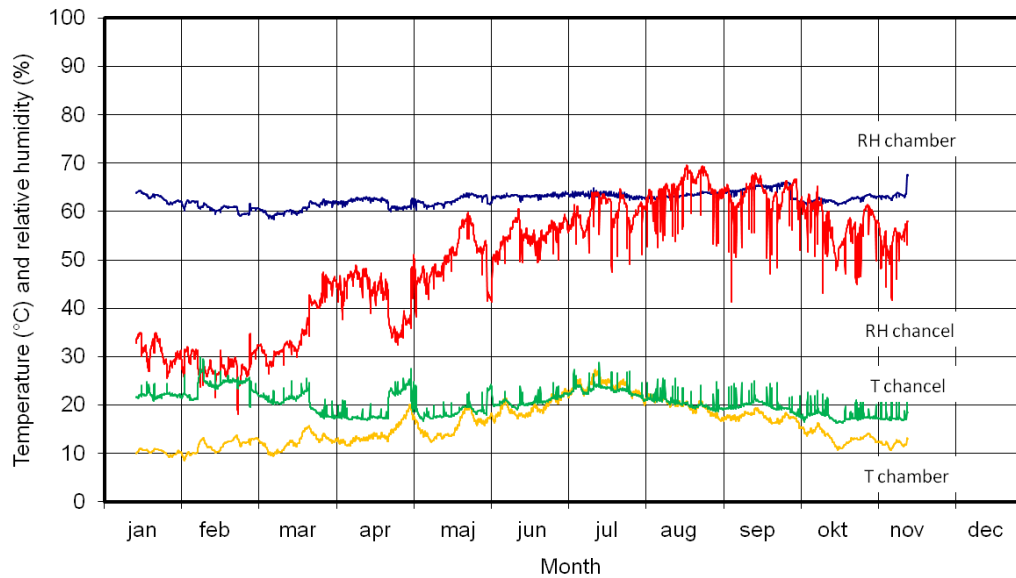
Fig. 6. Climate record from the chancel and the climate chamber for 2010. The temperature in the climate chamber was far lower than in the permanently heated church, and the RH was stable at 60% - 70%.

The climate record for one year is shown in fig. 6. The church was permanently heated all winter, which made the RH drop below 30% in February. The temperature in the climate chamber was down to 10 °C in winter, which kept the RH above 60%. The temperature behind the paint layer is shown in fig.7. The temperature followed the variations in the air temperature of the climate chamber with a difference of 2°C. It is reasonable to assume that the RH behind the paint layer was slightly higher than in the climate chamber due to the lower temperature. Nevertheless, the RH was below 70% RH, which was the limit for salt precipitation according to the ECOS-Runsalt calculation.

The temporary climate chamber showed it was possible to control the RH between 60% and 70% all year. A similar passive climate control strategy was first successfully tested in a case study in Rørby Church (Larsen 2002). Rørby Church had intermittent heating, but this present study has now shown the benefit of an air tight enclosure also in permanently heated churches. However, in Stroebj, the temporary enclosure was not sufficiently thermally insulated to keep the temperature low enough for the RH to stay above 70%. A permanent enclosure will hopefully solve this problem as the surface separating the two temperature zones will be smaller. The chancel will be separated from the nave by erecting a glass wall with glass doors in the chancel arch, which will open only for services. This solution has provided climatic stability for salt contaminated wall paintings in Dybe since 2005 (Larsen 2007).

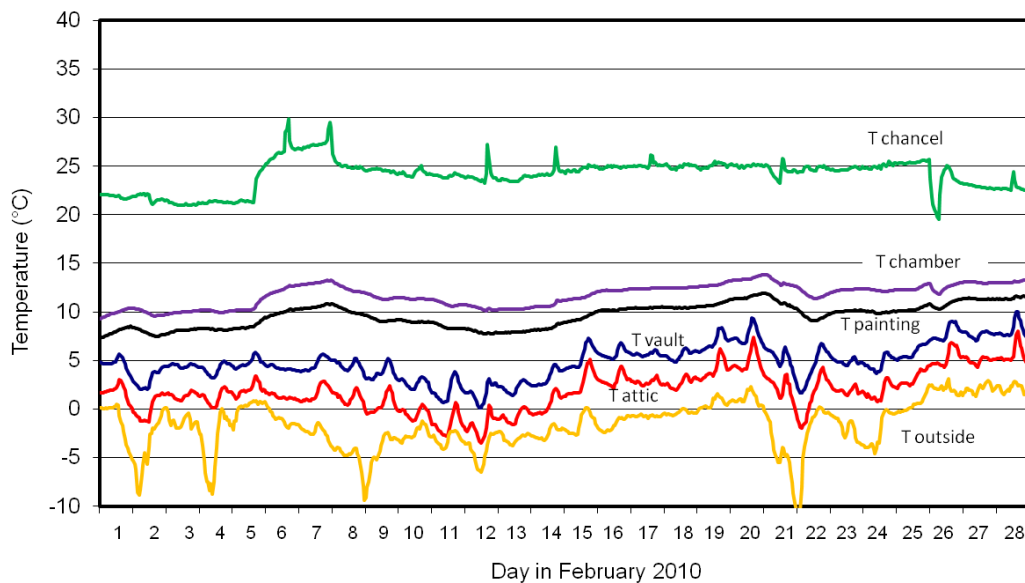
Fig. 7. Temperature record for February 2010. The temperature at the painted surface was always 2 °C lower than the temperature in the climate chamber, due to the lower temperature in the attic above. The temperature at the top side of the vault was always higher than in the attic, but experienced similar diurnal variations.
