**SWBSS**  
**2011** 19 - 22 October  
Limassol, Cyprus

# Salt Weathering on Buildings and Stone Sculptures

# Nanoparticles for stabilization of salts in St. Nicholas Church, Pittsburgh, Pennsylvania

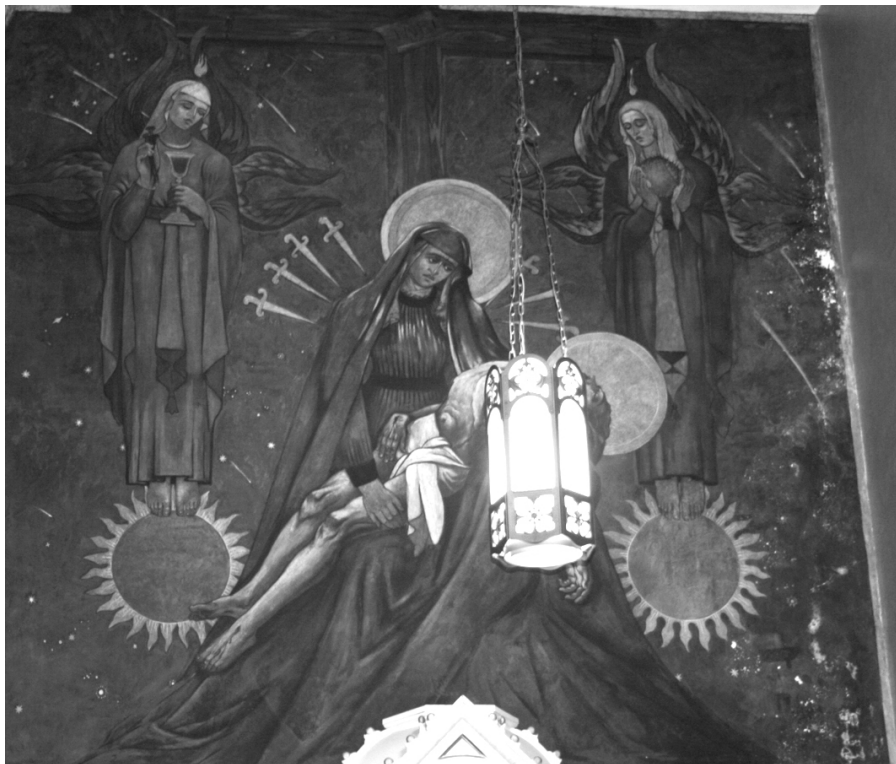
Figure 1. *Pietà* before treatment with efflorescence along right edge.

Water, entering through cracks, migrated through the walls and efflorescence is found primarily in areas of the murals *Pietà* and *Mati 1941*. *Pietà* is located in the corner of the interior of the building to the right of the high altar. Efflorescence is concentrated along the right edge of the mural. *Mati 1941* is located to the right of the large stained glass window, in the adjacent corner. Damage to *Mati 1941* from efflorescence is concentrated along the right edge and is characterized by a dry, fluffy white powder on the surface. Crystallization of infiltrates occurred at the interface of the plaster wall and paint layer. Increased volume of this new formation forced areas of original paint from the surface. Numerous losses resulted from small pockets filled with salts, and, having lost all inherent binding, fell from the wall. The ceiling in the choir loft and the stairwell leading to the north bell tower also exhibit extensive water damage and efflorescence, but these walls do not contain Vanka's paintings.

Contributing to a further weakened condition is the previous conservation treatment carried out in the late 1990s on the *Pietà*, which was to address efflorescence and removal of surface dirt. Water damage from the 2004 hurricanes has appeared in areas of the *Pietà* previously treated. Efflorescence was handled by brushing away the salts and fragile areas were re-adhered with synthetic polymers in the earlier treatment. Fills were made with modern materials and retouching was executed in acrylic. The undamaged, original surface of the *Pietà* was matte while areas with synthetic adhesives appeared dark and saturated, particularly where these polymers had been heavily applied. These materials were chosen, no doubt, in the belief that they were easily reversed. Areas of modern fill were as saturated with salts as original plaster. Passages with modern retouch responded to new water damage by trapping salts beneath the relatively elastic layer and billowing from the surface due to volume of its contents. Earlier attempts to re-adhere weakened areas with polymers failed and delamination of paint from the wall re-occurred.

The second step of the Ferroni-Dini method, barium hydroxide  $\text{Ba}(\text{OH})_2$  is applied in a super saturated solution in water to a fresh cellulose poultice. This step removes soluble ammonium sulfate  $(\text{NH}_4)_2\text{SO}_4$  and provides inorganic consolidation of damaged mural by forming the insoluble salt of barium sulfate  $\text{BaSO}_4$ . Products of water and ammonia have a cleaning effect on the wall then evaporate while barium sulfate partly fills small losses in the plaster. The materials continue a gradual consolidation process by conversion of barium sulfate  $\text{BaSO}_4$  into barium carbonate  $\text{BaCO}_3$  and reformation of calcium hydroxide  $\text{Ca}(\text{OH})_2$ . These two steps are the primary action of consolidation in the Ferroni-Dini method. By this method efflorescence on wall murals were de-sulfated and consolidation took place without the use of synthetic polymers.

A combination of methods was used in practical treatment of efflorescence on the painted murals. All areas of previous retouching in acrylic were removed. Due to salt build-up beneath the acrylic, this non-original layer was easily lifted. In areas of heavy loss of original paint and in areas previously covered with acrylic retouch, the Ferroni-Dini method was used to treat salts. Because original paint was no longer present, the aqueous component did not present a risk of additional damage. Areas of original paint affected by salts were treated with nanoparticles. Treatment in isopropanol assured less damage to the original medium and better penetration of the inorganic consolidation materials.
