# Salt-induced flaking of wall paintings at the Mogao Grottoes, China

Lori Wong<sup>1\*</sup>, Su Bomin<sup>2</sup>, Wang Xiaowei<sup>2</sup>, Amarilli Rava<sup>3</sup> and Neville Agnew<sup>1</sup>

<sup>1</sup> The Getty Conservation Institute, USA

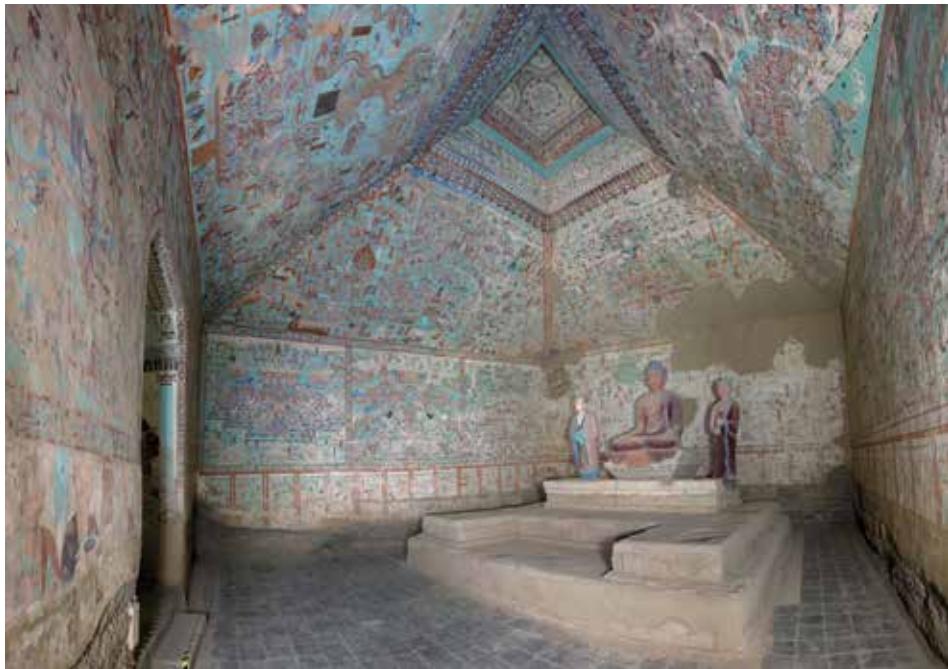
Figure 1: Cave 85, one of the 492 painted Buddhist cave temples at the Mogao Grottoes, was selected as the test cave for this project. Its wall paintings which date from the ninth century suffer from salt-induced flaking.

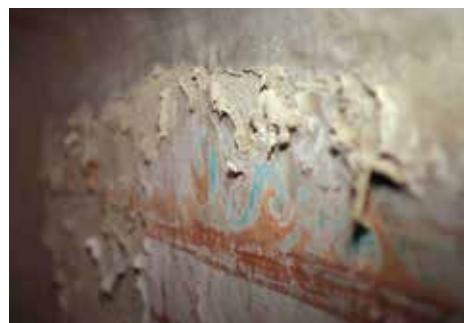
Figure 2: Salt-induced flaking or exfoliation of the wall paintings in Cave 85

Treatment of porous, inorganic substrates with synthetic polymers like polyvinyl alcohol (PVA) and polyvinyl acetate (PVAc) can decrease pore size with a consequent reduction of vapor and gas permeability.<sup>2, 3</sup> Upon exposure to high humidity the salts present undergo a phase change, from solid to liquid, and are free to move through the stratigraphy. The less permeable surface, where the synthetic organic materials were applied, can act as a barrier trapping the ions in solution; as the moisture evaporates, the solution becomes saturated, causing the salts to precipitate.<sup>4, 5</sup> Cycles of deliquescence and crystallization then causes gradual decohesion of the lower plaster layer; the upper layers are then separated from the powdering plaster below and are free to lift.

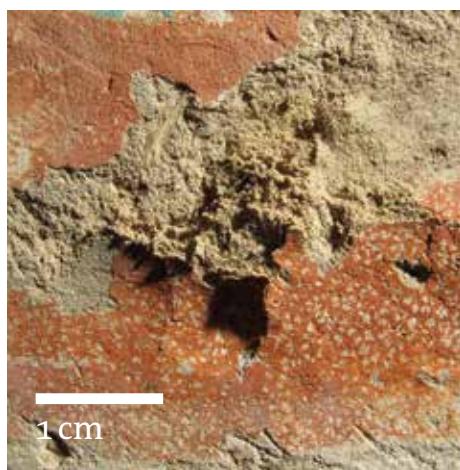
Conditions related to salt deterioration included plaster disruption which exhibits itself as powdering plaster caused by repeat cycles of salt activity (*Figure 4*); salt efflorescence seen as salt crystals on the painted surface; and, punctate loss, tiny, rounded losses, less than 1mm in diameter, in the paint, ground and/or fine plaster layer. Salt efflorescence and punctate loss are related conditions: individual salt crystals push through to the surface creating tiny losses in the paint layer. Over time, this gradually leads to complete loss of the paint layer in areas where salt problems are concentrated.

*Figure 4: Powdering and decohesion of the plaster and punctate losses, visible in the red paint layer, are both forms of salt deterioration.*

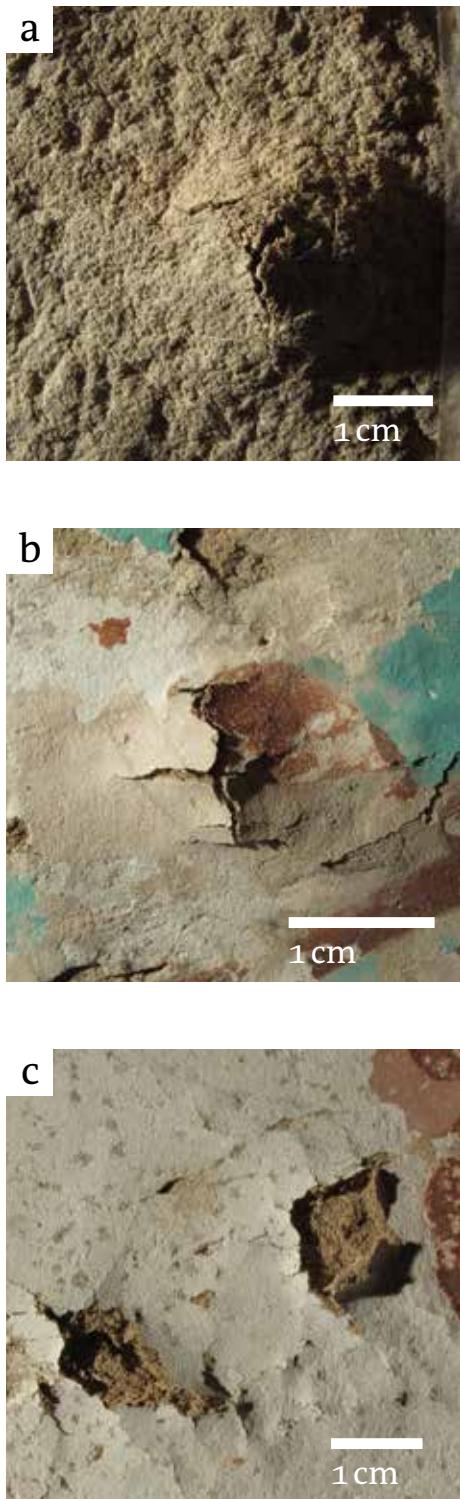
- 1) Decohesion of the plaster due to salt activity causing volume expansion that pushes out the layers above leading to bulging and tenting of the paint, ground and some fine plaster layers. In some cases the protruding area can have associated cracking but otherwise the surface is still closed (*Figure 5a*).
- 2) The protruding layers of paint, ground and some fine plaster breaks open along cracks and begins to lift further (*Figure 5b*).
- 3) The breakage and opening of protruding areas progresses further to a point where loss of original material occurs (*Figure 5c*).

Figure 5a-c: The three stages of progression of exfoliation.

volumetric expansion and the bulging of areas that is characteristic of stage 1 of exfoliation. If conditions persist then stage 2 occurs, where the protrusions burst open; and, then stage 3, when the area continues to open and lift to the point when losses occur.

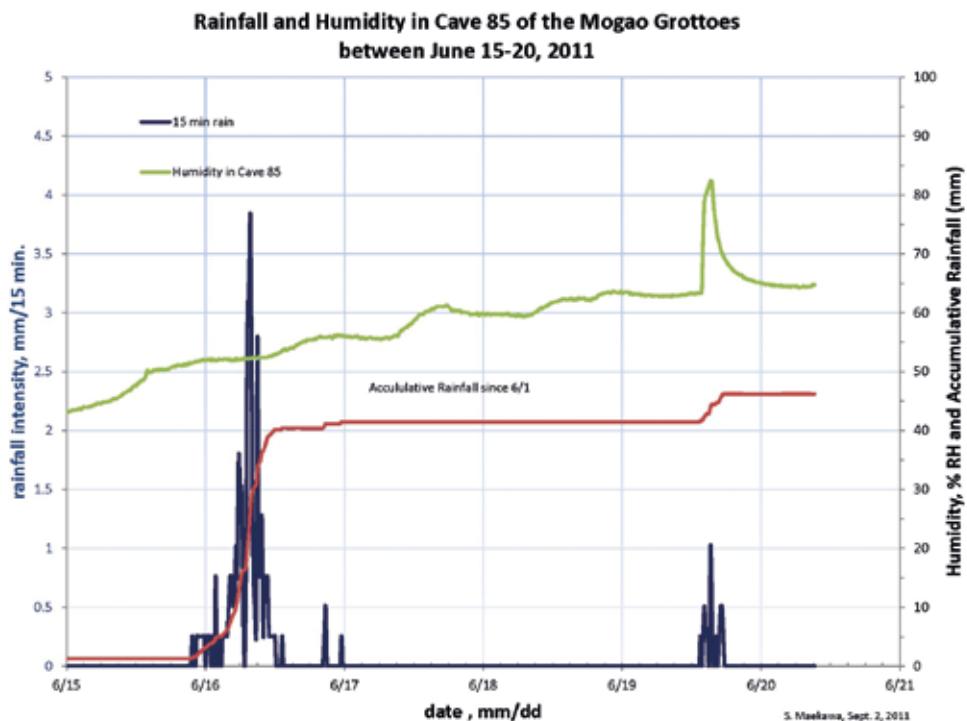
through natural ventilation which allows cave air to freely exchange with the outside when cave doors are opened during periods of visitation. Moisture produced by visitors does not significantly contribute to moisture levels in the cave.<sup>10</sup> The impact of the cave door being opened during high exterior humidity is dramatic, causing a sharp and sudden spike in RH (*Figure 6*). For the most part when a cave is not visited and the cave entrance door remains closed, a fairly stable climate is maintained.<sup>1</sup> However, when high humidity persists for extended periods, the RH inside the cave increases slowly even when the cave door is not opened. The louvered panels and gaps around the door allow humid air to enter.

*Figure 6: The humidity in Cave 85 rises even with the cave door closed after a prolonged period of rainfall on 6/16. The sharp peak in humidity that occurs between 6/19 and 6/20 is when the door is opened. In 2011, the RH exceeded 75% several times throughout the summer months.*

the aluminum door acts to buffer against the outside conditions, recommendations were made to improve the seal by closing gaps around the door and covering louvered panels with non-woven permeable fabric to slow air intrusion. This should be done in conjunction with continued condition and environmental monitoring in order to assess the stabilizing effects this has on the RH of the cave. Finally, visitation to the cave should be managed in a way that does not endanger the wall paintings with a system for closing the caves to visitors during periods of high RH.

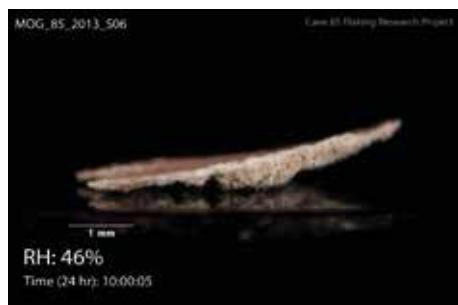
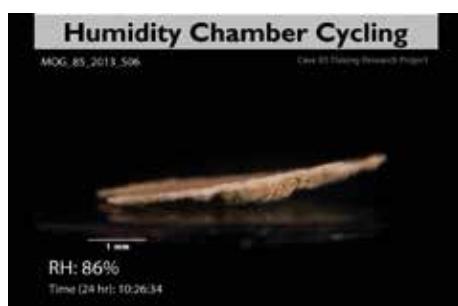
*Figure 7: A sample from Cave 85 placed in an environmental chamber contracted at 46% RH (left) and relaxed at 86% RH (right) in response to changing humidity. Movement in the sample was observed around 60% RH.*

cative of the lifting of layers that occurs with exfoliation. Time lapse images were put together into a short video to record the movement. However, given the complexity of the stratigraphy of the samples including paint, ground, fine plaster plus soluble salts and PVAc – each of which has a different moisture uptake rate – it was not possible to pinpoint the exact reasons for the lifting.<sup>11</sup>
