Investigation of salts sources at the Karadjordje's Gate on the Belgrade Fortress

Maja Franković^{1*}, Nevenka Novaković², Suzana Erić³, Predrag Vulić³ and Vesna Matović³

Abstract

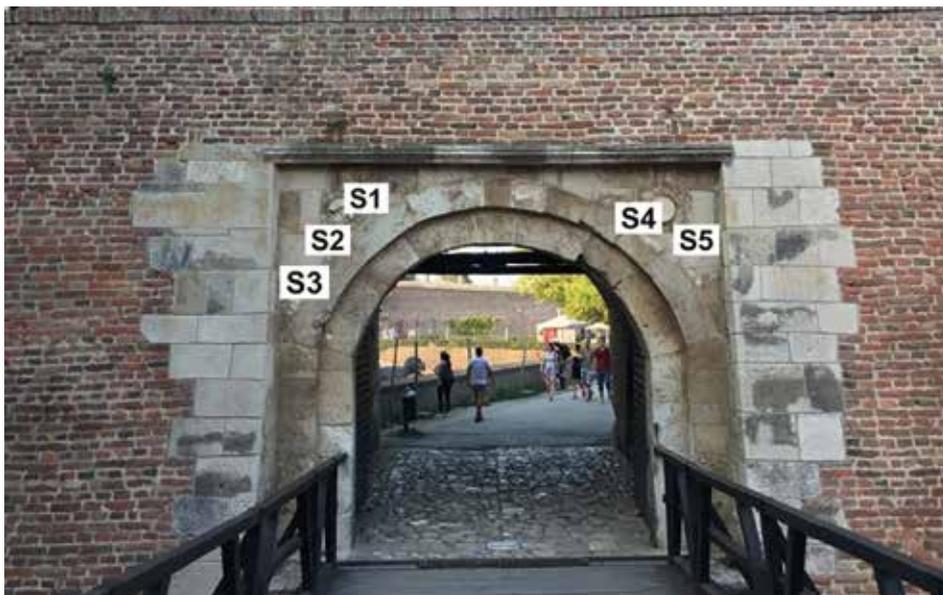
Figure 1: The view of the Karadjordje's Gate in Belgrade (Serbia) and position of the taken salt samples

Salt samples were taken from stone blocks built in exterior walls of the Karadjordje's Gate in November 2016. The main criteria for the sampling positions were: significant quantities of salt in the form of efflorescence on the surface and the originality of the blocks (natural and artificial) where salts appear. In order to analyse of salt composition by X-ray powder diffraction (XRPD) and SEM/EDS, five samples of salts were taken from the substrate in following order: S1 – beneath the broken rosette made of “artificial stone”; S2 – from the surface of the cement mortar joint above restored stone block; S3 – beneath a scale on the original stone block; S4 – from contact zone between rosette of “artificial stone” and original stone substrate; S5 – beneath a scale located on the original stone block surrounded by blocks reconstructed with “artificial stone” (Fig. 1).

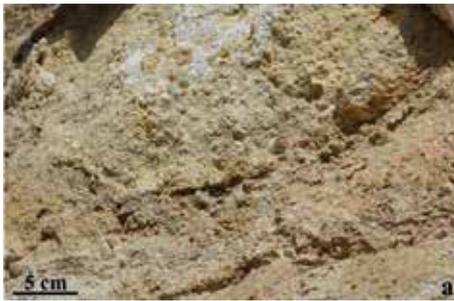
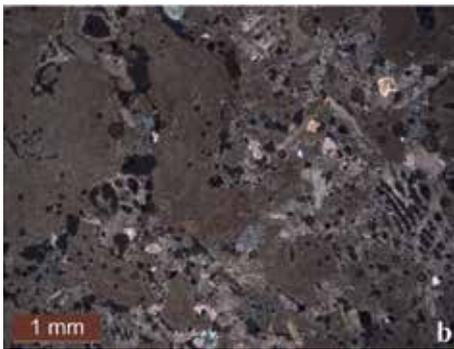
Petrographic analyses of natural stones imply that the most dominant material built into the structure are autochthonous, allochemical limestones, Miocene in age. Textural features and micro- and macro-faunal characteristics of the limestones identify them as Grainstone microfacies and Algal rudstone microfacies. These two microfacies types are limestones mineralogically composed of calcite (CaCO_3), with very small amounts of silici-clastic input. The limestones are whitish, pale yellow or beige in colour (Fig. 2a).

Figure 2: The macroscopic appearance (a) and photomicrograph (XPL) of built Algal rudstone from the Karadjordje's Gate

The prevailing allochemical compounds in all types are fossil-skeletal fragments of red algae (*Lithothamnium ramissimum*; family Corallinaceae) (Fig. 2b). The remains are micrite in composition with a well-developed and prominent mesh texture consisting of micron-sized rectangle chambers. Fossil remains of some other species (e.g., bryozoans, gastropods and different foraminifer species) were also recognised. They are recrystallised and filled with sparry calcite. The algal biosparrodite is extremely porous and weakly consolidated rock with sparite bounds with numerous vesicles, mesopores, rounded cavities and channels but fine/capillary pores, too. Grainstone microfacies is moderate porous rock with pores in range up to 0.1 mm. Water absorption of limestones used to build Belgrade fortress is about 15%, while the compressive strength vary from 4.5 to 13 MPa.¹⁹

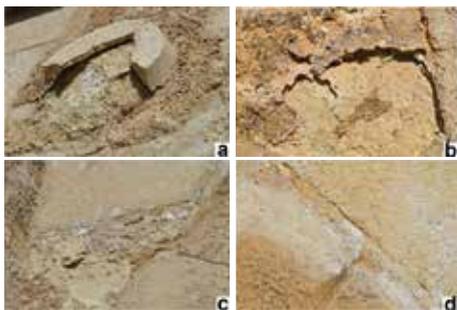
Mapping of the Gate's façades and registration of decay forms of stone degradation after the restoration was carried out. Damage occurs on the stone blocks at the upper part of the south façade. The most dominant decay forms are scaling and disaggregation of the original stone blocks, as well as detachment of "artificial stone" used for restoration from the rosettes (Fig. 3a, b). Salts deposits occur around the joints on the stone blocks

Figure 3: The damage forms on stone blocks. a) detachment of "artificial stone"; b) scaling and disaggregation of the original stone blocks; c-d) efflorescence on mortar joints and surface of artificial stone

in the upper part of the gate, as well as beneath the broken parts of rosette or beneath the scales on the original stone (Fig. 3c, d).

The study of damage type and salts deposits on stone blocks on the Karadjordje's gate show that there are several factors which contribute to decay of restored stone blocks as well as to the occurrence of salts. First, cement mortars used for joint filling and "artificial stone" possess different properties from the original substrate. Its incompatibility is reflected in significantly lower water absorption and greater compressive strength comparing to original limestone substrate. Original soft stone blocks easily absorb and release water. That indicates that the contact zone between the original porous limestone and cement mortar used for restoration represents hygric impermeable zone. Longer moisture retention

in repair mortars can cause its chemical dissolution which could be potential source of sulphates. Water retention also causes physical damage due to freeze/thaw cycles. Gate's architectural features and its positioning within the rampart also contribute to described degradation mechanism. Slightly indrawn south facade creates semi-sheltered area at the upper part and prevents stone blocks to be washed by rain, which is pogodna environment for the forming of gypsum.

This case study demonstrates the importance of compatibility of materials used in restoration with the original. If

the properties of the „artificial stone“ do not match those of the original, especially its hygric and mechanical properties, and if the Portland cement is used in restoration, damage is likely to occur and it will lead to the deterioration of the very stone that is meant to be protected.

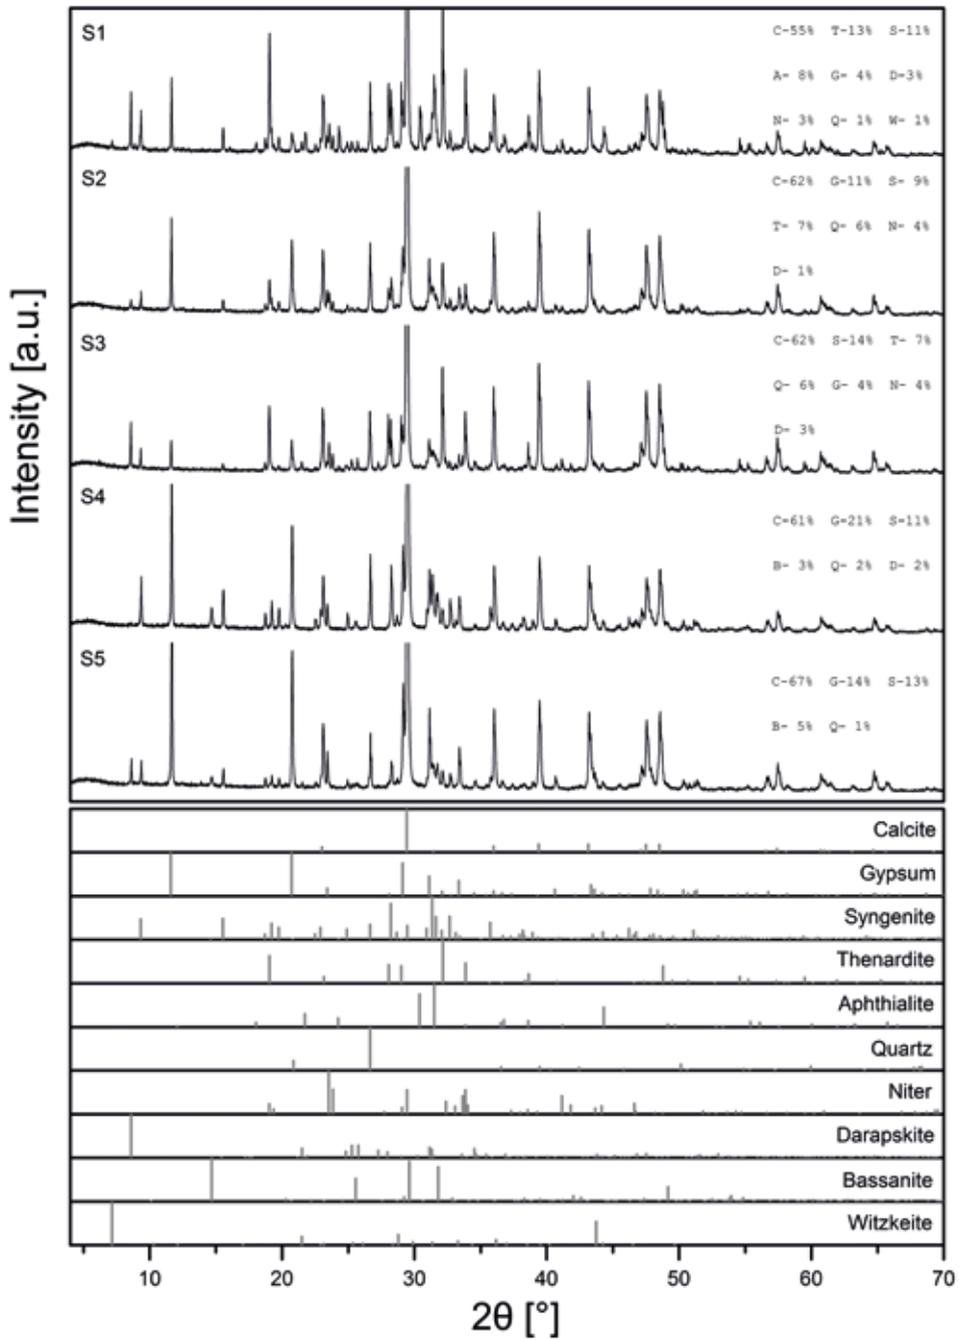
XRPD and SEM-EDS analyses of the samples showed the presence of the following salts: syngenite, gypsum, thenardite, darapskite, bassanite, niter, apthitalite and witzkeite (Table 1, Fig. 4, 5).

Calcite prevails in the all samples but its presence origins of substrate. Syngenite occurs in prismatic or rarely elongated aggregates as dominant salt in all samples but vary in contents (8.5-13.4%). Gypsum in the form of tabular aggre-

gates and variable content (4.5-20.7%) ordinarily follows syngenite in the all samples. Although thenardite is present to a lesser extent (6.5-13.4%), its presence in the form of tabular aggregates or bipyramidal crystals, is evident on the left side of the façade. Darapskite and niter (crust-like aggregates) occur up to 4% in contents. Apthitalite occurs only in sample S1 as trigonal crystals ranging from 3 to 10 μm in content of 8.3%, whereas bassanite is present on right side of outer façade (3-5%).

Figure 4: X-ray diffraction patterns of the salts formed on built limestones of Karadjordje's Gate with respective semi quantitative analyses results

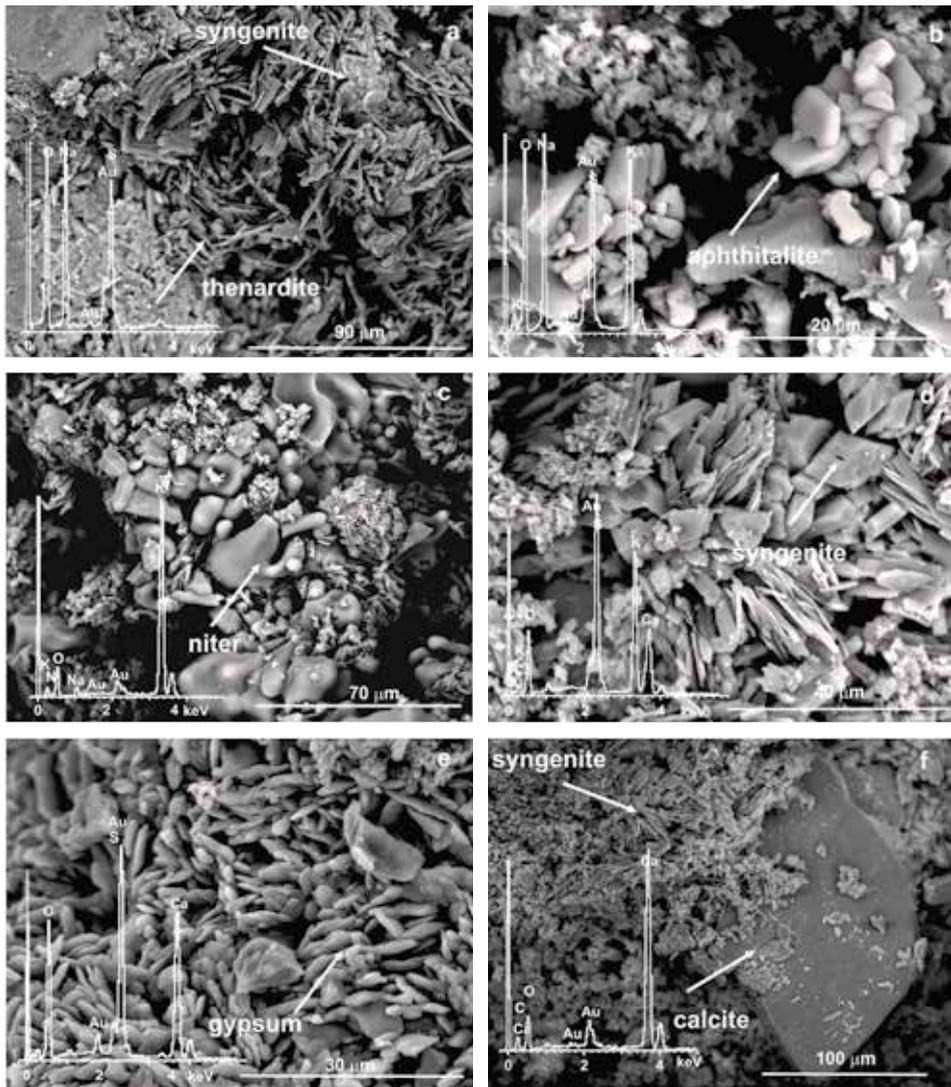
Figure 5: SEI images with EDS spectrums of salts from the analyzed samples S1-S5
