Salt Damage and RH Changes: The Case of the Waag Building in Amsterdam

B. Lubelli^(1*) and R.P.J. van Hees^(1, 2)

¹ Delft University of Technology, Delft, The Netherlands

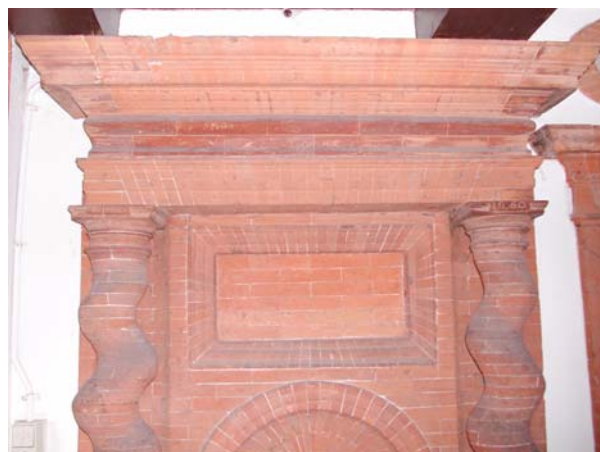
Figure 2: Detail of the master proofs in the mason's tower

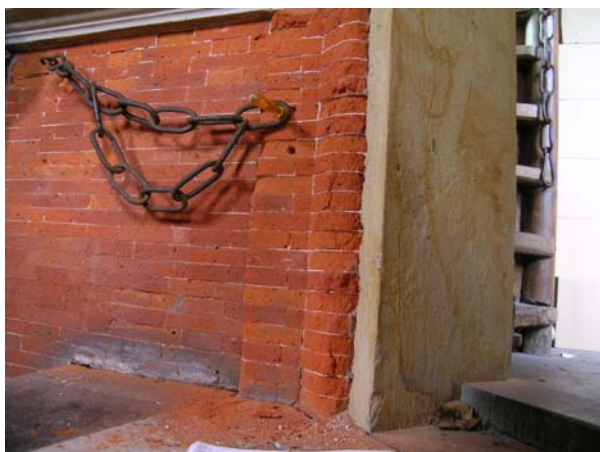
Severe salt crystallization damage affects the master proofs in the masons' tower. The bricks show powdering, and in some cases, scaling of the outer surface (Fig. 3). The very thin mortar joints show powdering and, at some locations, they are completely gone. There is no clear pattern in the decay: damage is present both in the lower and in the upper part of the tower. At some locations the damage seems to start at the joint and to develop then into the brick, whereas at some other locations the mortar is still sound while the brick is completely powdered. The natural stone, which was used at the door entrance on the first and 2nd floor, shows damage too.

Figure 3: Powdering of the brick in one of the master proofs on the 1st floor of the tower

On the basis of the results obtained, an advice for the conservation of the masonry master proofs can be formulated. In order to limit the damage development two options exist: eliminate or reduce the salt amount by desalinating the wall and/or control the RH of the air in order to limit dissolution/crystallization cycles.

In this case the moisture adsorption starts already at low RH (50 %), therefore controlling the climate in order to keep the RH always lower than 50 % does not seem the best option. This would require a system of air conditioning (the RH is high also in the summer) implying measures (sealing of doors, window etc.) which are considered very invasive from the point of view of conservation of the building. The hypothesis of maintaining the RH always higher than the RH of crystallization of the salt mix is not considered realistic, because it would be uncomfortable for the people working in the building and have a high risk of indoor mould growth and/or surface condensation. Desalination seems therefore the best option in this case. Even if desalination would reduce the salt content only in the outer cm of the masonry, this would probably be enough in this case. In fact the salts located near the surface are most susceptible to the RH changes of the air. Reducing the salt amount near the surface would slow down the development of the damage.

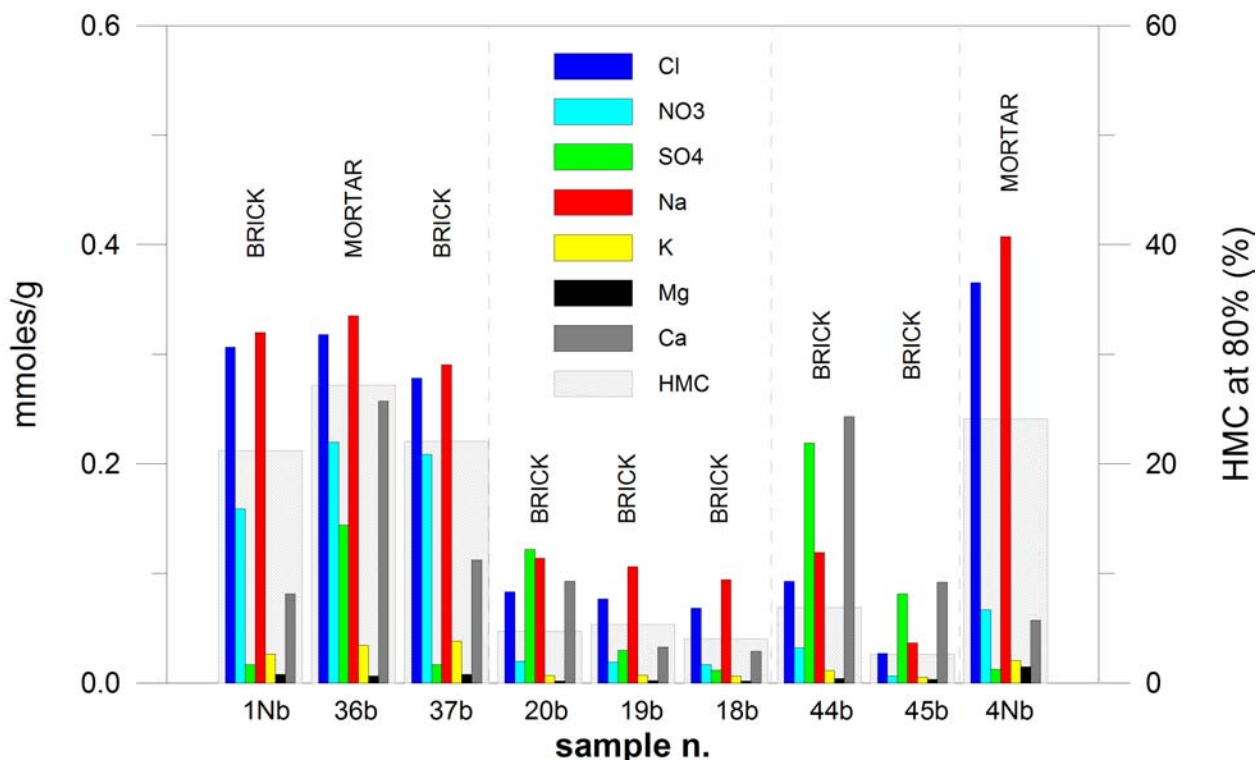
- NaCl is the main salt present. The Na/Cl molar ratio of about 1 indicates the presence of NaCl. NaCl is present in all the samples analyzed by IC. In some of the samples very high Cl (up to 1.2 wt %) and Na (0.9 wt %) contents have been measured.

- Apart from chlorides, nitrates are present too. Chlorides and nitrates are very hygroscopic salts, which start adsorbing moisture at a quite low RH (RH_{equ} at 20 °C: NaCl = 75.5 %; NaNO₃ = 75.4 %). This explains the high HMC₈₀ values.

- Sulfates are present in large quantities in samples 36b, 10b, 44b and 45b. It can be reasonably supposed that in samples 20b, 44b and 45b they are mainly present combined into gypsum (CaSO₄·2H₂O). Gypsum is not very hygroscopic: this explains the quite low HMC measured in these samples in spite of their high sulfate content. The hypothesis of the presence of gypsum is also supported by the XRD analyses performed on the efflorescences (§ 4.3).

Figure 4: Results of IC performed on powder samples

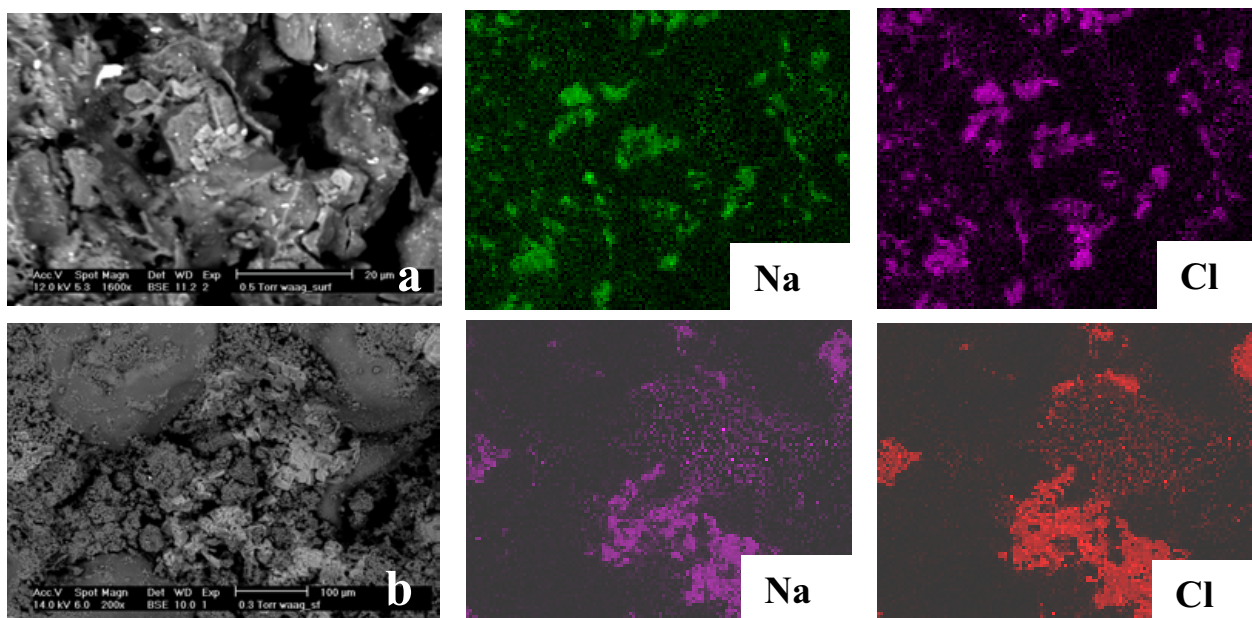
Figure 5: Na and Cl mapping performed by EDX on brick (a) and mortar (b) samples

The ESEM observations performed on a brick flake show the presence of salt crystals which have been identified, by EDX mapping, to be NaCl (Fig. 5a). Similar results have been obtained on the mortar sample (Fig. 5b).

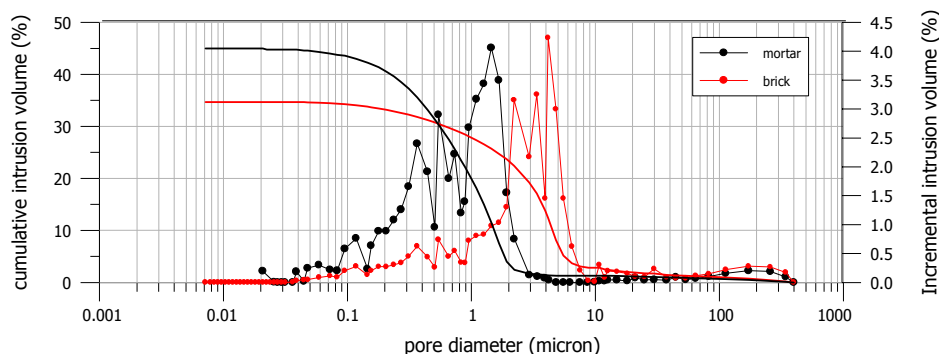
Figure 6: Open porosity and pore size distribution of the brick and the mortar as determined by MIP

porosity. The mortar has a high total open porosity (about 45 %) constituted by pores smaller than 1 μm . The absence of larger pores is due to the fact that no aggregate is present in this lime mortar. Knowing that moisture transport occurs from larger to smaller pores because of difference in capillary pressure, it is possible to conclude that in this case salt transport takes place preferentially from the brick to the mortar joint.

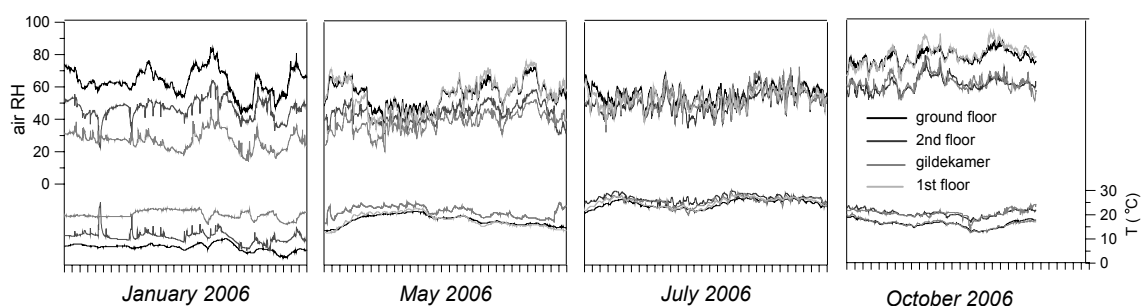
Figure 7: Temperature and RH at different locations in the building

- In the staircase, at the ground level and at the 1st floor, the RH reaches very high values (up to 90 %) in the winter. RH changes between 60 and 90 % RH occur. In the summer months the RH varies between 40 and 70 %.
- In the *gildekamer* and on the 2nd floor the RH can recede in the winter below 30 % due to the use of a heating system. While the *gildekamer* is continuously heated, the small room on the second floor is intermittently heated: this causes there fast RH variations between 20 and 60 % RH.
- In the winter large differences in RH exist between the not heated and the heated spaces.

In the summer these differences disappear and the RH varies between 40 and 70 % for all locations.

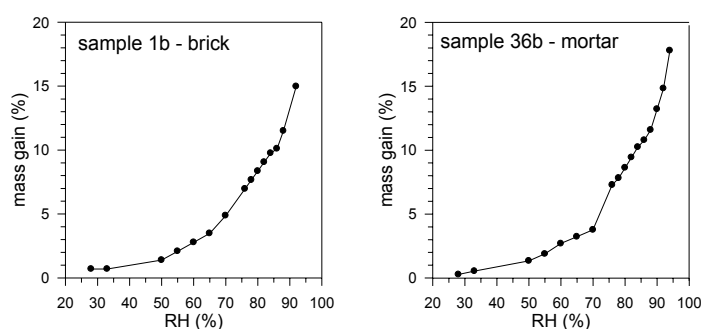
The results of the adsorption experiment are reported in Fig. 8. The adsorption curve of sample 36 shows a clear increase in the hygroscopic moisture uptake between 70 and 76 % RH, which corresponds to the RH_{equ} of NaCl, the salt present in large quantity in this sample (see IC results). Some moisture adsorption is present also at lower RH. This can be due to the presence of other salts (the ion chromatography indicated the presence of nitrates). The adsorption curve for sample 1 does not show any clear step; it can be observed that the slope of the adsorption curve increases at 50 % and then again at 70 % RH. Also in this case, the presence of a salt mix is responsible for this behaviour.

It can therefore be concluded that the hygroscopic moisture uptake already starts at 50 % RH and becomes more relevant for RH higher than 65 %. This confirms that frequent RH changes through these values enhance the development of the damage by causing dissolution/crystallization cycles of the salt present in the masonry.

Figure 8: Adsorption curves of sample 1b (left) and 36b (right)
