Wall paintings salt induced decay in residential buildings in Hierapolis of Phrygia (Turkey)

E. Cantisani, B. Sacchi*, S. Bracci, C. Riminesi and S. Vettori

Institute for the Conservation and Valorization of Cultural Heritage,
National Council of Research, Sesto Fiorentino (FI), Italy

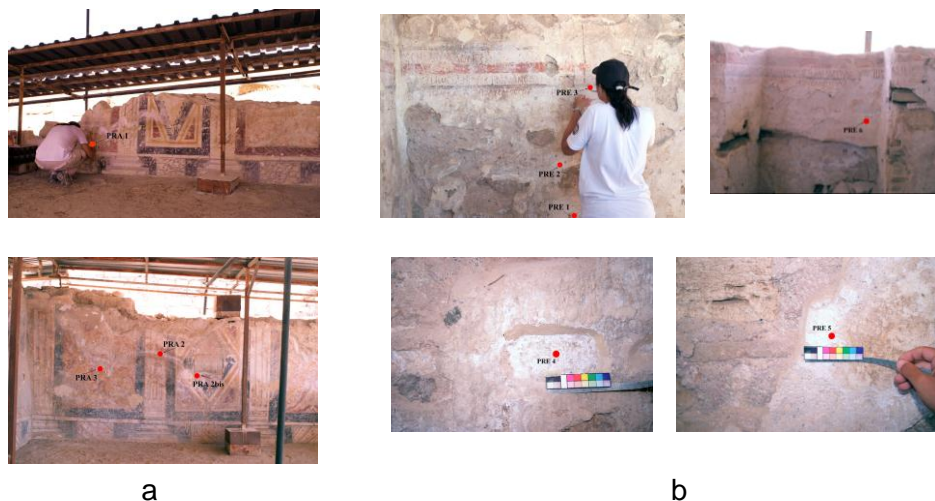
House of the Painted Inscription (room A 1267, known as *Room of the Prayer of Manasseh*). Four samples were collected from room A 1207, *House of the Doric Courtyard*, and six samples from room A 1267, *Room of the Prayer of Manasseh* (see Figure 1).

Figure 1: Location of collected samples in room A 1207 (a) and room A 1267 (b).

In room A 1207, sulfates are prevalent in the efflorescence of the lower part of the wall, whilst nitrates are prevailing at higher levels. In room A 1267 chlorides and nitrates are prevalent: from bottom to the top of the wall, the amount of chlorides increases, while that of nitrates decreases. In Table 1 the main results of XRD and IC analyses are presented.

The deposition of sulfates and nitrates can be ascribed to rising damp or to infiltration from filling soils that are in contact with the wall. The presence of significant amounts of chlorides is instead quite unusual in a place that is far from the sea-side (at least at present time), and could be due to the particular re-utilization of the room as a building materials warehouse.
