DECAY PATTERNS OF WEATHERED QUARTZ SANDSTONES: EVIDENCE OF GYPSUM INDUCED STRUCTURAL CHANGES

H.-H. Neumann⁽¹⁾, A. Lork⁽²⁾, M. Steiger⁽¹⁾, Herbert Juling⁽²⁾

E.L. Sveinsdottir (ed): PROCEEDINGS 6TH EUROSEMINAR ON MICROSCOPY APPLIED TO BUILDING MATERIALS.

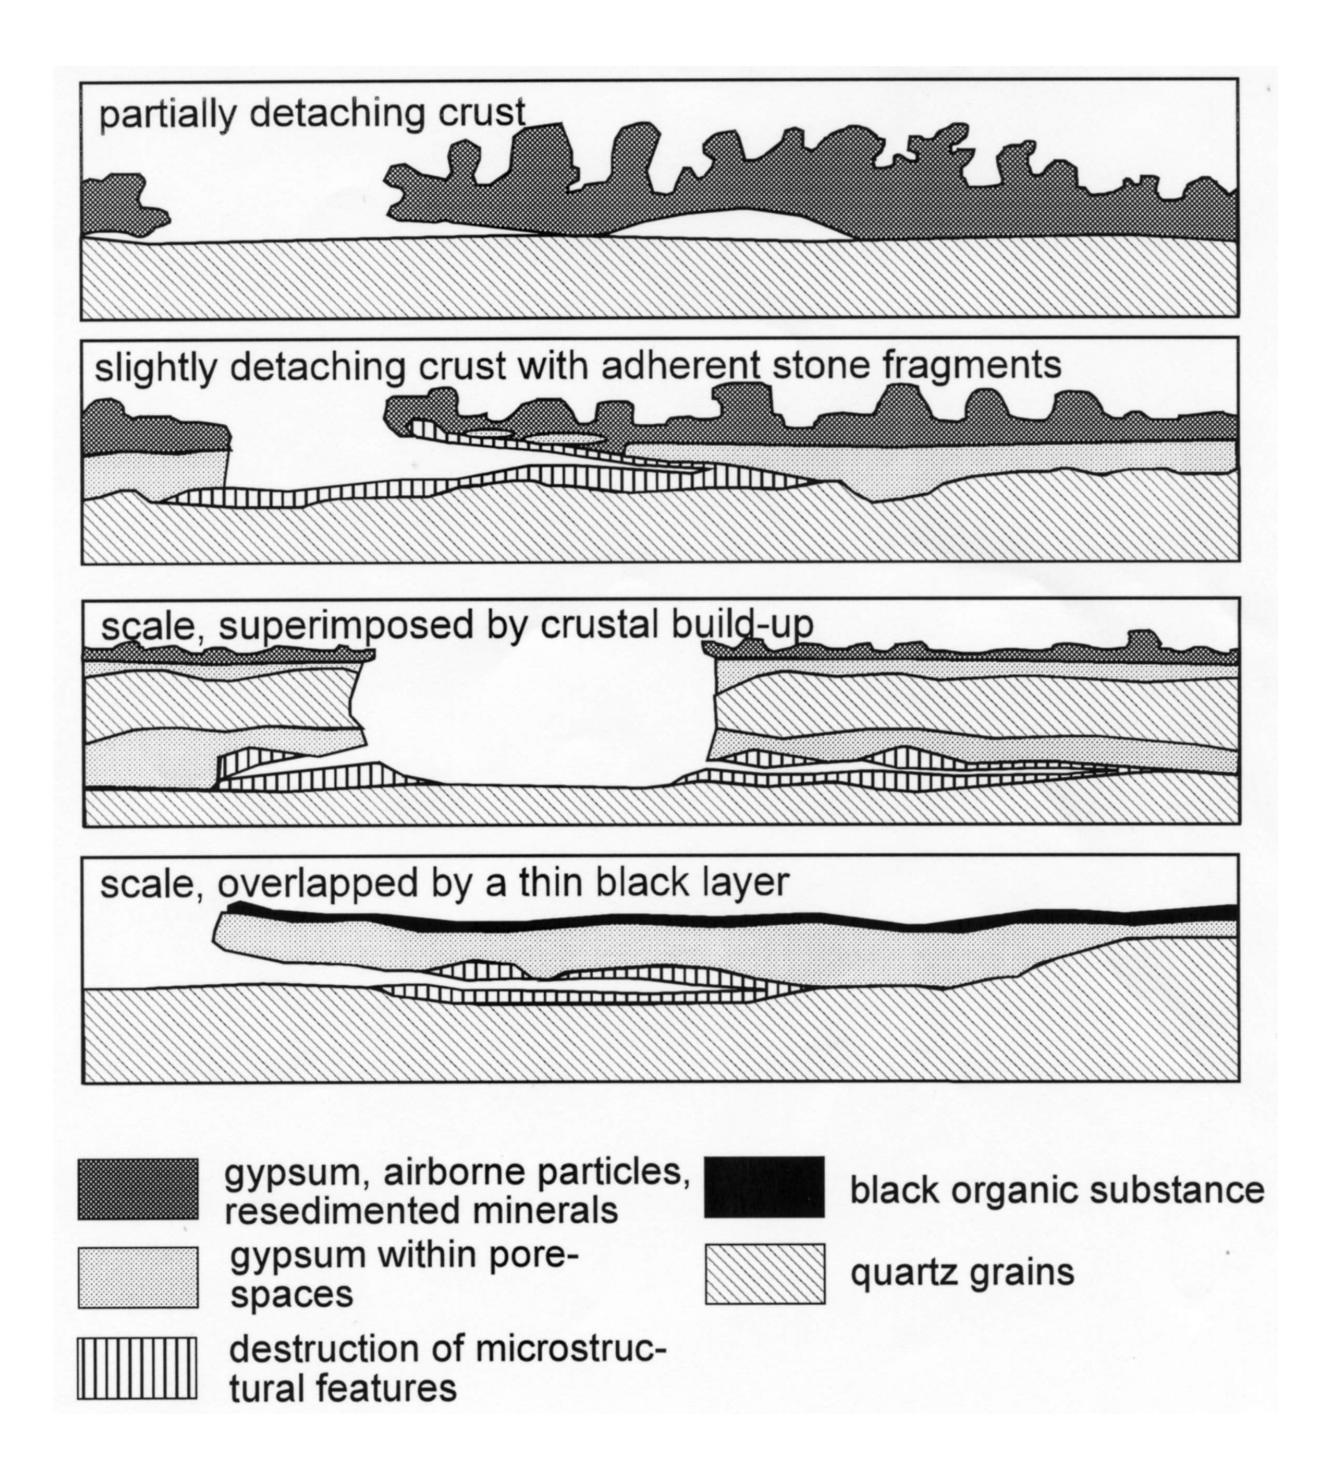
Fig. 1: Different types of microstructural changes (schematic illustration of cross sections)

A review of different typs of crusts and thin black layers and associated structural changes of the surface area is documented by schematic illustrations in fig. 1. Macroscopically visible back weathering may appear due to loss of crusts with or without adherent stone material. Only few crust build-ups under cornice overhangs or ledges do not show incorporated stone material, but all of them are characterized by outward gypsum growth on the stone surface (Fig. 2/3). The alteration crusts vary in thickness between 0,5 and 10 mm. Detached gypsum crusts intergrown with quartz grains from the sandstone are mainly observed in transition zones of sheltered areas not directly exposed to water runoff and rain exposed surfaces. These locations are characterized by a high moisture content and by a higher SO_2 uptake, not being washed out quantitatively.

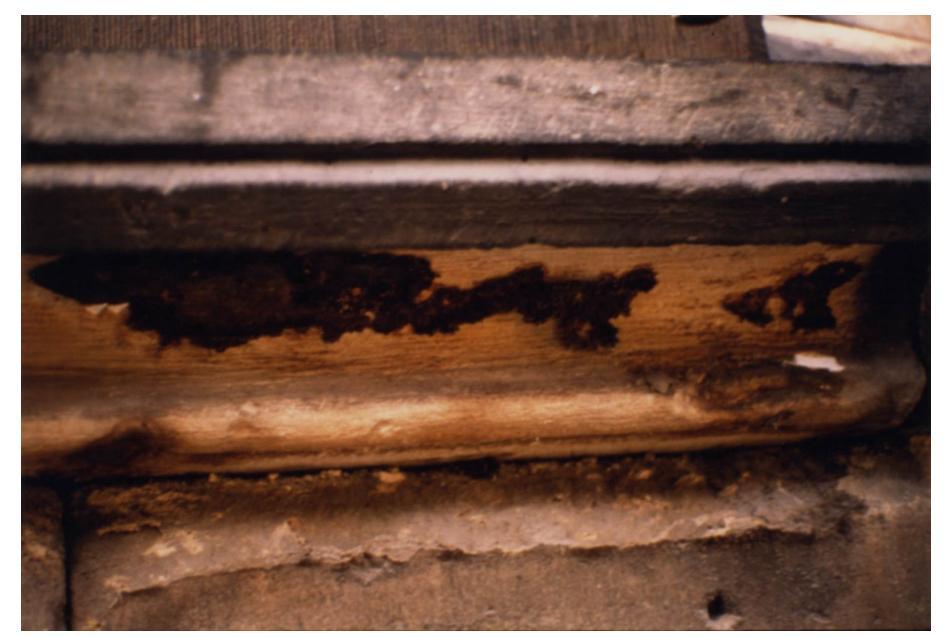
Fig. 2:

Partially detaching crust under a cornice, Erfurt cathedral (ER3)

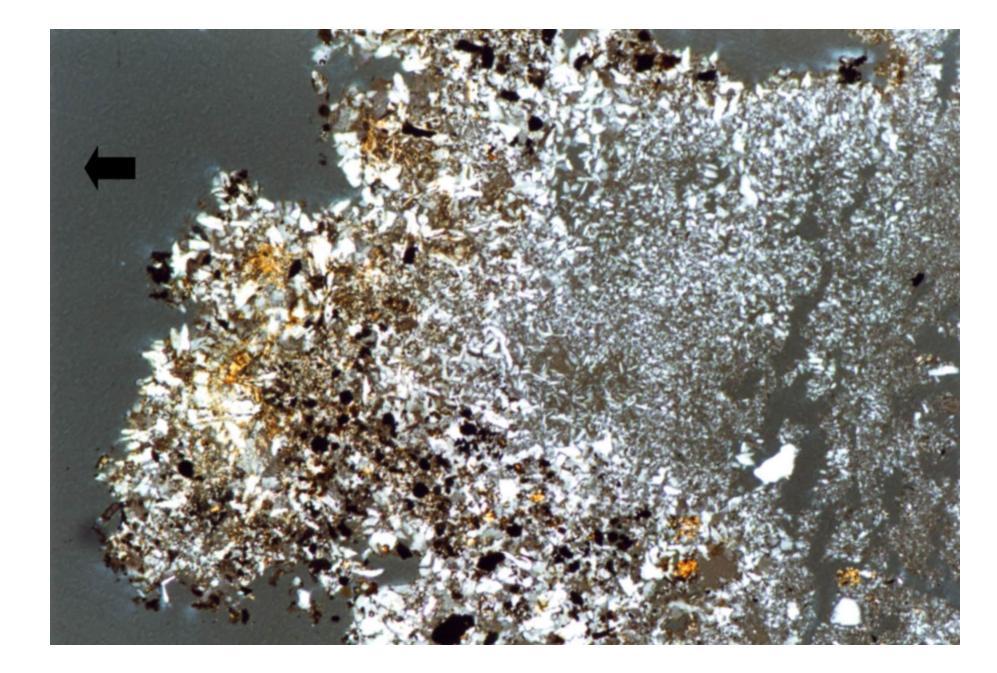
Fig. 3:

Thin section of sample ER3 (arrow points to the surface). X nicols.

A characteristical feature of detached crusts with adherent stone components is the destruction of their primary internal fabric by a secondary gypsum supported fabric. Additionally, a secondary porosity was generating. Often quartz grains with intracrystal microcracks are observed. Between this layer and the stone substrate several fissures have been detected, parallel oriented to the surface. They are follwed by a small zone of granular desintegration. The detached crusts are completely gypsum cemented and show blistering. Sometimes they seem to roll up from the subsurface.

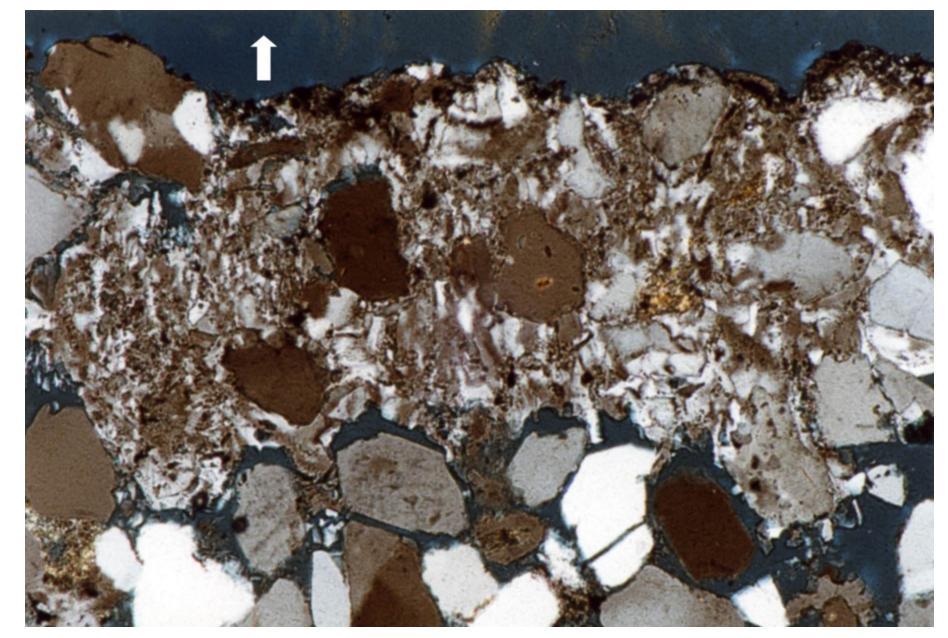
Fig. 4:

The same microstructural changes are recocognized in crust build-ups intergrown with the building stone. Macroscopically the investigated ashlars seem to be undamaged. Usually the internal destruction of the microfabric resulted in a loss of grain bond gradually moving inward from the crust-stone interface. Isolated grains or clusters of quartz grains are fixed in a network of gypsum crystals (Fig. 4), with a parallel arrangement of the constituents in respect to the surface. Perpendicularly grown gypsum crystals show suturated boundaries. Microcracks in quartz grains are rarely observed. In an advanced stage of damaging the quartz grains have lost any contact, being fixed in a gypsum supported fabric.

Quartz sandstone with a crust build-up. Quartz grains in the surface area are secondary stabalized through gypsum. Sample H BK484 from Leineschloß, Hanover (arrow points to the surface). X nicols.

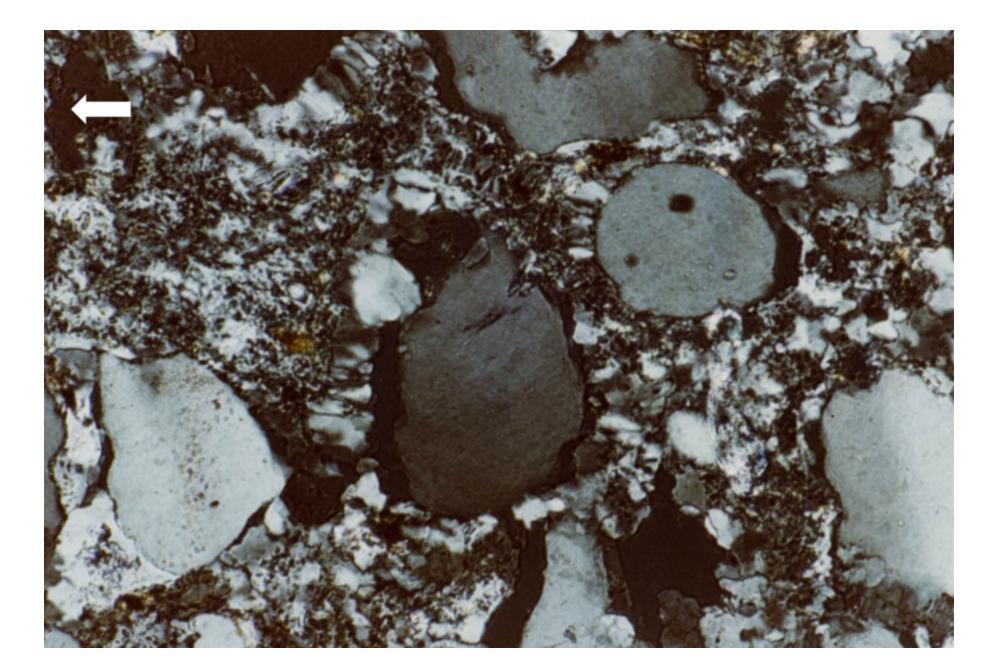
Fig. 5:

Another type of secondary microfabric originates from locations with a high moisture and gypsum content. Gypsum crystallization seems to record an inward growth from the stone surface, completely filling the pores, as far as visible to a depth up to 3 mm. The gypsum crystals often appeared to be cryptocrystalline. Occasionally clayminerals or organic matter, are found between the gypsum precipitates marking the original pore space of the primary microfabric right before disintegration. The microscopical examination of a sample from church Saint Mary in Zwickau suggests, that clear gypsum crystals were growing on the pore fillings towards the quartz grains as documented in fig. 5. In fact the expansion of mineral

phases within the fabric might generate higher values perpendicular to the surface than to the parallel direction. Only individual gypsum crystals were showing point contacts to the quartz grains caused by a different rate of growth. Thus, circulating secondary pores were developing. The sample was located within the transition zone of masonry and the cornice of the plinth, which was strongly affected by the uptake of sulfate saturated water in the area of runoff.

Structural changes of a quartz sandstone. Secondary gypsum stablized fabric. Sample Z 15c from church Saint Mary, Zwickau (arrow points to the surface). X nicols.

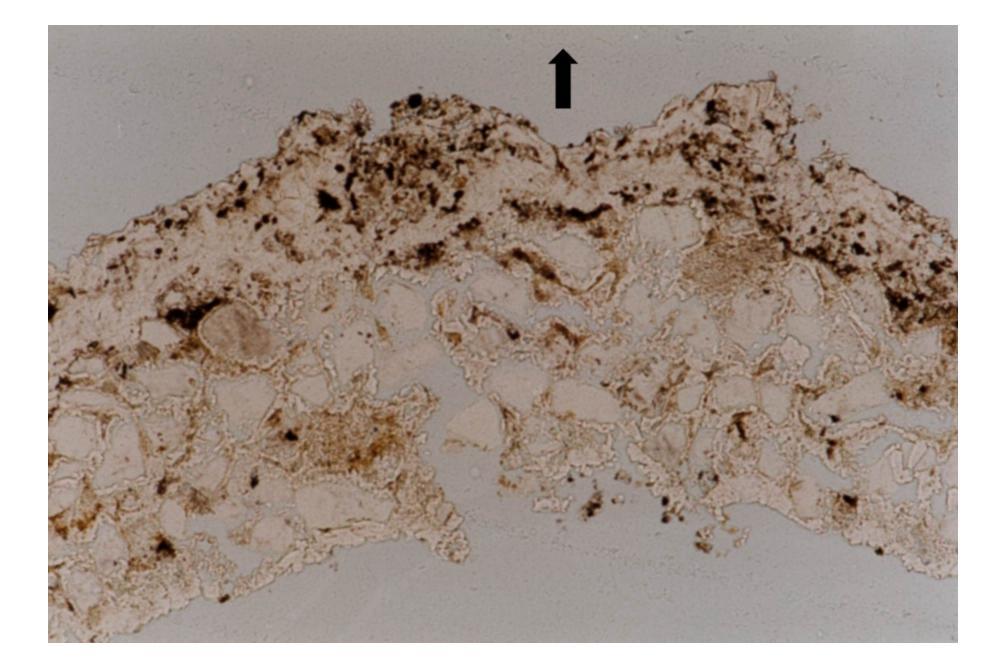
Fig. 6:

Identical microstructural patterns were visible at the little "Porticus" of the Leineschloß, presumably caused by percolating water as a result of a damaged roof. The weathering condition of the sample shown in fig. 6 is typical for a moderate rain sheltered position. On the back side of the above mentioned sandstone, contour scales separated from the stone substrate, covered by thin crustal overgrowths (Fig. 7). The structural change of the quartz sandstone takes place closely to the surface. The distribution of gypsum crystals is restricted to this area as well. It is assumed, that the content of percolating water on both sides of the building stone might increase to similar values, but the evaporation in front of the quartz sandstone is different to that of the backside. Thus causing differing structural alteration forms.

Detaching crust buildup with incorporated stonematerial. High gypsum content. Sample H 43, Leineschloß in Hanover, little Porticus (arrow points to the surface). // nicols.

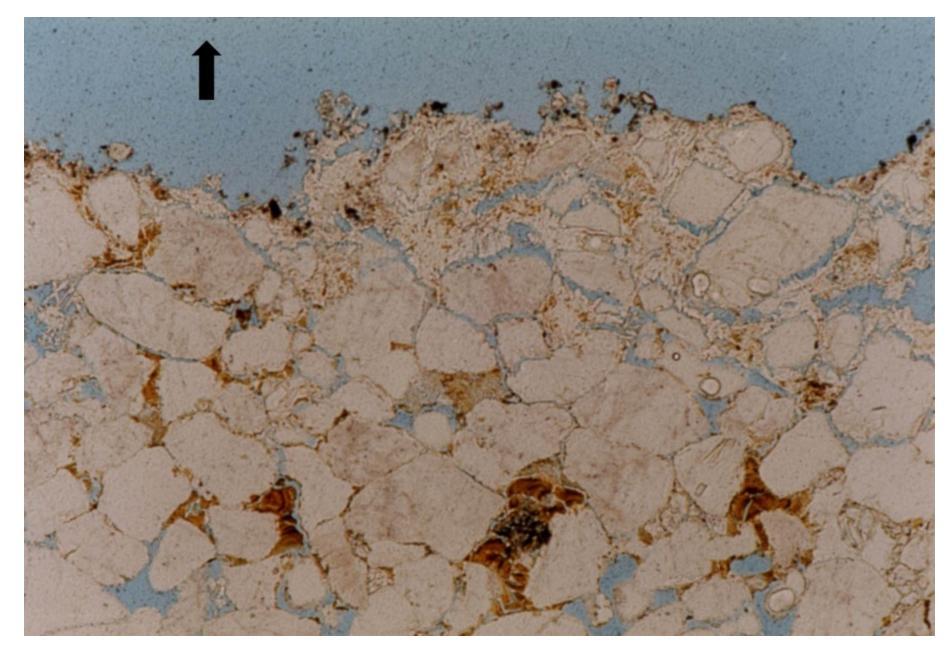
Fig. 7:

Exfoliation (backside not visible) covered by a crustal overgrowth and partially microstructural alteration. Sample H 43, Leineschloß in Hanover, little Porticus (arrow points to the surface). // nicols.

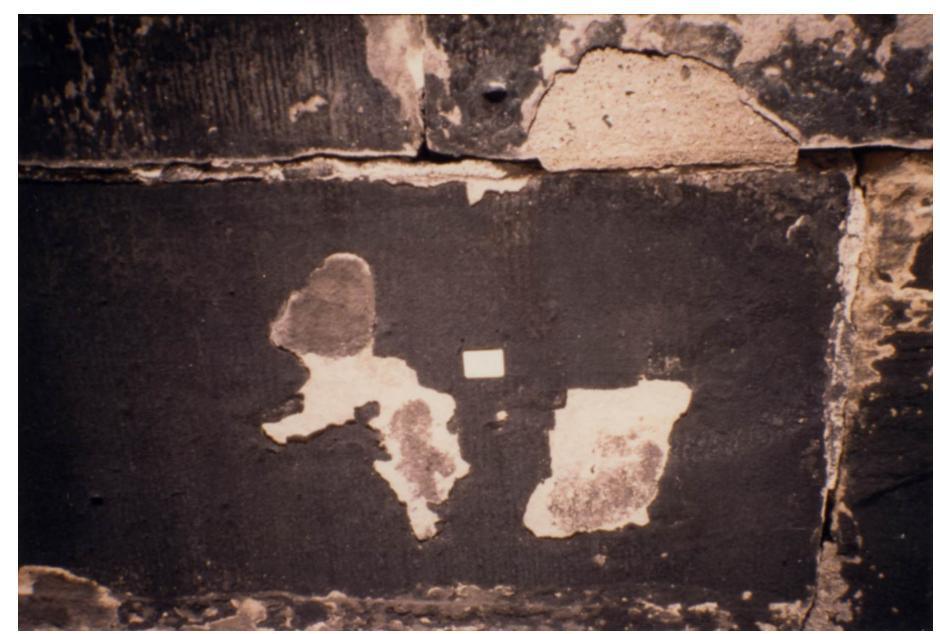
Fig. 8:

On sandstone facades with a black staining the most common damage is exfoliation of the surface area of the quartz sandstone, as illustrated in fig. 8. Neglecting the different origin, thin black layers normally range in thickness from 0,02 mm to 0,2 mm. Usually, the pore space beneath thin black layers is characterized by gypsum impregnation. However, a great variety of structural changes is reflected in the petrofabric. As demonstrated in Fig. 9, for example, gypsum and calcite (brown coloured compound, // nicols) completely filled pores within the exfoliating area. Underneath algae growth occured after detaching. It is suggested that the algae assimilation was responsable for the calcite precipitation (NEUMANN 1994). In other samples a high content of gypsum crystals seems to have affected the interior sides of scales, resulting in a severely disaggregated zone.

Scaling of the stone surface, overlapped by a thin black layer, Leineschloß, Hanover.

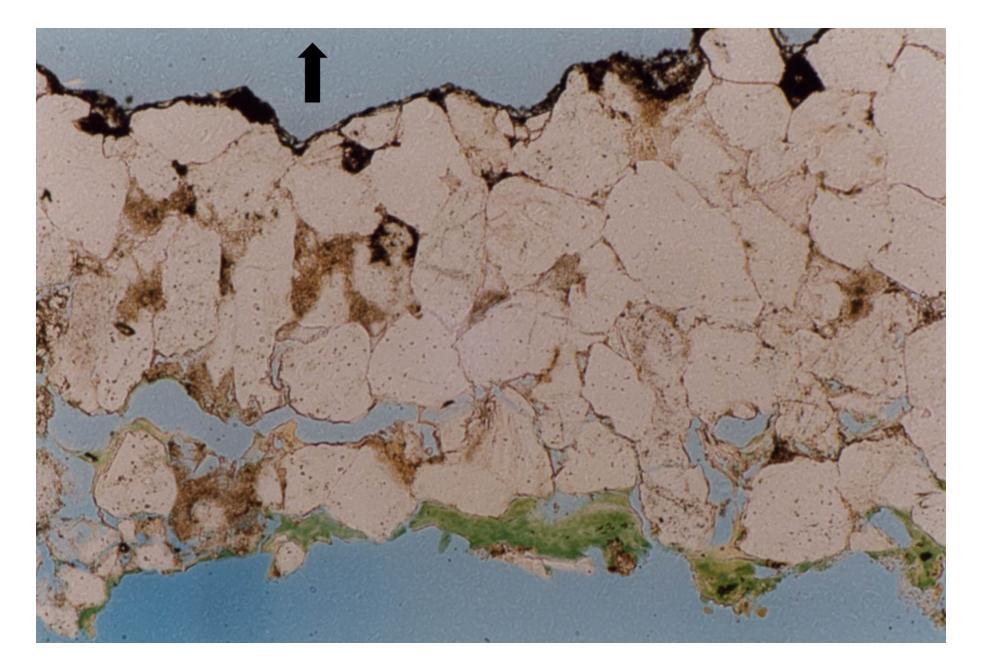
Fig. 9:

Cross section from exfoliation shown in Fig. 8. Sample H 67 (arrow points to the surface). // nicols.

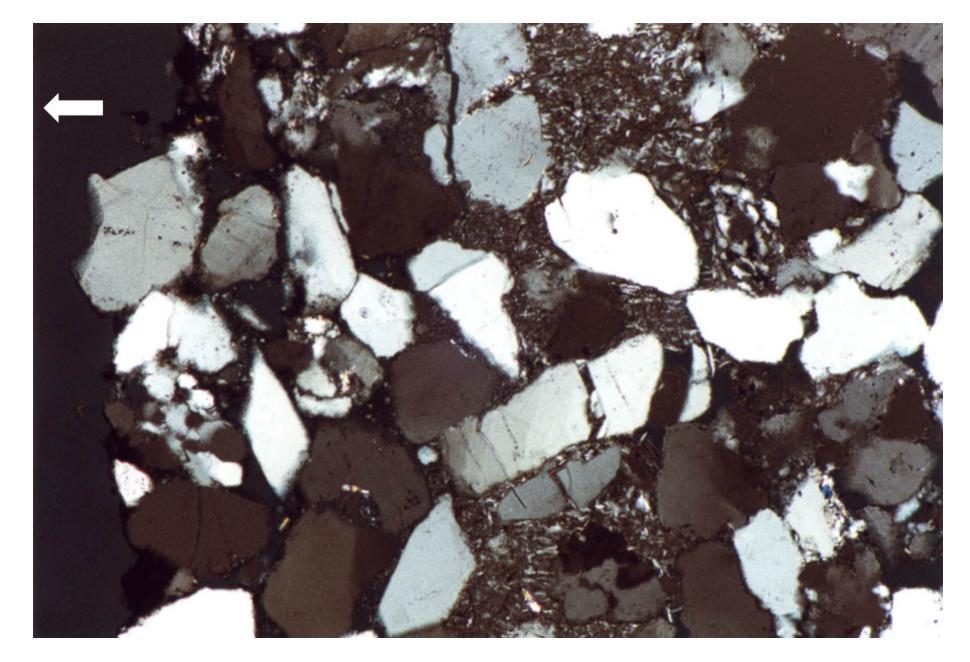
Fig. 10:

In areas without macroscopically visible damage the primary microstructure is destroyed frequently and replaced by a secondary gypsum supported fabric. If the depth of desintegration is considered, there is an analogy to the thickness of the investigated scales (Fig. 10). In these zones fracturing is evident within quartz grains.

Stone surface with a thin black layer. Macroscopically without damage. In the middle and right part microstructural changes are visible (secondary stabilized gypsum supported fabric, microcracks in quartz grains). Sample H 78 from Leineschloß, Hannover (arrow points to the surface). X nicols.

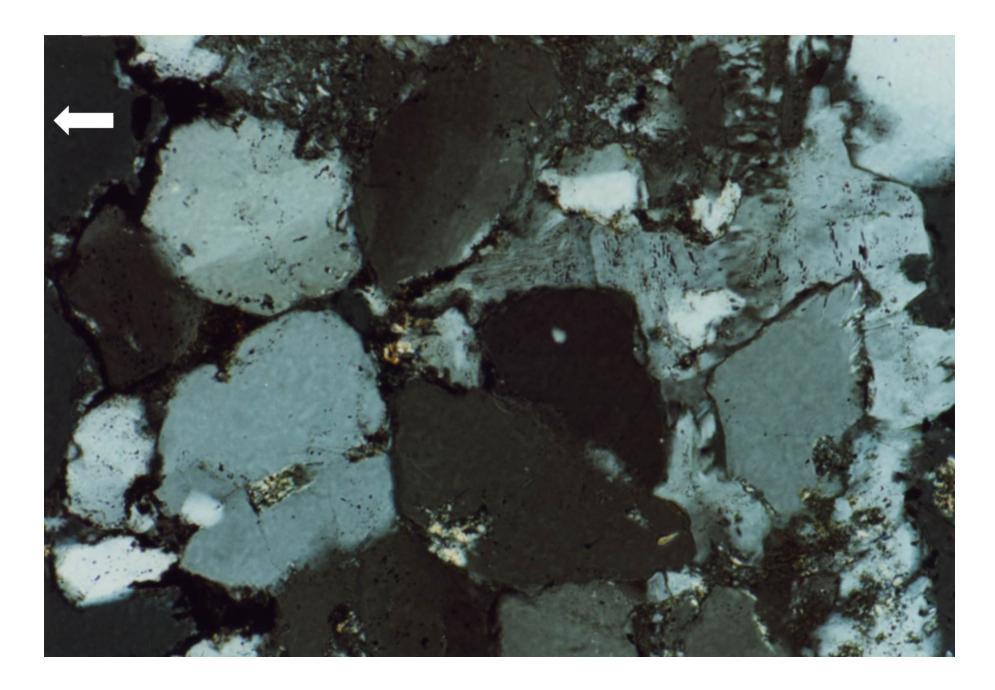
Fig. 11:

Poikilitic gypsum crystal in the pore space of a scale. Sample H 83 from Leineschloß, Hanover (arrow points to the surface). X nicols.

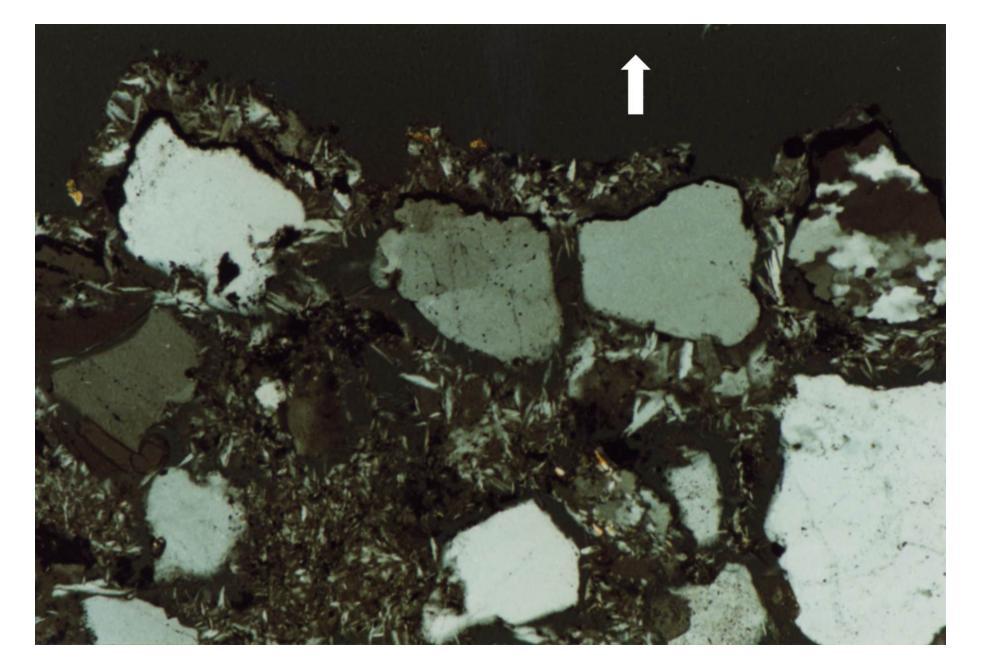
Fig. 12:

Microscopical investigations of the petrofabric support by documentary evidence (Fig. 12) that thin black layers develop into crust build-ups as a result of changing weathering conditions. A first step towards crustal formation is the generation of a thin black layer covering the stone surface. A certain joint mortar, being adjacent to the investigated sample (sample H 80a, Leineschloß, Hanover) already has lost its mortar-stone adhering force, resulting in fissure generation. For that reason, sulfate saturated solutions start to penetrate witin the stone substrate, the most likely mechanism of decohesion. Stone components are fractured by means of the gypsum growth and seperated from the underlying stone by the newly developing crust.

Development of a thin black layer into a crust build-up. Sample H 80a from Leineschloß, Hanover (arrow points to the surface). X nicols.
