Salt extractions of brickwork: a standard procedure?

H. De Clercq* and S. Godts

Royal Institute for Cultural Heritage (KIK-IRPA), Brussels, Belgium

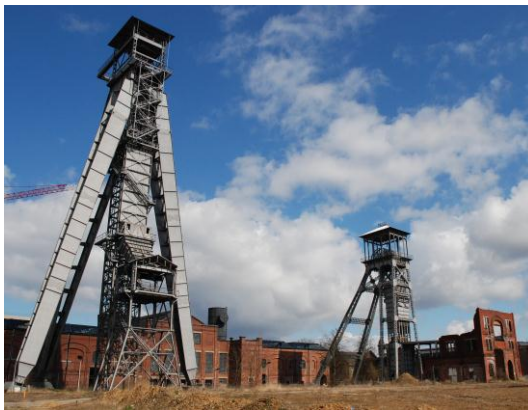
Figure 1: Coal mine site in Winterslag (wikipedia)

The *Kempen*, the eastern part of Belgium, was during the 20th century known for its coal mine activities. One of the seven coal mines was located at Winterslag (Figure 1), active from 1917 till 1988. After a period of neglect, the entire mine site became the subject of stepwise rehabilitation projects. The C-mines, where the “C” stands for “creativity”, comprise a unique industrial heritage and a witness of historical industrial activities typical for the region.

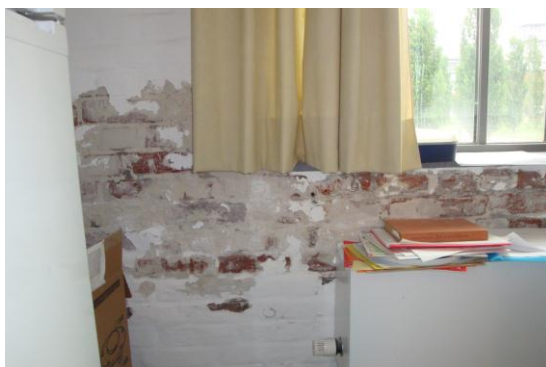
Figure 2: interior wall with salt damage due to the presence of up to 7.5 w% sodium chloride in the mortar and at least 1 w% in the brick

A section of the old C-mine buildings was transformed into workshops and exhibition rooms for a local artist designing ceramics. Salt analyses on mortar and brick samples revealed a high salt content, principally composed of sodium chloride at contents up to 7.5 w% in the mortar while at least 1 w% in the brick, crystallizing around 75% RH (ECOS/RUNSALT output, not shown here) and causing damage to the finishing layers as shown in Figure 2.

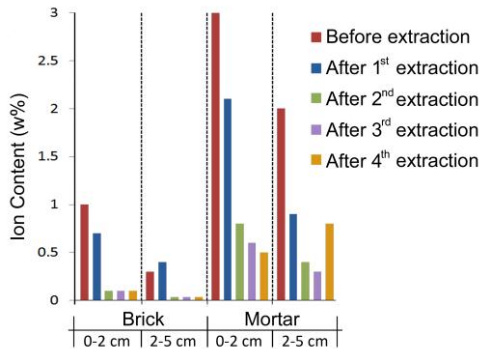
Figure 3: results of the total ion content before and after 4 salt extractions of brick and mortar samples, 0-2 and 2-5 cm.

therefore, it was advised to carry out salt extractions to decrease the salt content in the walls. The paint layer was carefully removed followed by a pre-humidification (2 l/m^2) prior to the application of a poultice for the salt extraction. The poultice, with a composition as described earlier, was applied on 1m^2 four times, such that a new application immediately followed the previous one, again after pre-humidification (2l.m^{-2}). The poultice was easily mixed and applied to the wall; it dried equally starting at the borders curling off the substrate. No shrinkage cracks were noticed. During all four application it took approximately ten days before it partly sagged down. Because it still adhered to the wall it was then removed mechanically. After each application, drill powder samples were lifted from the brick and the mortar at a depth of 0-2 and 2-5 cm from which the salt content was quantitatively determined [10]. The results of the total ion content before and after 4 salt extractions are shown in Figure 3.

Initially, the brick contains a lower salt content compared to the mortar. The results show that after one poultice application the salt content in the brick is reduced to an acceptable value and even more so after two applications. This is not the case for the mortar for which at least three applications seem necessary. An inconsistency was noticed within the depth of the mortar as the salt content increased after the fourth application at a depth between 2-5 cm. This could indicate that the dissolved ions are being pushed deeper into the wall rather than being extracted. In the following case study the sample depth was increased to understand this phenomenon.

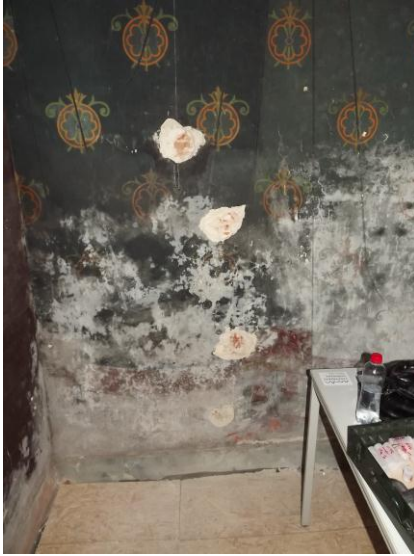
Figure 4: typical damage pattern of a 19th century mural painting in the St-Vincentius Chapel.

The 19th century mural paintings of the St.-Vincentius- and St.-Jozeph Chapel of the Antwerp Our Lady Cathedral showed salt efflorescence and severe damage. Figure 4 illustrates an example of the typical damage. The restoration vision includes the preservation and restoration of the mural paintings and underlying plaster layer, if advised from a material-technical point of view. To scientifically approach this vision, the salt contamination of the plaster and underlying brick masonry was mapped out according to the damage patterns (discoloration, staining and/or loss of the paint layer and lack of adhesion and powdering of the plaster). Similar to the previous case study, samples were lifted from the plaster and underlying brickwork to a depth of 5 cm from which the salt content was determined.

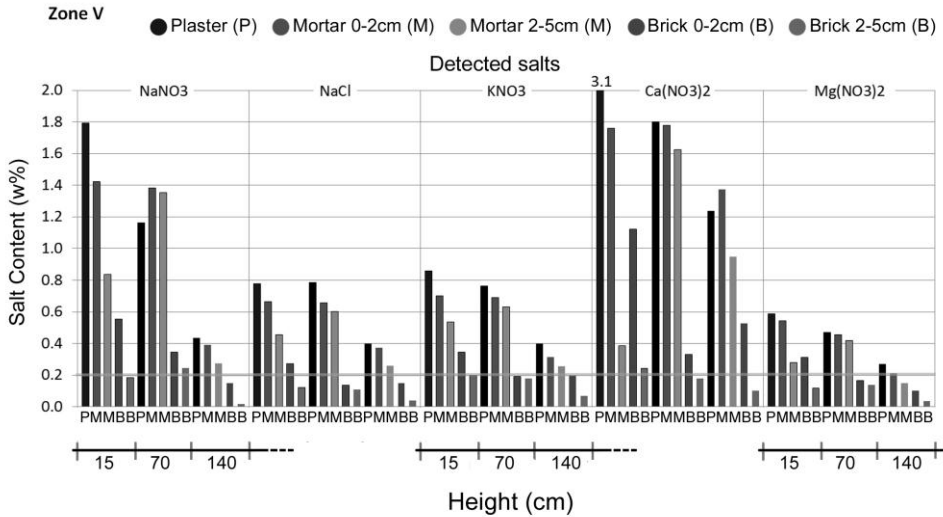
Figure 5: zone V, content of sodium chloride and nitrates of plaster and underlying brick and mortar at two depths and several heights.

As an example Figure 5 illustrates the results of the salt content in plaster, brick and mortar at several heights and depths. Excluding gypsum the salt contamination consisted of mainly sodium chloride and nitrates.

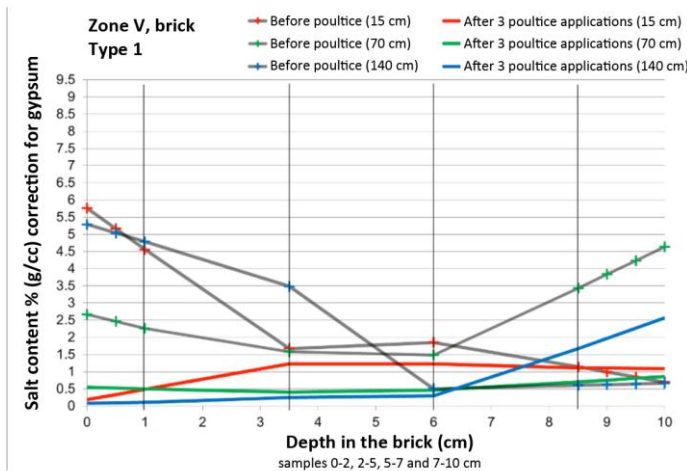
Figure 6: average salt content (% , g/cc) before and after the third salt extraction of brick samples lifted at different heights and to a depth of 10 cm.

Following the results of the simulated extraction process, a poultice was applied three times on two different zones of about 2 m height and 1 m length of a brick wall. The effect of the salt extraction was controlled by moisture and salt content measurements. Figures 6 and 7 illustrate the results expressed as total average salt content for respectively brick and mortar before and after the third application.

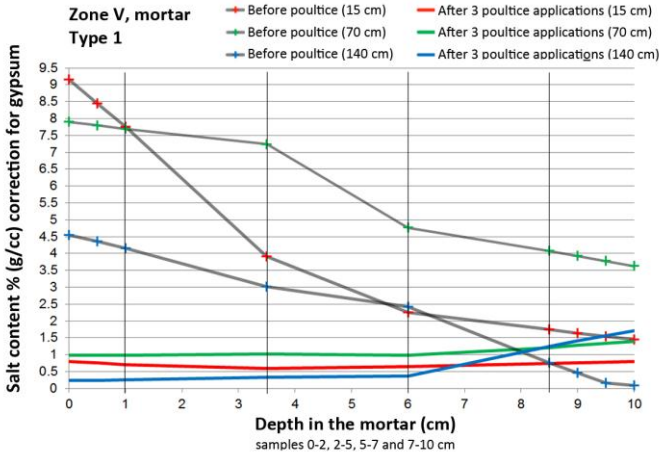
Figure 7: average salt content (% , g/cc) before and after the third salt extraction of mortar samples lifted at different heights and to a depth of 10 cm.

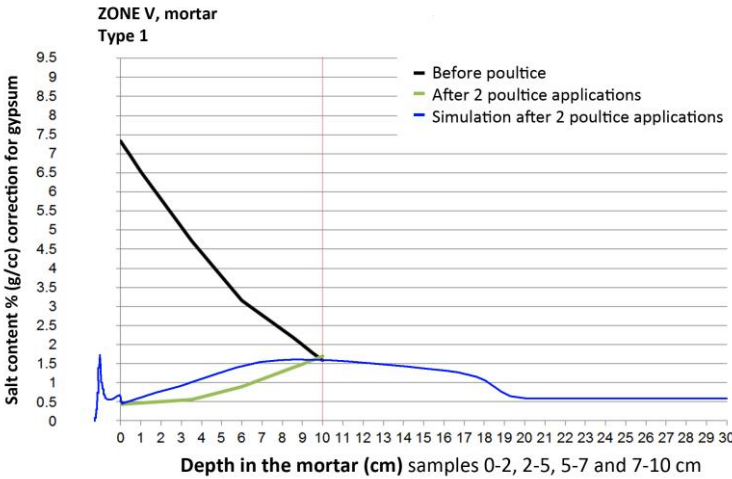
Figure 8: experimental average salt content (% , g/cc), before and after the second salt extraction of the mortar and related to the theoretical one.

The experimental results were compared to the ones theoretically determined by modelling (Dephin 5.5) (Figure 8) from which a good agreement was concluded.

Both experimental and simulated results show that the salt content was significantly reduced, especially in the first 5 cm. However, especially at a

height of 140 cm, an increase of the salt content was noticed starting at a depth of about 6 cm, indicative for a salt migration deeper into the masonry. In terms of durability of the restoration strategy, the extent of their migration back to the surface is a crucial point.

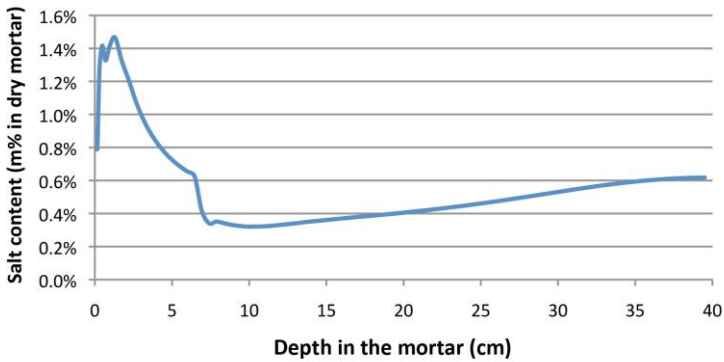
Figure 9: simulated total dissolved salt content (m%) in the mortar for a brick masonry after 1 year.

Hence, in order to address the influence of the application of a 1 cm thick lime plaster layer on the long-term salt distribution of brickwork, and hence the risk assessment of salt damage to the future plaster and paint layer, further simulations were carried out. For example, Figure 9 illustrates the simulated total salt content for mortar of brickwork, without a plaster layer, after 1 year, while in Figure 10 that for brickwork including a plaster layer over a longer time span (3 years).

The simulated results revealed that, without plaster, the water introduced during the pre-wetting of the three salt extractions, dries out very slowly; after one year the outer 5 cm of the mortar is quite dry, while the underlying part is still quite wet (not shown here). In this surface layer, the salt content increases to 1.1 w% on average. Applying a plaster of 1 cm thickness results in a further decrease of the drying, and hence of the amount of salts migrating back to the surface; in this case the outmost 5 cm contains on average 0.8 w% of salts after 3 years. Taken into account that initially, before salt extraction, the average salt content of this surface layer was maximum 4.9 w%, this corresponds to a long-term decrease of at least 80 %. Moreover, it is supposed that the paint layer as such will further reduce the drying process and hence the migration of salts to the surface.

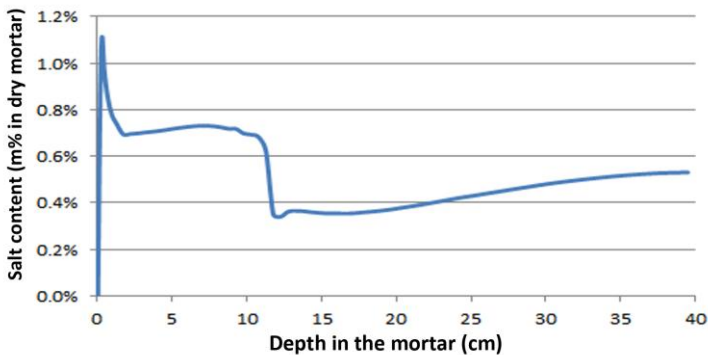
Figure 10: simulated total dissolved salt content (m%) in the mortar for a brick masonry containing a 1 cm thick plaster layer after 3 years.
