Salt conversion, backfilling, and back anchoring: the securing of the painted ceiling of the Red Hall in the Neues Museum, Berlin

W. Wedekind* and J. Rüdrieh†

Geoscience Centre of the University of Göttingen, Göttingen, Germany

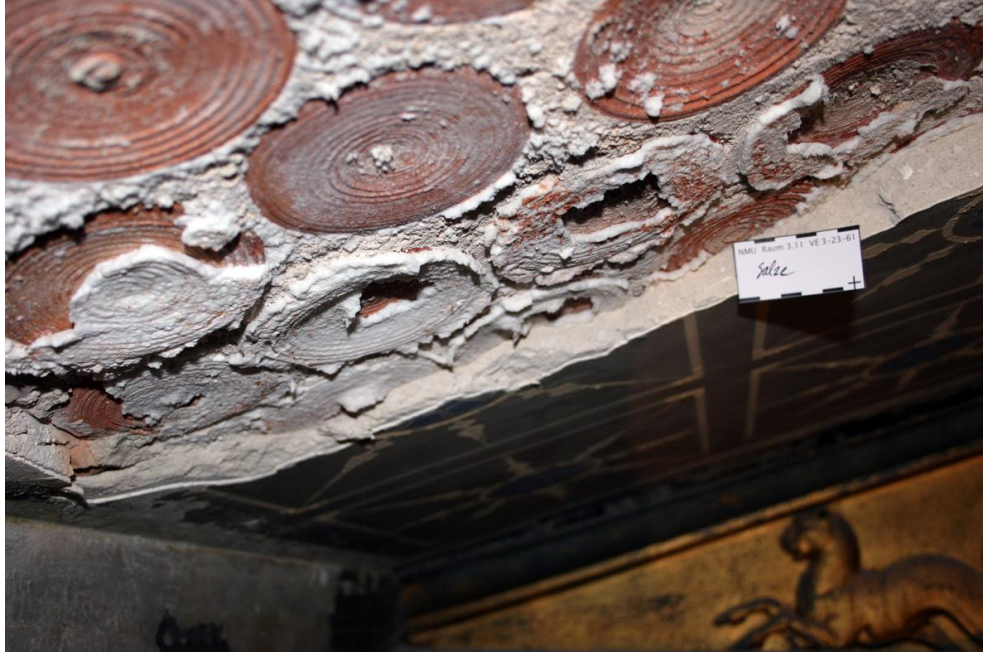
Figure 2: Massive salt efflorescence under the fallen ceiling area.

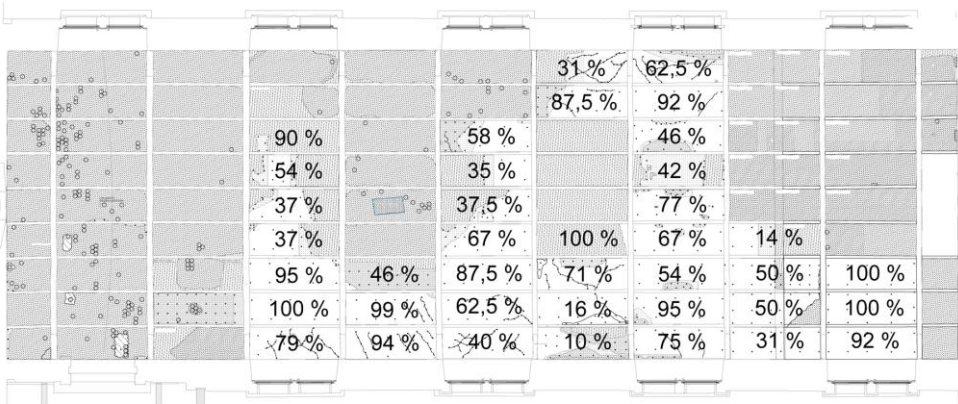
Figure 4: Hollows in percent (drawing adapted from pro Denkmal).

For each plaster area to be treated cracks, hollow spaces and all subsequent measures were mapped. Detection of the hollows was done by simple knocking. The mapping of the hollowed areas yielded different results (Fig. 4): the extent of the hollow areas varied between 10 and 100% with an average of 63%.

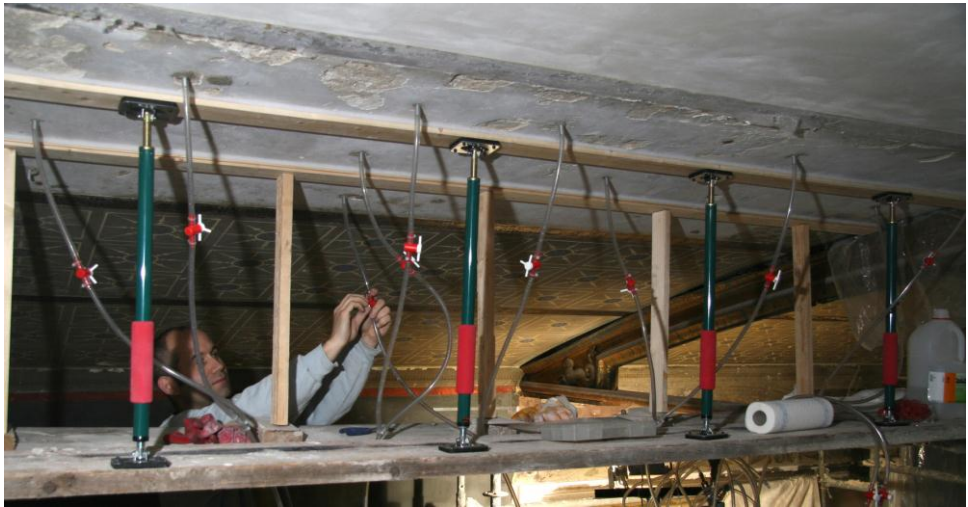
Figure 5: Installation of the hose and packer system (photo: Hüttich).

During the conservation work the respective plaster areas were supported by at least six corner steadies (Fig. 5).

After the salt conversion and drying, the hollow space was filled using the same apparatus. For this step the plaster was secured partially lengthwise with cushioned slats and corner steadies (see Fig. 5).
