Sodium chloride damage to porous building materials

PROEFSCHRIFT

Barbara Antonietta LUBELLI

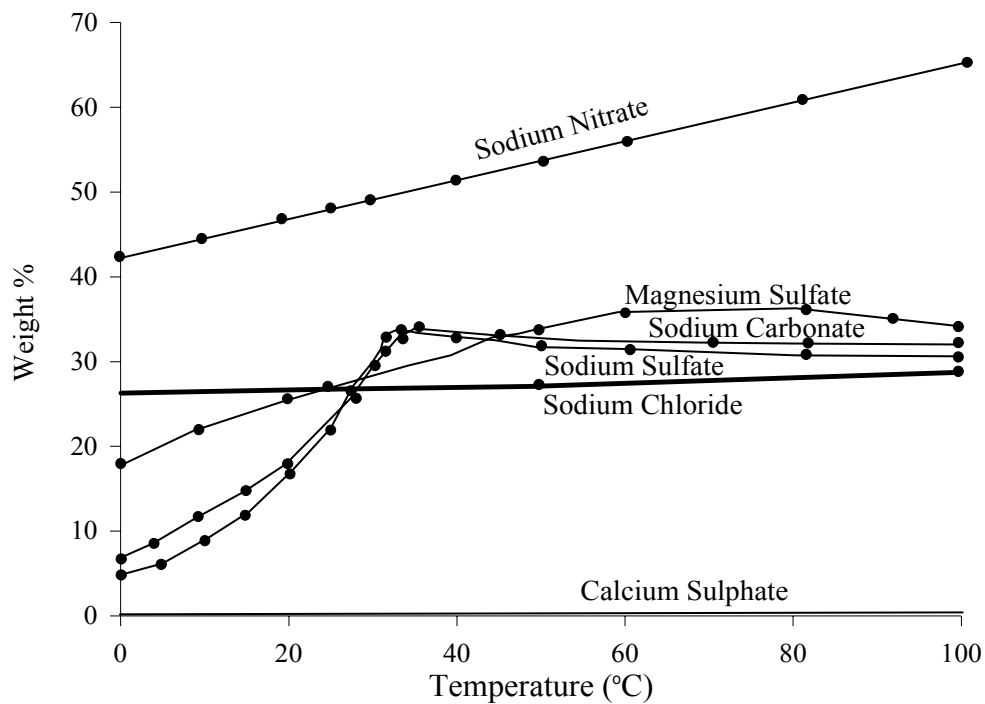
Figure 2.1 Solubility of different salts in relation to solution temperature [Gou97]

When an ionic solid dissolves in water, bonds within the crystal lattice are broken and formed between the liberated ions and water molecules. For most salts the solubility increases with increasing temperature. By contrast the solubility of sodium chloride is almost independent of temperature (figure 2.1).

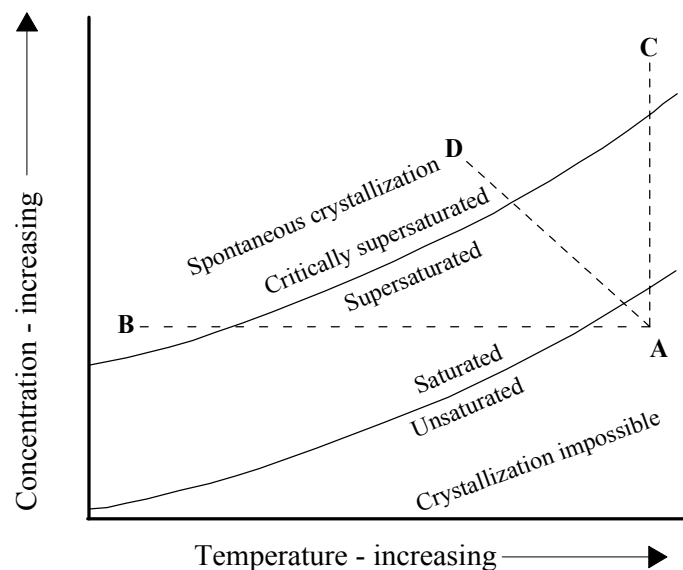
Figure 2.2 Temperature – solute concentration plot [Win94]

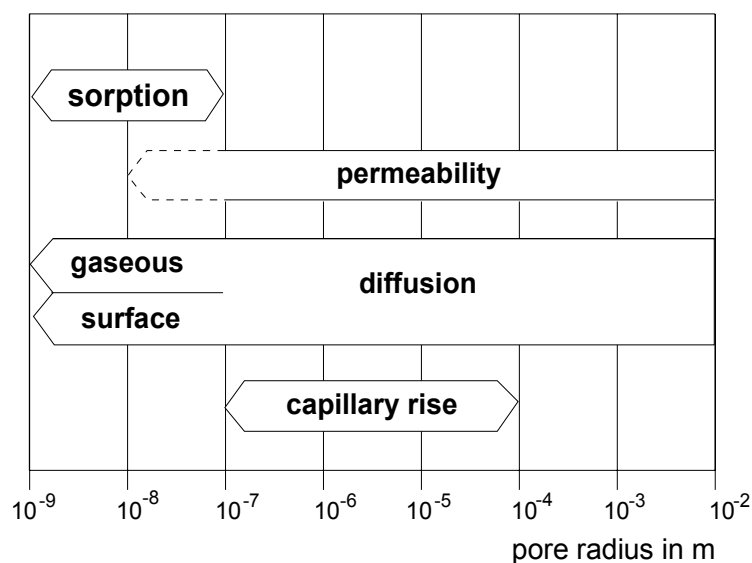
Figure 2.4 Size ranges of relevance for different transport phenomena [Men92]

The different mechanisms of moisture transport effective at the different pore sizes are summarized in figure 2.4.

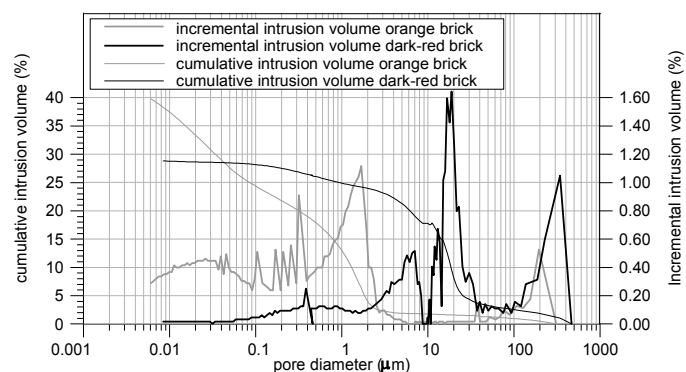
Figure 3.1 (left) Different seriousness of salt damage in bricks exposed to the same environmental conditions (church in Oostkapelle, The Netherlands)

The influence of the pore size distribution on the occurrence of salt damage has been observed by the author in the case study of the church of Oostkapelle (NL). The west wall of this building, subjected to sea-salt spray, showed the presence of two types of bricks, recognizable by their colour: orange bricks and dark-red bricks. Notwithstanding the fact that both brick types were subjected to the same environmental conditions, the orange bricks were seriously powdered whereas the dark-red bricks were not damaged (figure 3.1). From the analyses performed it was found that the orange bricks had a high open porosity (about 40% vol/vol), constituted by a large number of small pores ($< 2\mu\text{m}$), whereas the dark-red bricks had a lower open porosity and almost no small pores (figure 3.2). The analyses of thin sections of the two types of brick showed that the fine porosity measured in the orange brick is most probably the result of a large carbonate content in the original clay and of the use of too low firing temperatures [Lub05a]. In this case the orange brick has also a higher open porosity than the dark-red brick, resulting in a low mechanical strength.

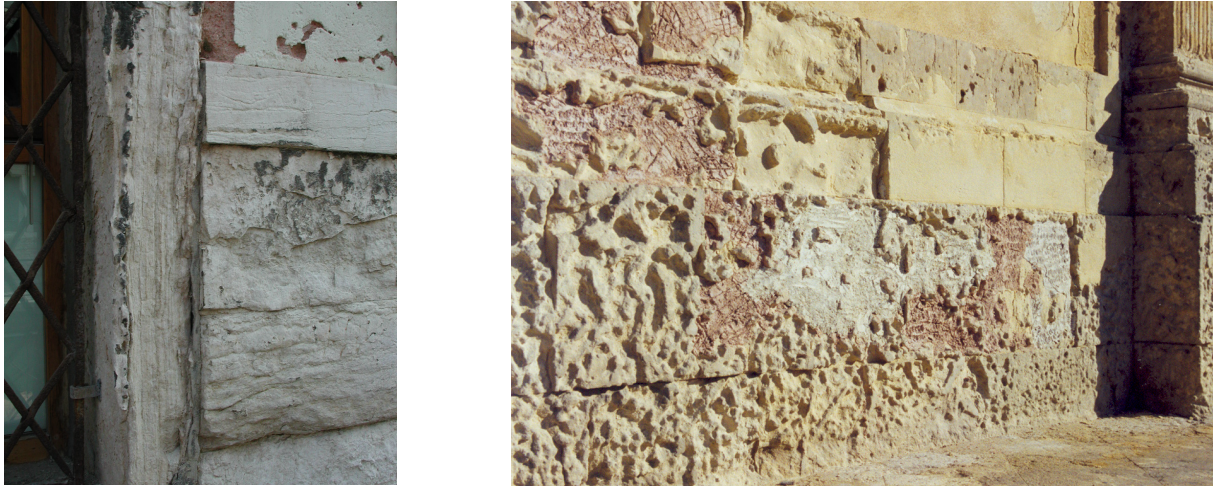
Figure 3.3 (left) Preferential weathering showing as delamination in Istria stone (building in Venice, Italy)

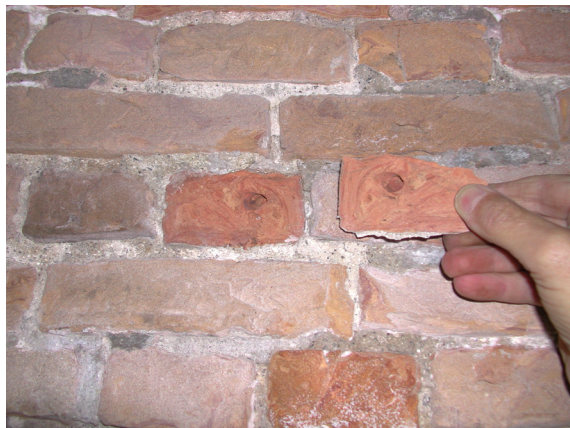
Figure 3.5 (left) Delamination of brick (mill in Alkmaar, The Netherlands)

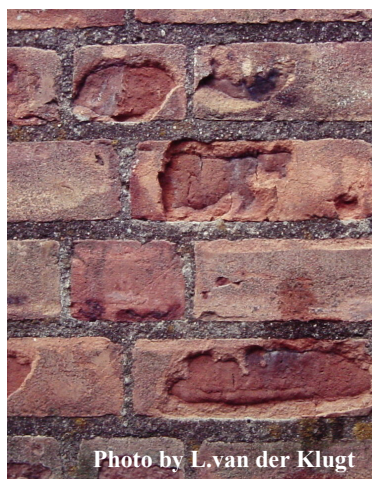
Figure 3.7 (left) Spalling of the treated outer layer of the bricks due to the application of a water repellent (building in Rotterdam, the Netherlands)

Discontinuities in homogenous materials may also be introduced in a later stage, for example by the application of surface treatments like water repellents. These create an outer zone permeable to vapour but not permeable to liquid: the salt, which can be transported only in solution, accumulates under the treated layer, resulting in spalling of the treated part (figure 3.7).

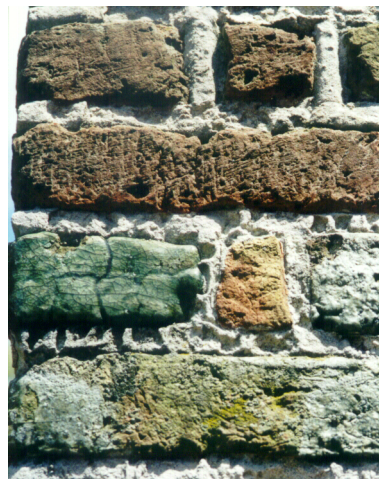
Figure 3.8 (middle) Alveolization of mortar joints (church in Heer Abtskerke, The Netherlands)

alveolization of mortar joints in the presence of salts observed in the case study of Heer Abtskerke and Oostkapelle. Holes are visible in the middle of the joints. These holes may be separate (figure 3.8) or connected to form a long groove (figure 3.9). Presence of lime-blowing, or inhomogeneities due to a bad mixing, the application technique or differences in the degree of carbonation, may be at the origin of these peculiar damage patterns.

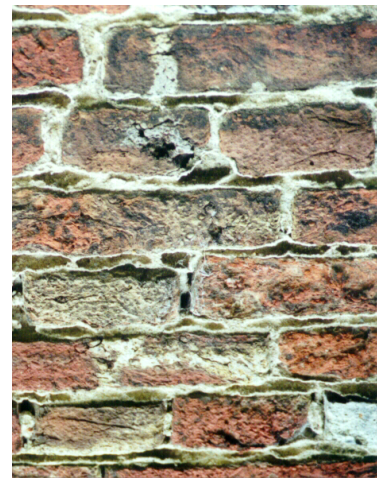
Figure 3.9 (right) Dissolution of the mortar starting in the middle of the joint (church in Oostkapelle, the Netherlands)

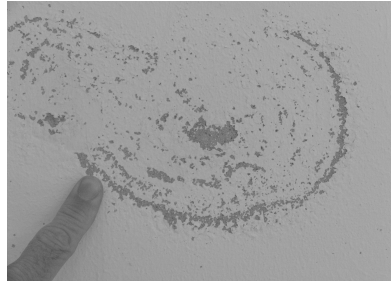
Figure 3.10 Damage pattern originating probably from the application technique (St. Nicholas church in Brouwershaven, the Netherlands)

Sometimes differences in properties and damage patterns may be related to the application techniques [Bal05]: this probably happens in the decay of the plaster inside the church of Brouwershaven where the circular decay pattern (figure 3.10) seems to be caused by the shape of the tool and the technique used during the application.

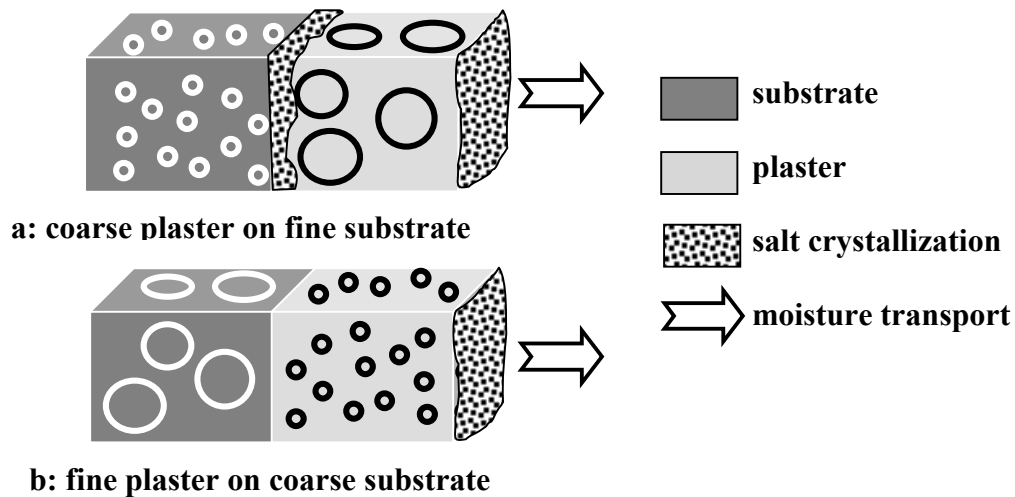
Figure 3.11 Moisture transport during drying of two initially saturated two-layers systems: the arrows indicate the direction of the moisture transport, from the substrate (dark grey) to the plaster (light grey). Depending on the pore size distribution of the plaster/substrate combination, salt accumulation occurs at the interface between the two pore systems (a) or at the surface of the plaster (b)³

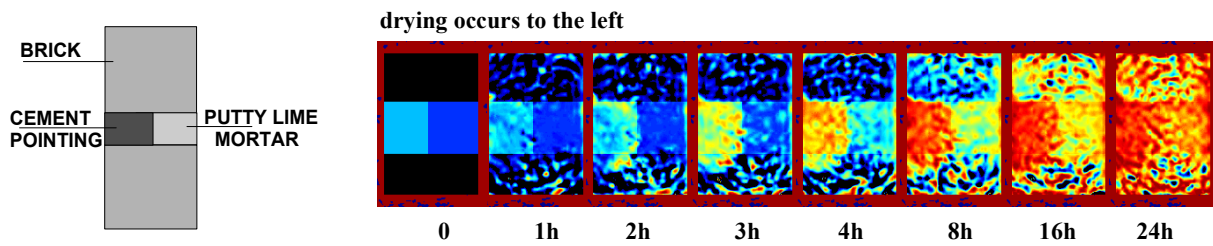
Figure 3.12 The 2D moisture distribution as measured in the system: brick – putty lime bedding mortar – cement pointing during a drying experiment at 0, 1, 2, 3, 4, 8, 16 and 24hours: blue indicates wet areas, red indicates dry areas [Lub01]

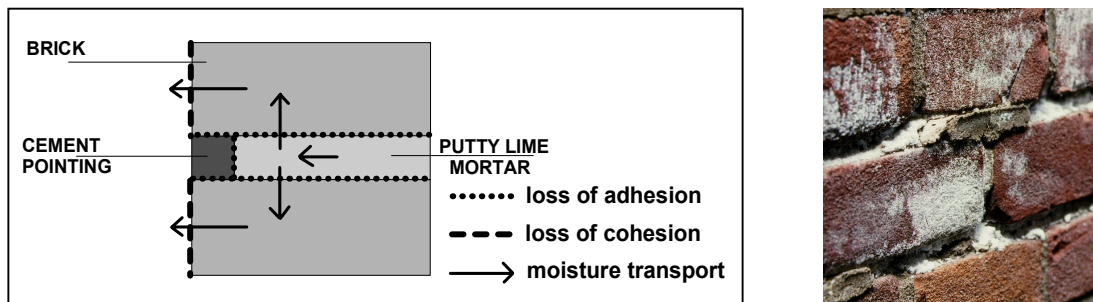
Figure 3.13 (left) Drying behaviour of the system: brick – putty lime bedding mortar – cement pointing mortar: salt accumulation occurs at the interface between the putty lime bedding mortar and the cement pointing resulting in loss of adhesion and push out of the pointing

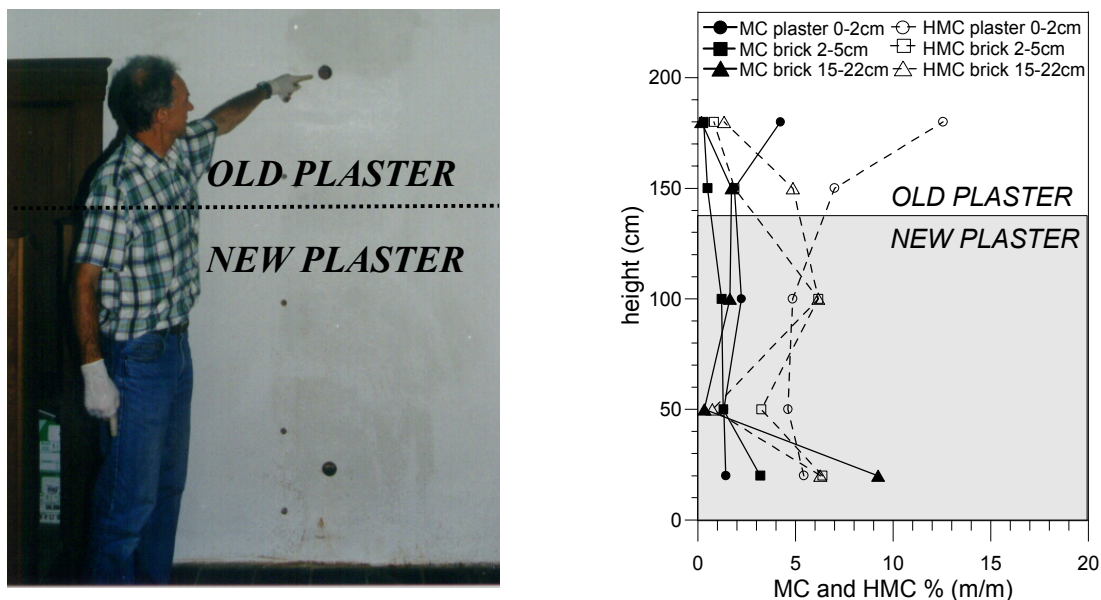
Figure 3.15 Location of the sampling (left) and moisture (MC) and hygroscopic moisture content (HMC) (right): salts concentrate in the old plaster and new damage occurs (church in Dreischor, the Netherlands)

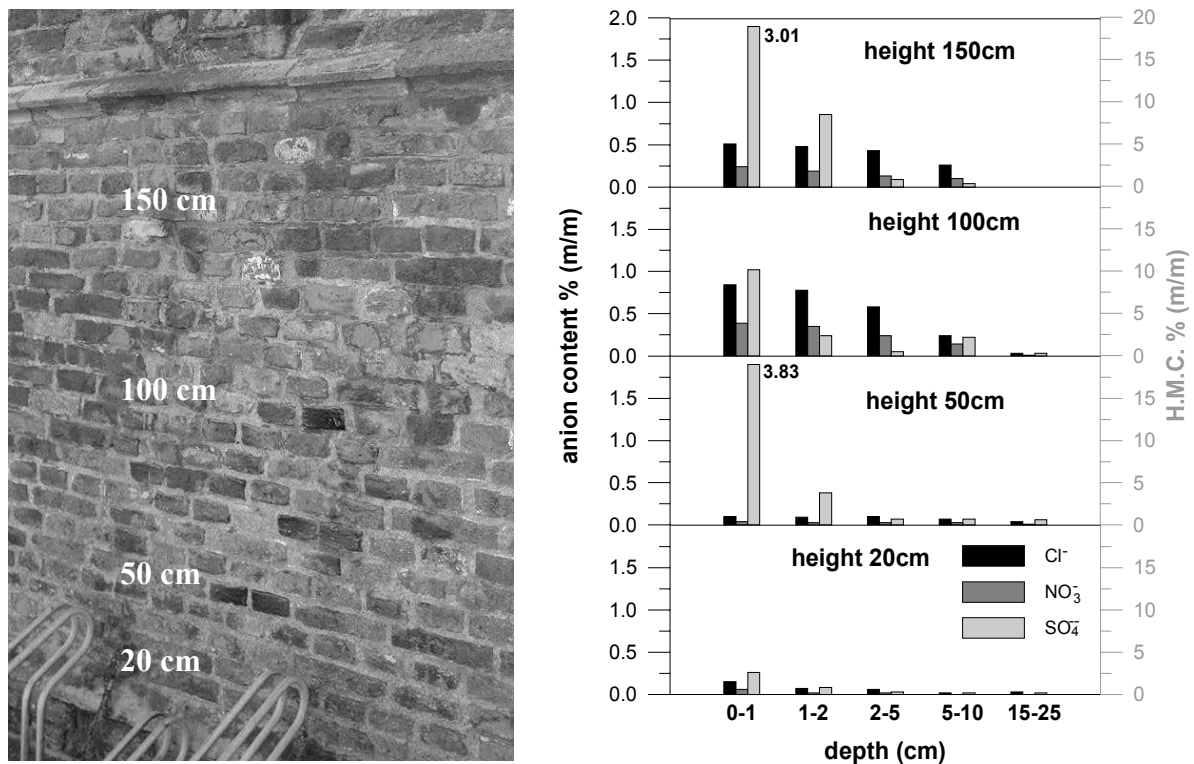
Figure 3.16 Location of sampling (left); anion distribution (measured by ion chromatography) along a vertical profile at different depths (right) (church in Domburg, the Netherlands)

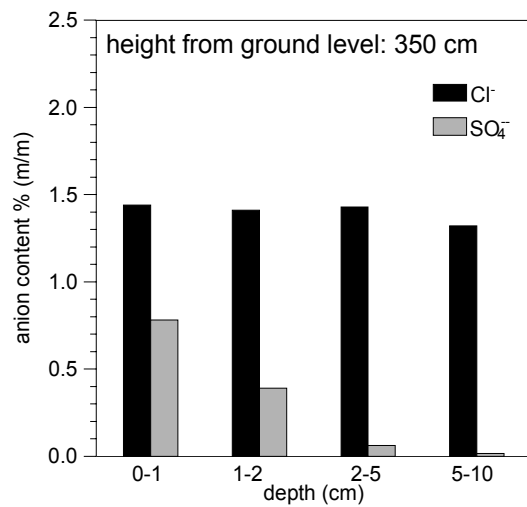
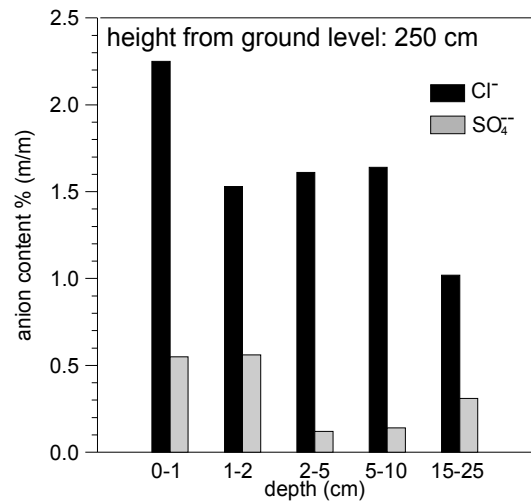
Figure 3.17 (left) Cl^- and SO_4^{2-} content in brick subjected to sea-salt spray (church in Oostkapelle, the Netherlands)

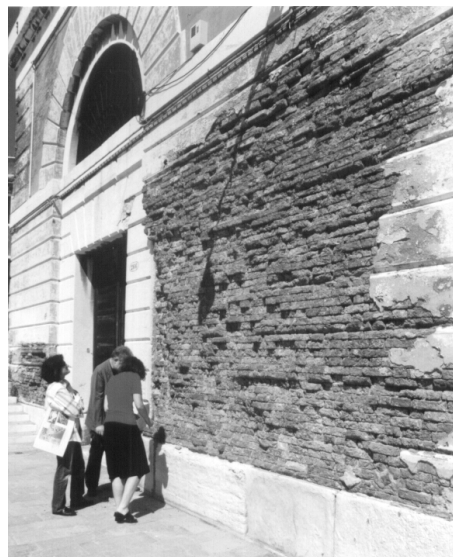
Figure 3.19 Salt damage on the exterior wall of a building used as salt storage in the past (Magazzini del sale, Venezia, Italy)

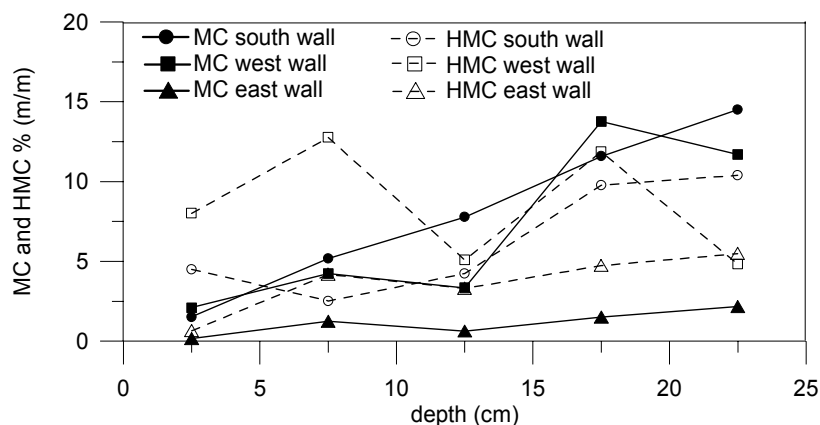
Figure 3.20 Moisture (MC) and hygroscopic moisture content (HMC) on different orientations. The depth is measured from the interior surface (0 cm) (mill in Alkmaar, the Netherlands)

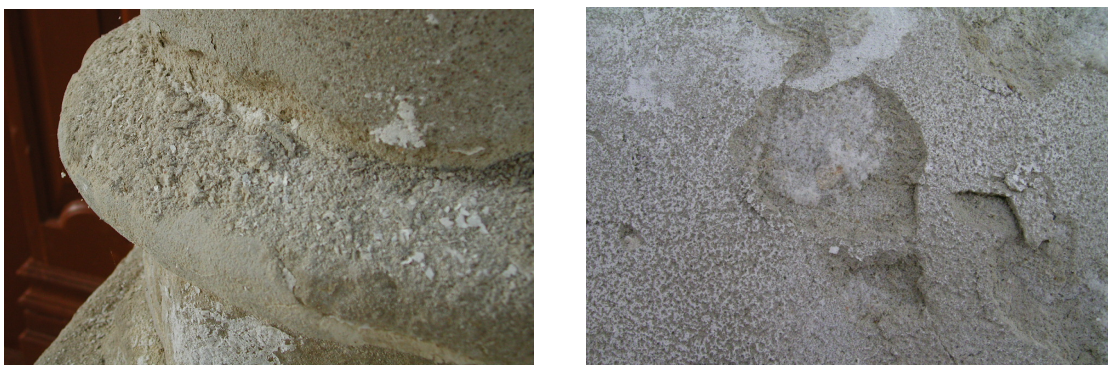
Figure 3.21 Sanding (left) and scaling (right) of the plaster (St. Nicholas church in Brouwershaven, the Netherlands)

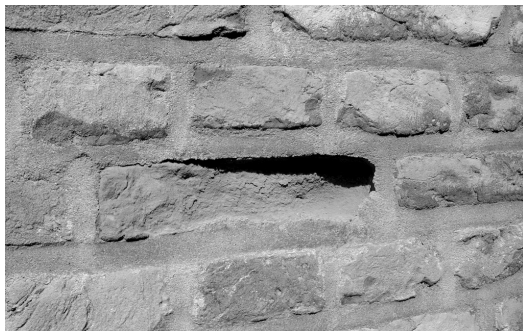
Figure 4.3 (left) Powdering of brick (exterior)

In the exterior few bricks show powdering (figure 4.3) and some of the stones show powdering and scaling of the outer surface (figure 4.4). In the interior the damage affects mainly the plaster layer. The sandstone constituting the basement of the columns shows often a white salt patina and sanding (figure 4.5). The damage to the plaster is mainly located up to 4 meters from the ground level, and is particularly severe on the walls (figure 4.6) and the plastered columns (figure 4.7) of the choir.

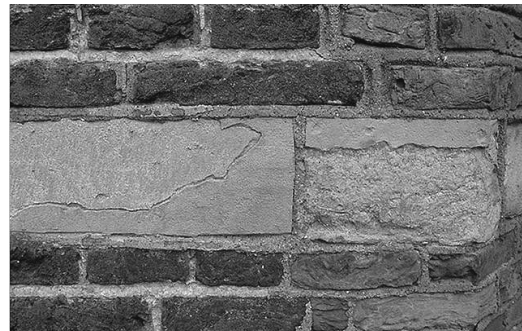
Figure 4.4 (right) Powdering and scaling of the stone (exterior)

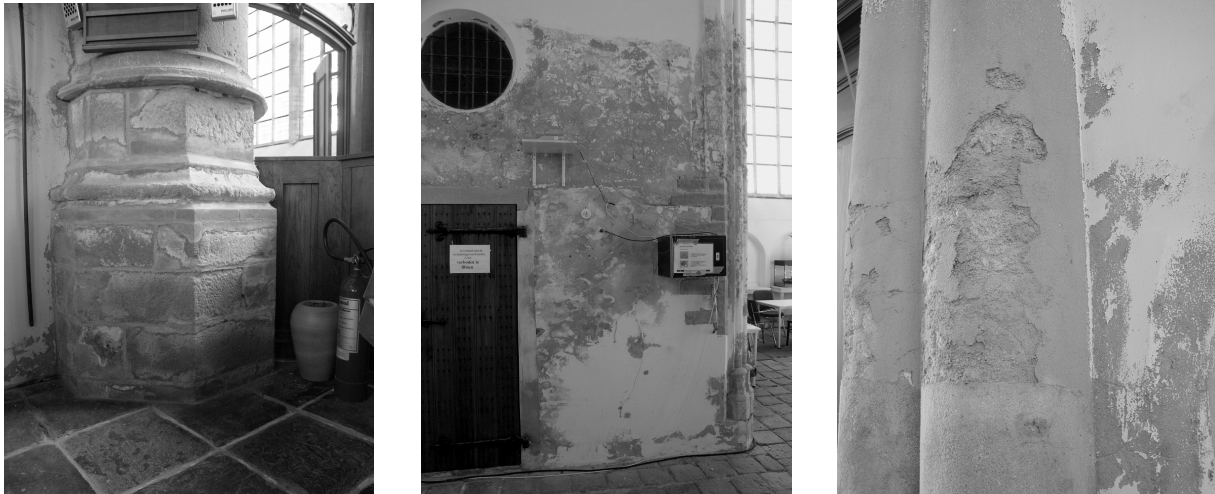
Figure 4.5 (left) Stone basements of the column showing white salt patina and sanding

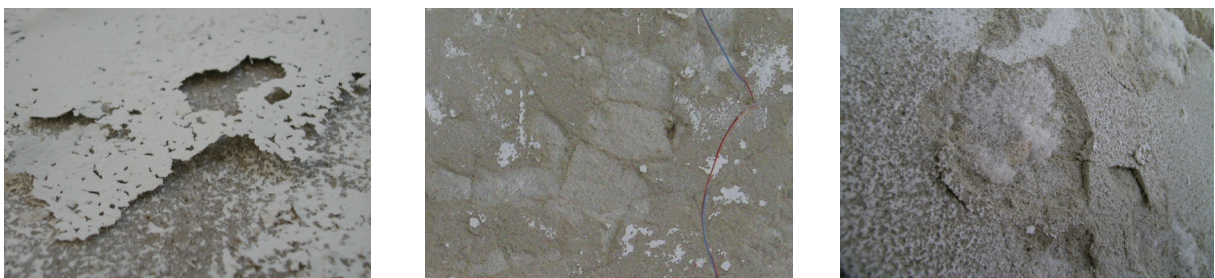
Figure 4.8 Evolution of the damage: from peeling of the paint (left), to appearance of cracks in the plaster (middle) to sanding, scaling and crumbling of the plaster layer (right)

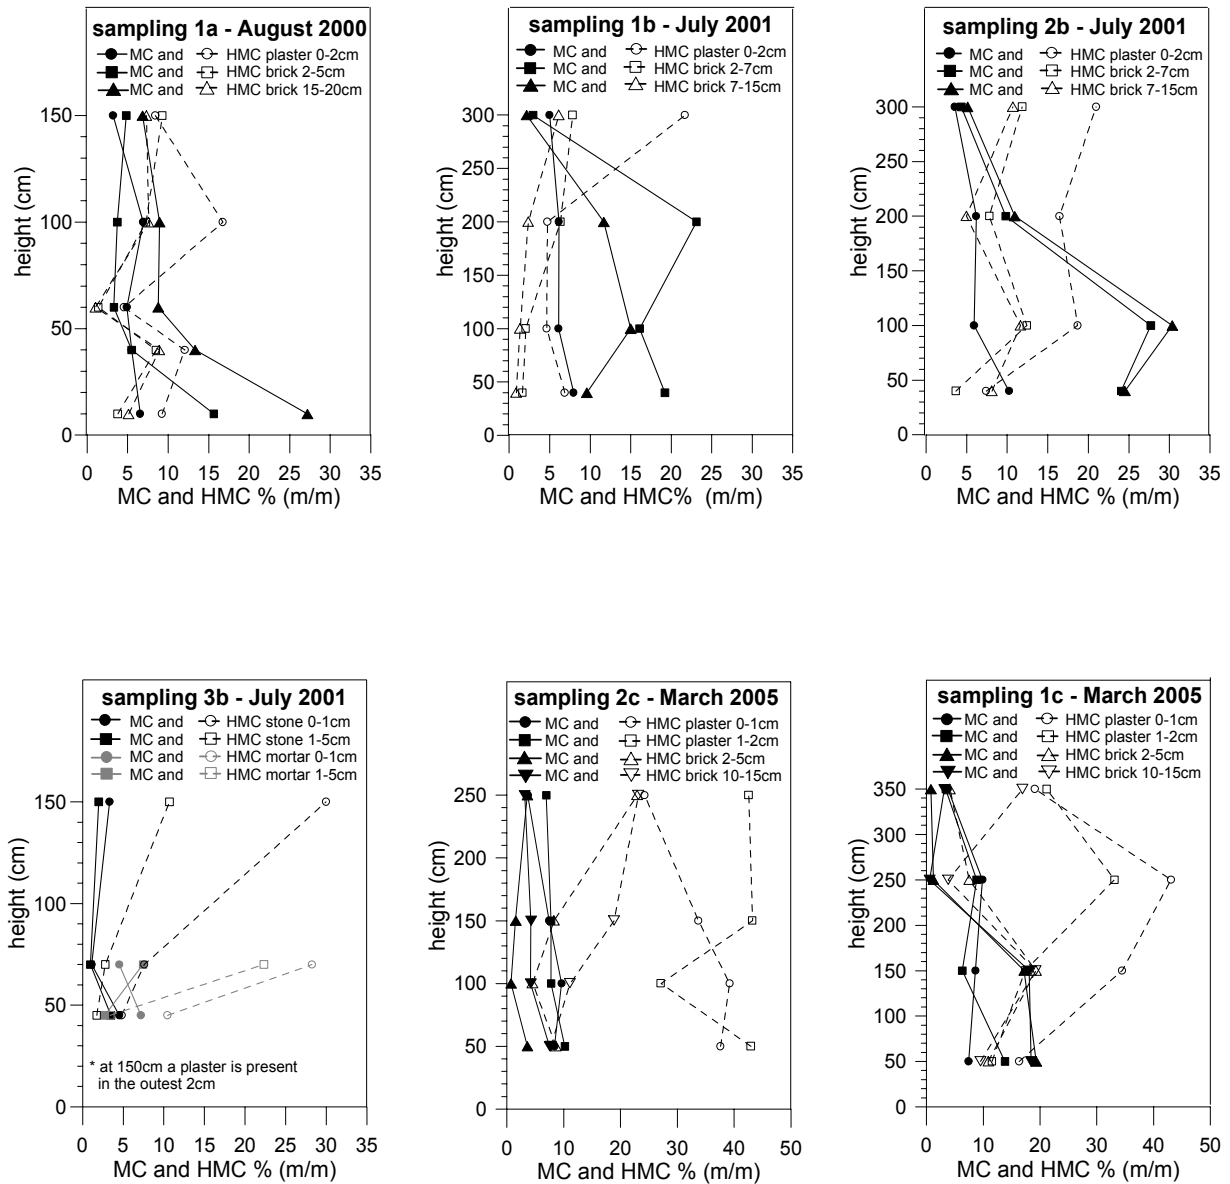
Figure 4.10 Moisture (MC) and hygroscopic moisture content (HMC) at different locations in the church as measured in the three sampling campaigns

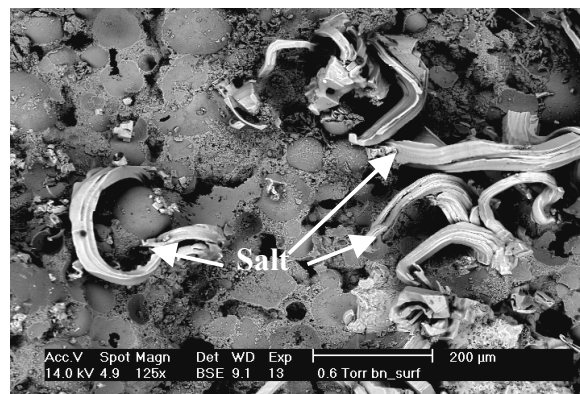
Figure 4.11 (left) ESEM photomicrograph showing salt crystals at the aggregate/binder interface

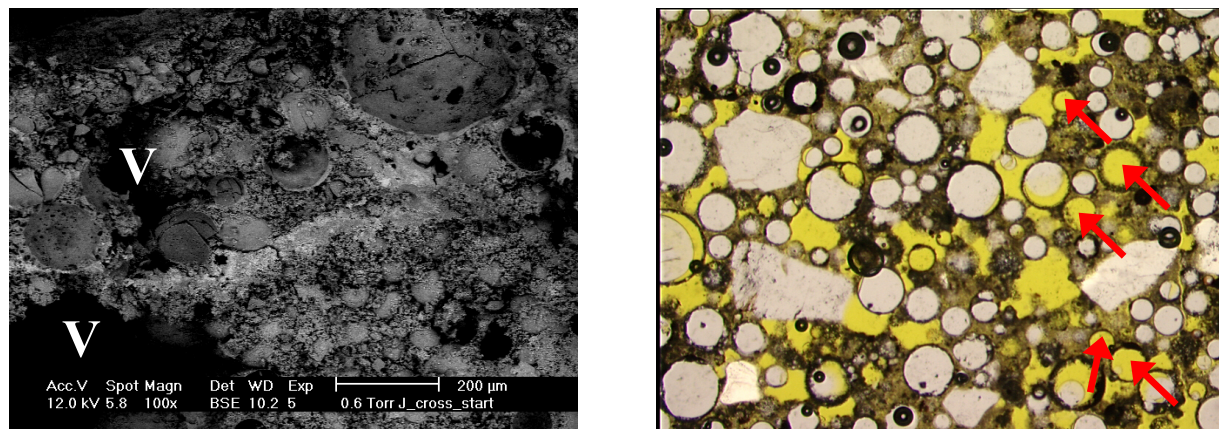
Figure 4.14 (left) ESEM photomicrograph of a broken section of the plaster: large voids (V) are visible

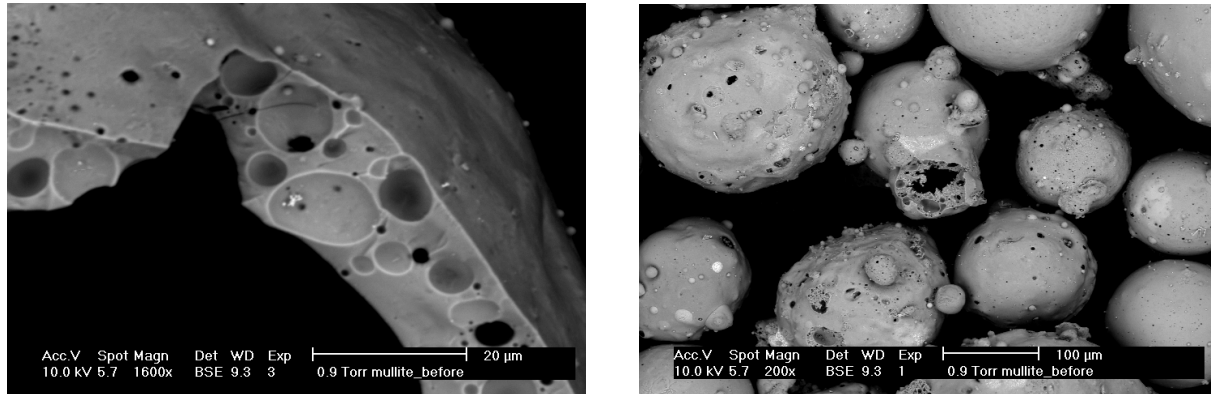
Figure 4.16 (left) ESEM photomicrograph of the porous wall of a mullite sphere

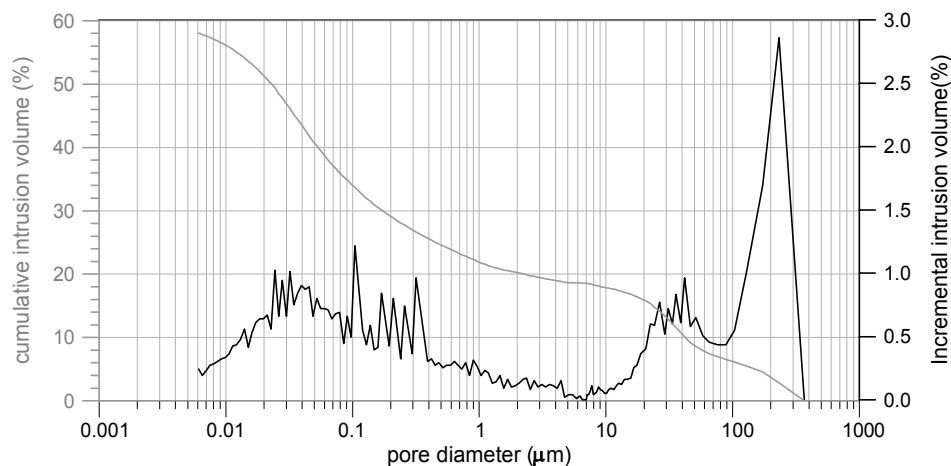
Figure 4.18 Open porosity and pore size distribution of the plaster as determined by Mercury Intrusion Porosimetry

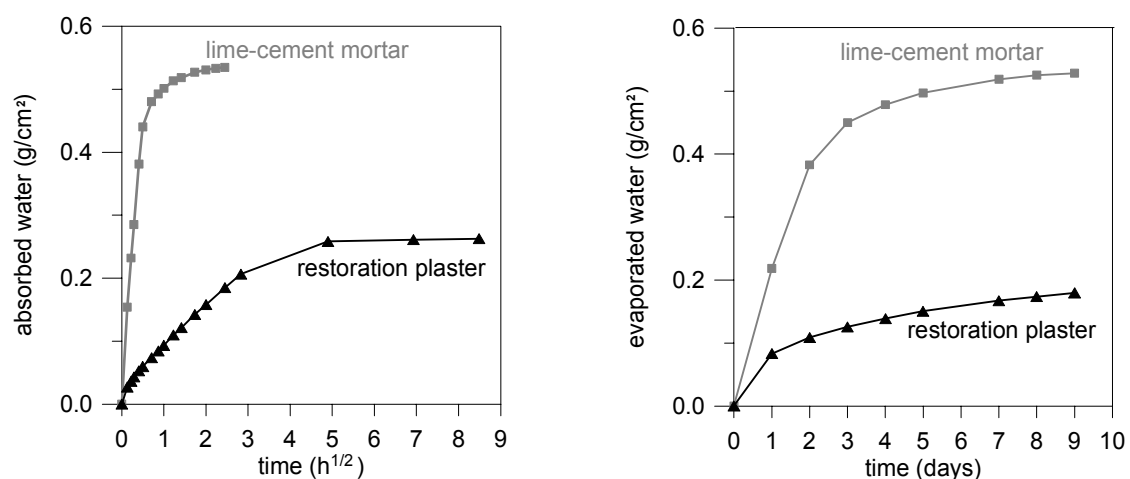
Figure 4.19 Water absorption by capillarity (left) and drying behaviour (right) of the restoration plaster in comparison to a lime-cement mortar

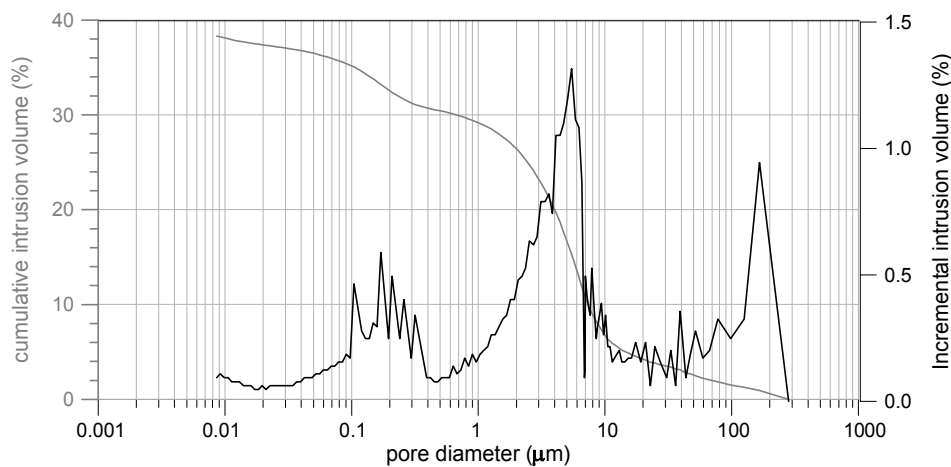
Figure 4.20 Open porosity and pore size distribution of the brick substrate as determined by MIP

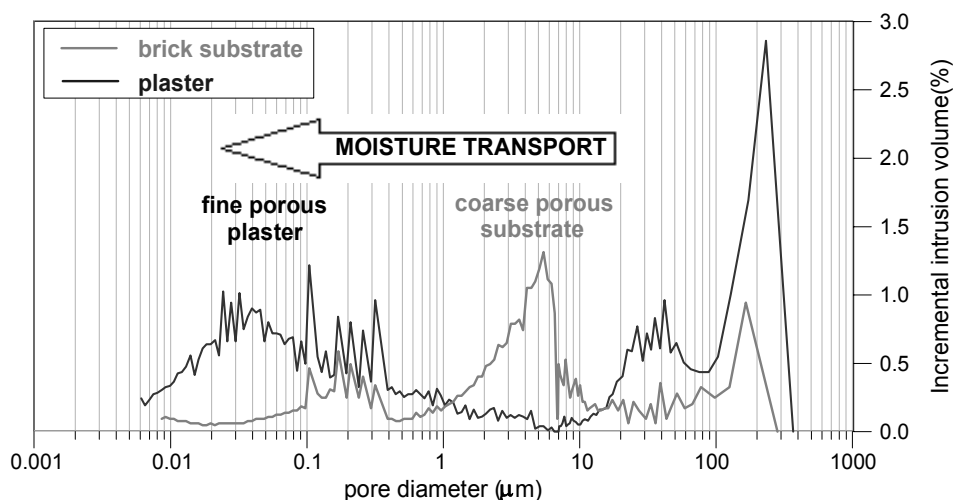
Figure 4.21 Pore size distribution of the brick substrate and of the plaster: the pore size distribution of the substrate/plaster combination determines the moisture transport from the coarse substrate to the fine plaster

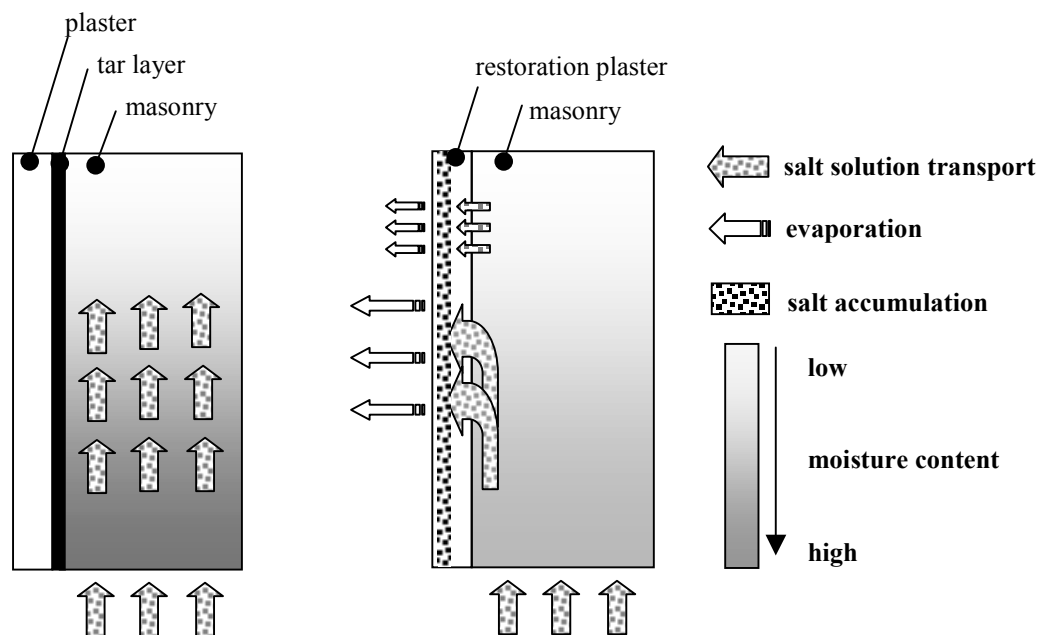
Figure 4.22 Sketch of the situation before (left) and after (right) the restoration of 1991-1994: the removal of the tar layer has allowed the drying out of the masonry and the transport of the salt from the substrate to the plaster

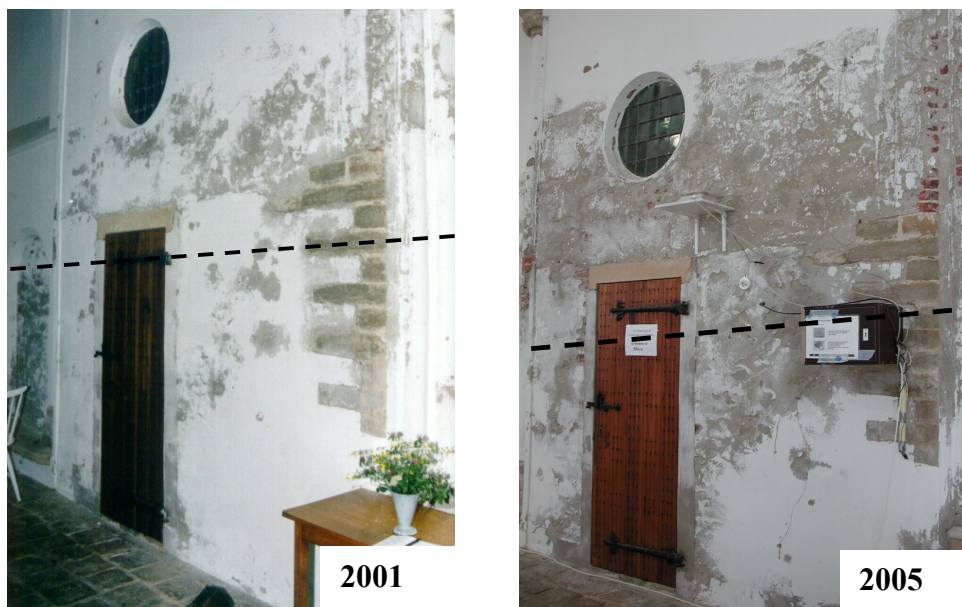
Figure 4.23 Evolution of the damage between 2001 and 2005; the dashed lines indicate the maximum height reached by the rising damp at the moment of the sampling

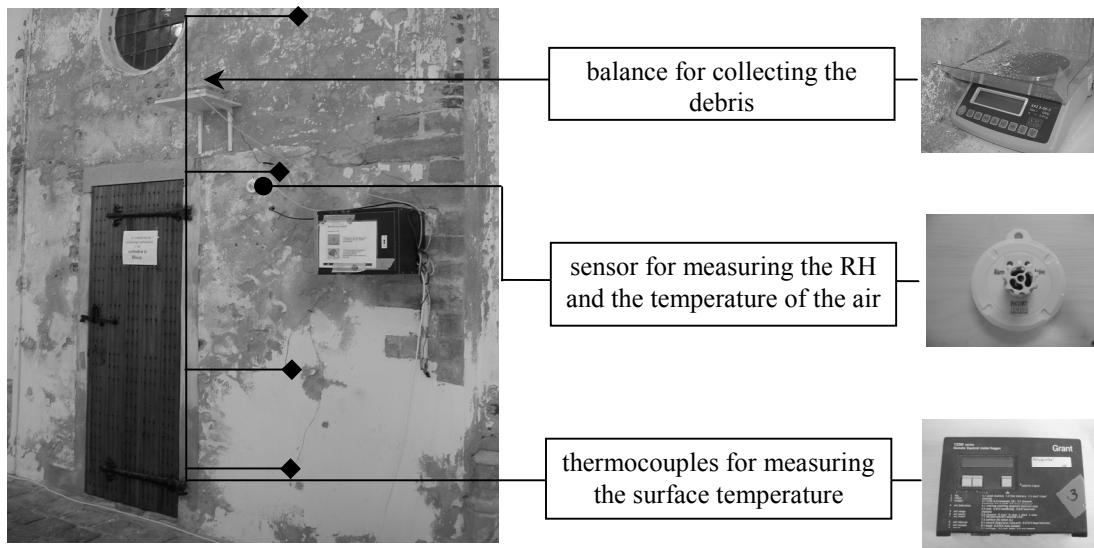
Fig 4.24 Monitoring system placed on the south wall of the choir

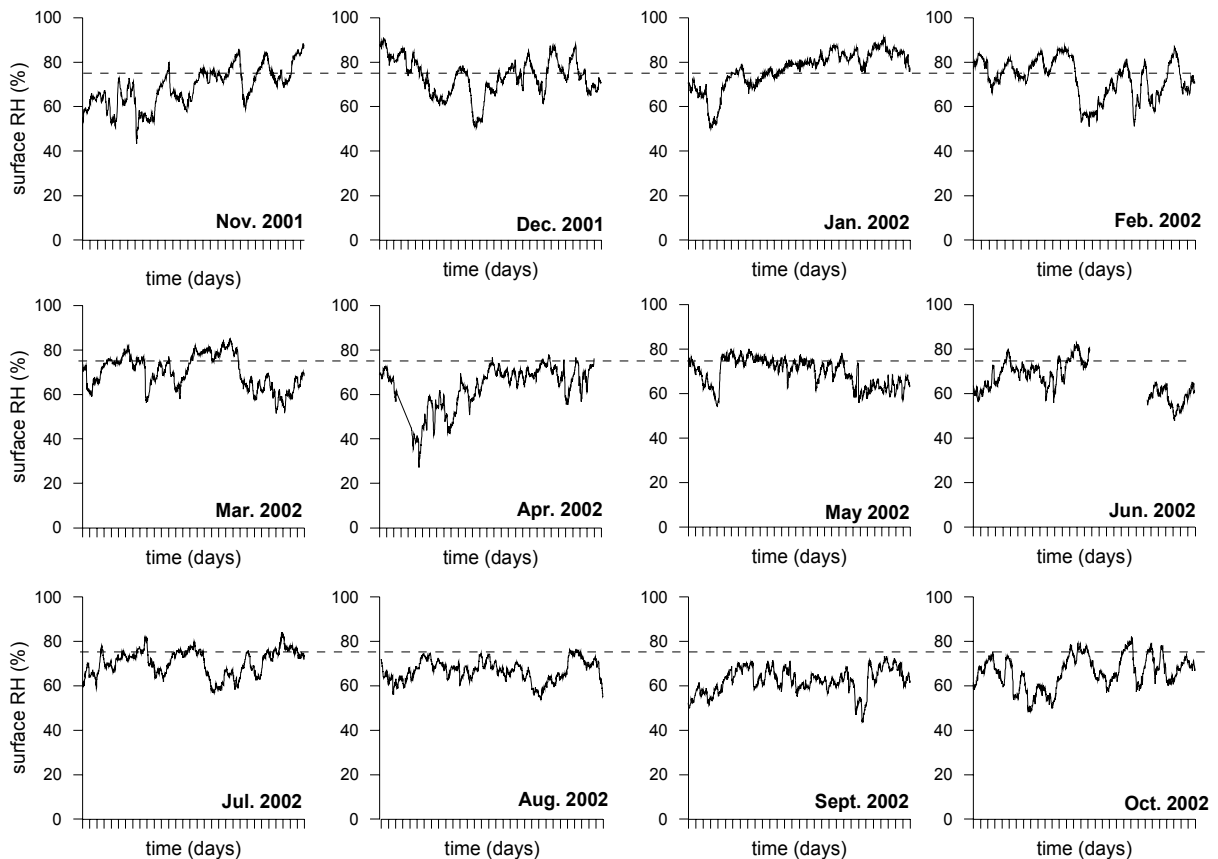
Figure 4.25 RH at the surface of the south wall of the choir wall at the height of 300 cm from the ground level in the period from November 2001 to October 2002. The dotted lines indicate the RH of crystallization of NaCl

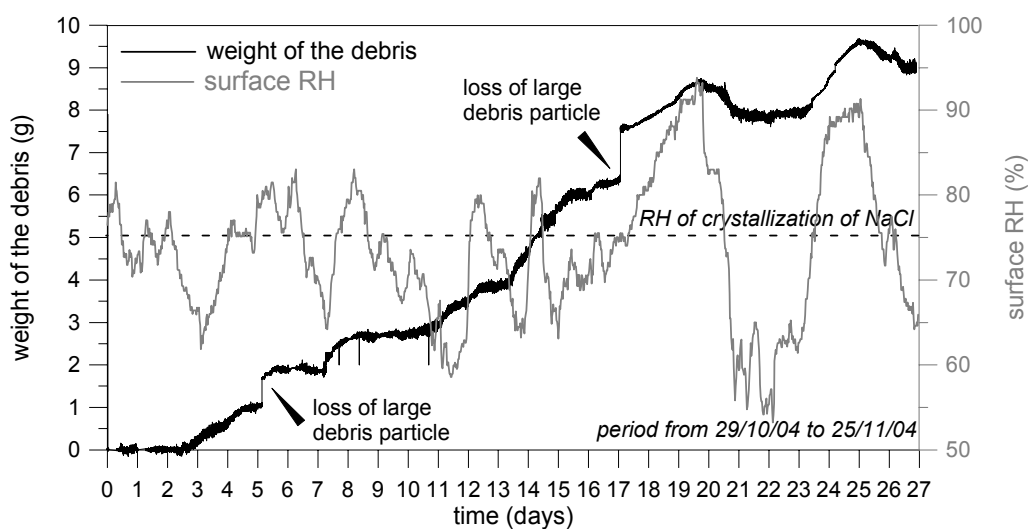
Figure 4.26 Surface RH and weight of the debris falling on the balance plate: the steep increase in the weight of the debris indicates that most of the debris is falling during the high RH periods

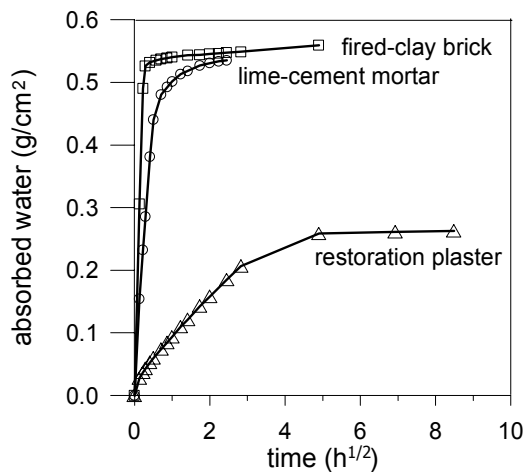
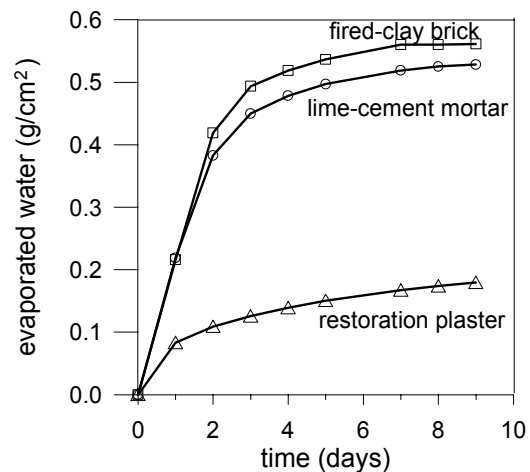
Figure 5.4 (left) Water absorption behaviour of the three materials measured on 5x5x2cm specimens at 20 °C / 50% RH

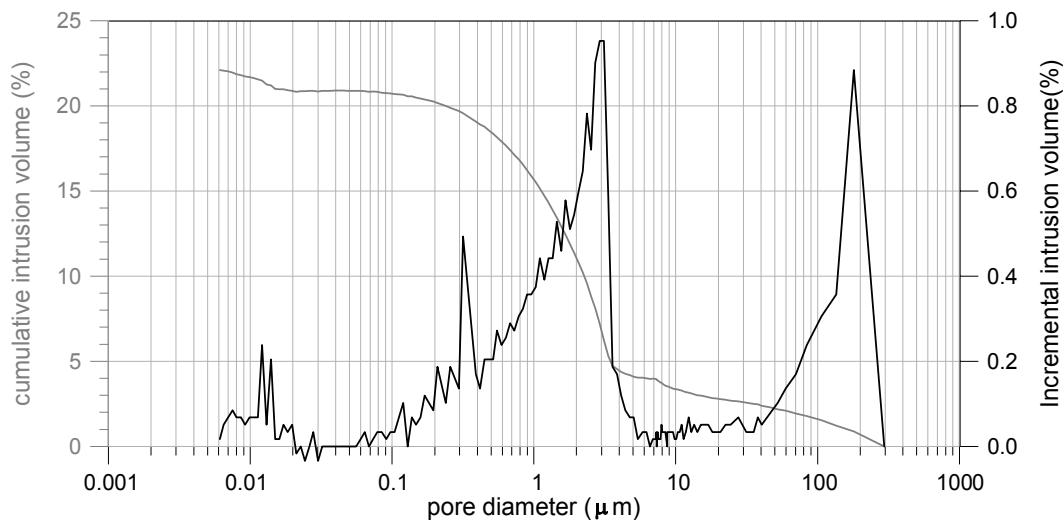
Figure 5.8 Pore size distribution and open porosity of fired-clay brick measured by MIP

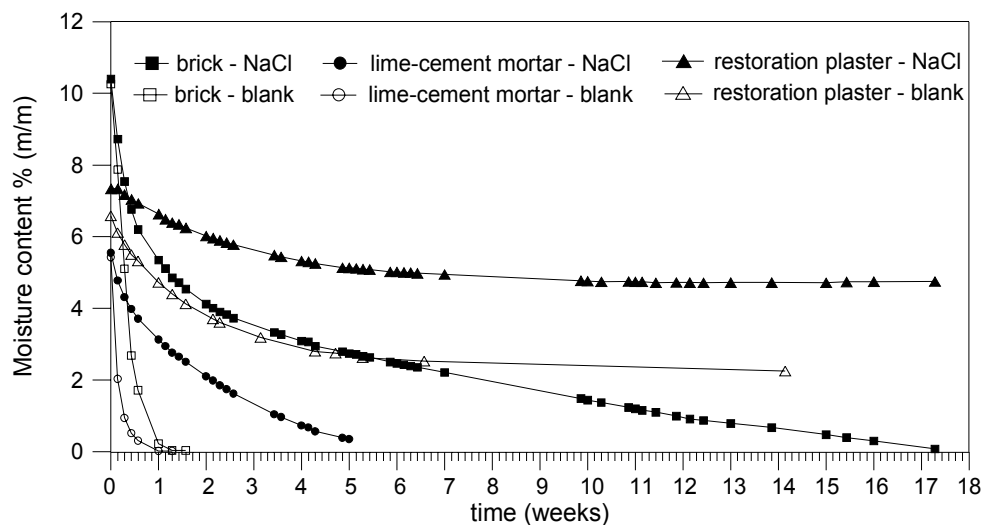
Figure 5.9 Drying curves at 20 °C 50% RH of the three materials, blank and contaminated with NaCl

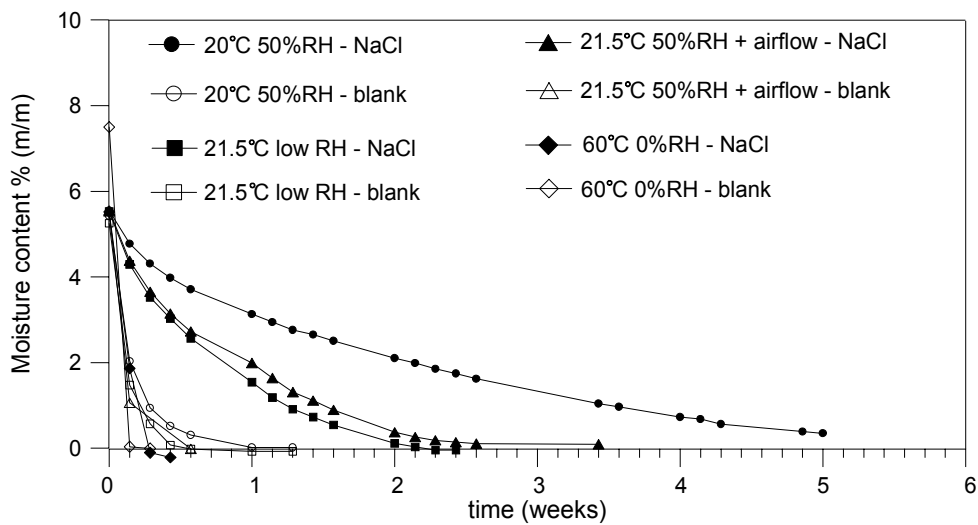
Figure 5.10 Drying curves at different environmental conditions of the lime-cement mortar, blank and contaminated with NaCl

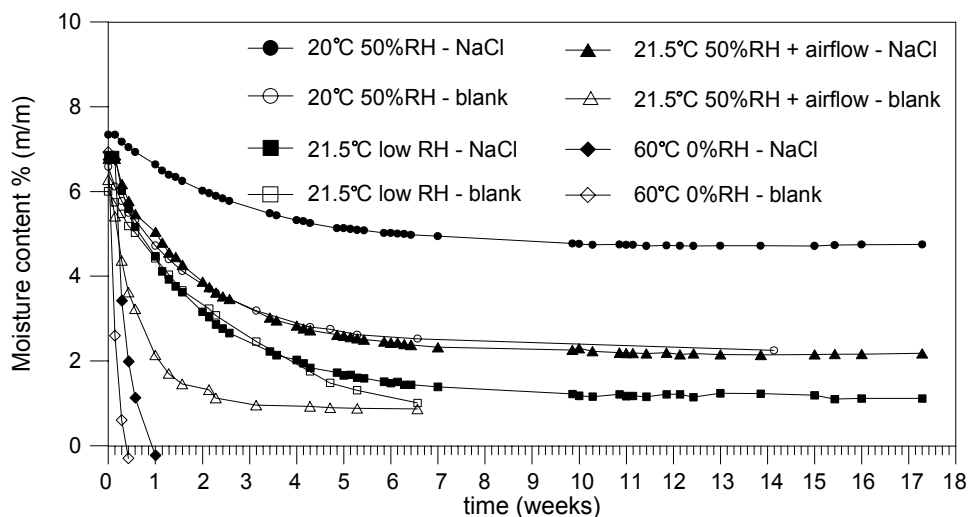
Figure 5.11 Drying curves at different environmental conditions of the restoration plaster, blank and contaminated with NaCl

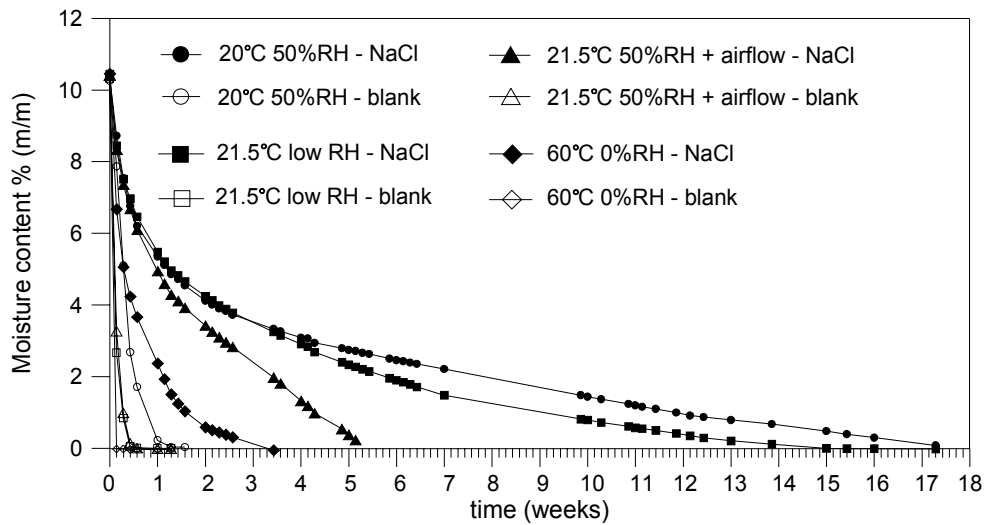
Figure 5.12 Drying curves at different environmental conditions of the fired-clay brick, blank and contaminated with NaCl

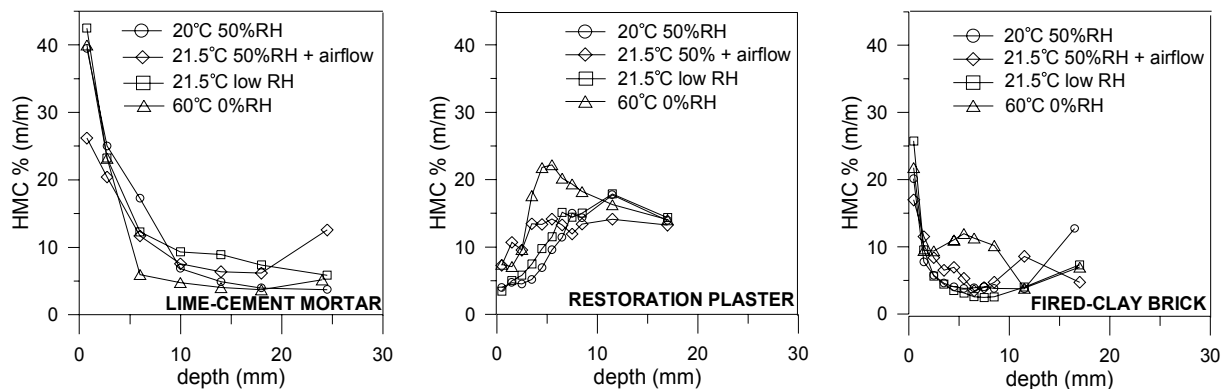
Figure 5.13 Hygroscopic Moisture Content (HMC) distribution measured at 96% RH in the three materials after one drying cycle at different environmental conditions
