Sodium chloride damage to porous building materials

PROEFSCHRIFT

Barbara Antonietta LUBELLI

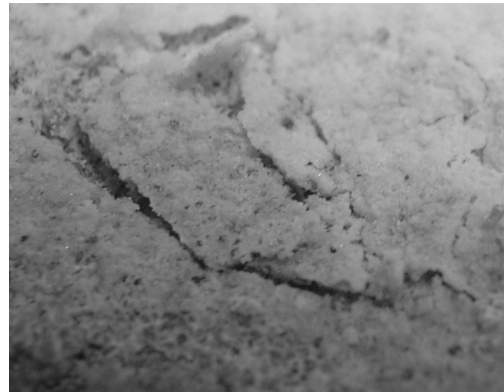
Figure 5.16 (right) Scaling of the outer layer of a lime-cement mortar specimen after 2 drying cycles at 20°C / 50% RH

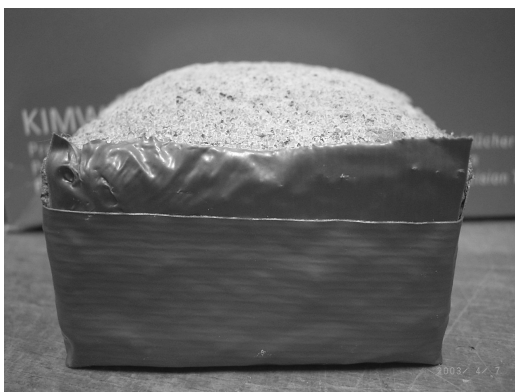
Figure 5.17 (left) Bulging of the outer layer of a lime-cement mortar specimen after 2 drying cycles at 60°C / 0% RH

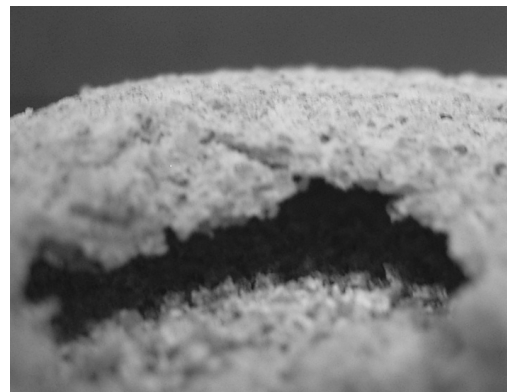
Figure 5.18 (right) Bulging of the outer layer of a lime-cement mortar specimen after 2 drying cycles at 60°C / 0% RH: no salt efflorescences pushing out the outer layer are visible; the material under the bulged layer is reduced to sand

The mechanism causing the bulging in the lime-cement mortar was investigated using different methods. First the hypothesis of crypto-florescence pushing up the outer layer was checked by breaking the bulged layer. No crystals were visible in the void under the bulged layer, but powdered material was present (figure 5.18). The HMC and the chloride content of the bulged layer and of the powdered material directly beneath it was measured: the data showed that most of the salts were located in the bulged layer and not under it (figure 5.19).

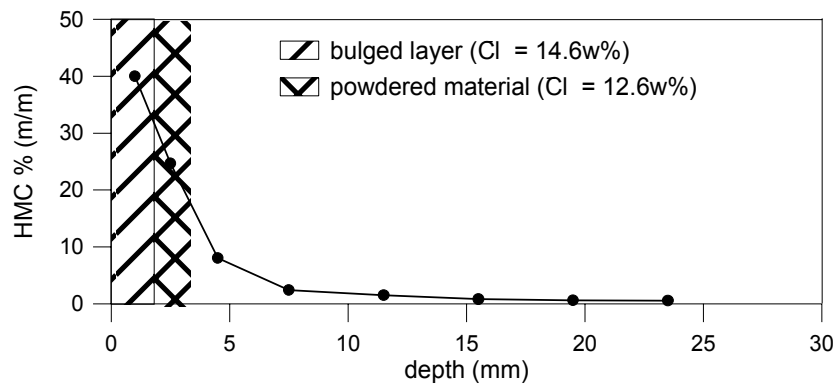
Figure 5.19 Hygroscopic moisture distribution in lime-cement mortar specimen after 2 drying cycles at 60 °C / 0% RH: most of the salt accumulates in the bulged layer

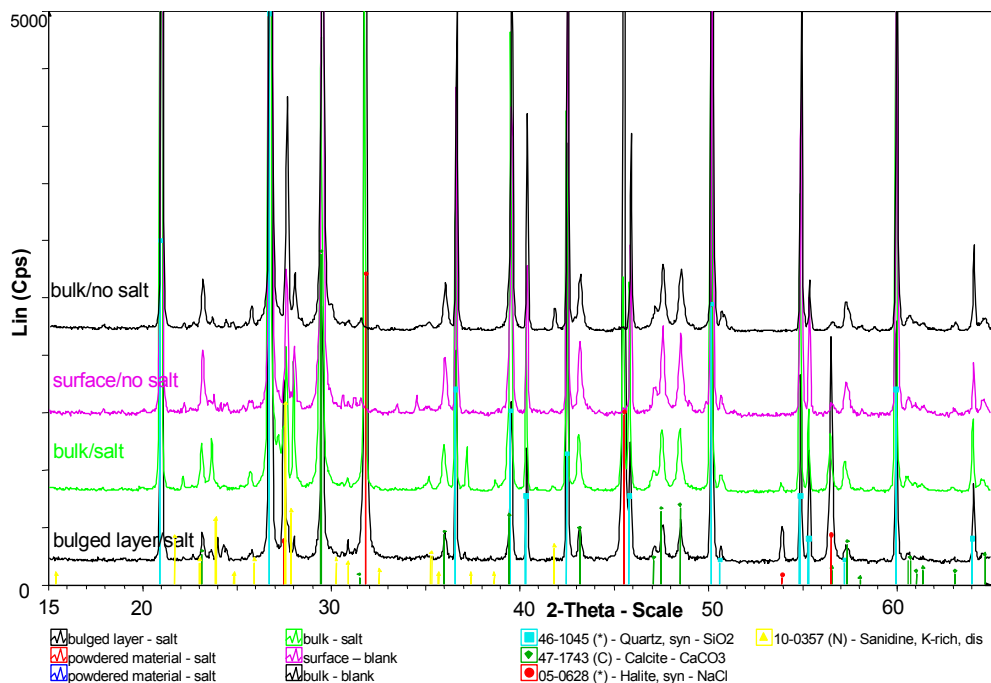
Figure 5.20 Results of the XRD analyses on samples from the NaCl contaminated (bulged layer, bulk) and blank (surface layer and bulk) lime-cement specimens

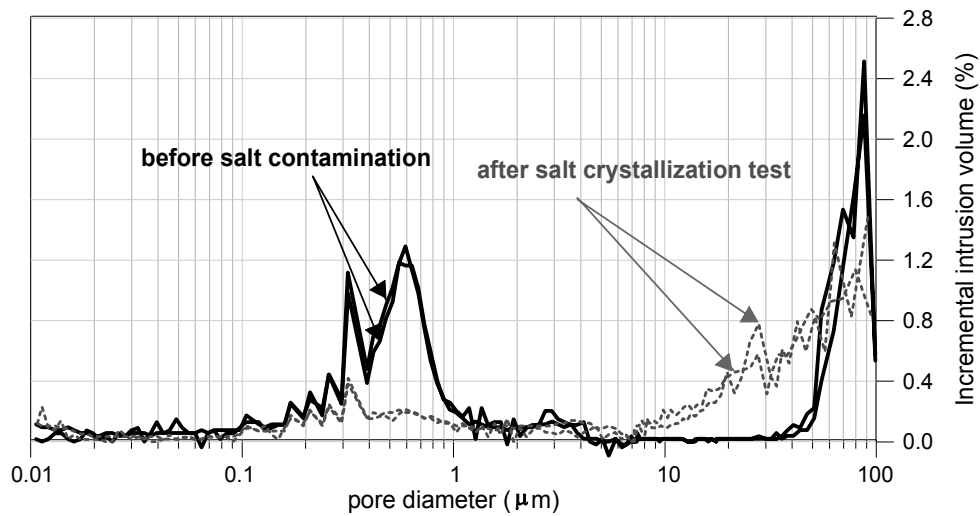
Figure 5.21 Pore size distribution of lime-cement mortar samples before salt contamination and after salt crystallization test (2 drying cycles at 60 °C / 0% RH)

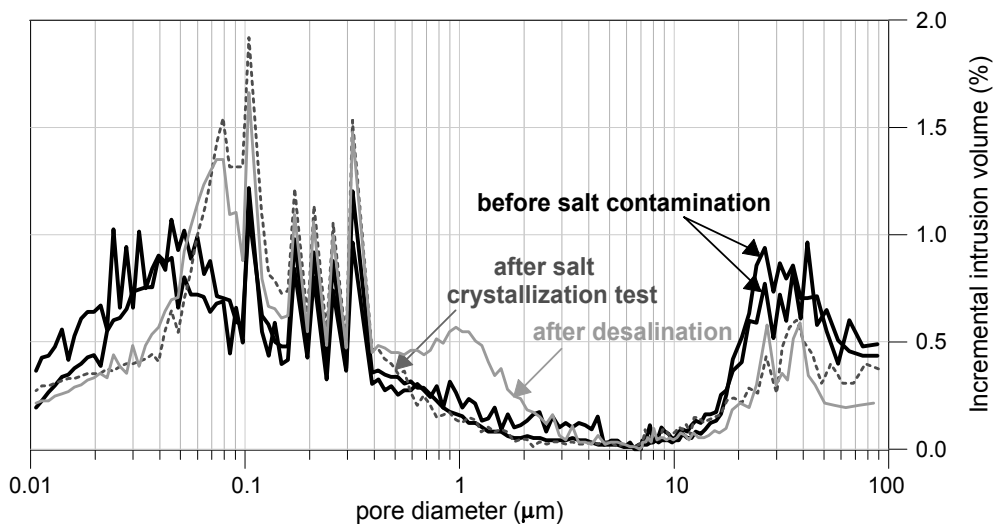
Figure 5.22 Pore size distribution of restoration plaster samples before salt contamination, after salt crystallization test (6 drying cycles at 60 °C / 0% RH) and after desalination

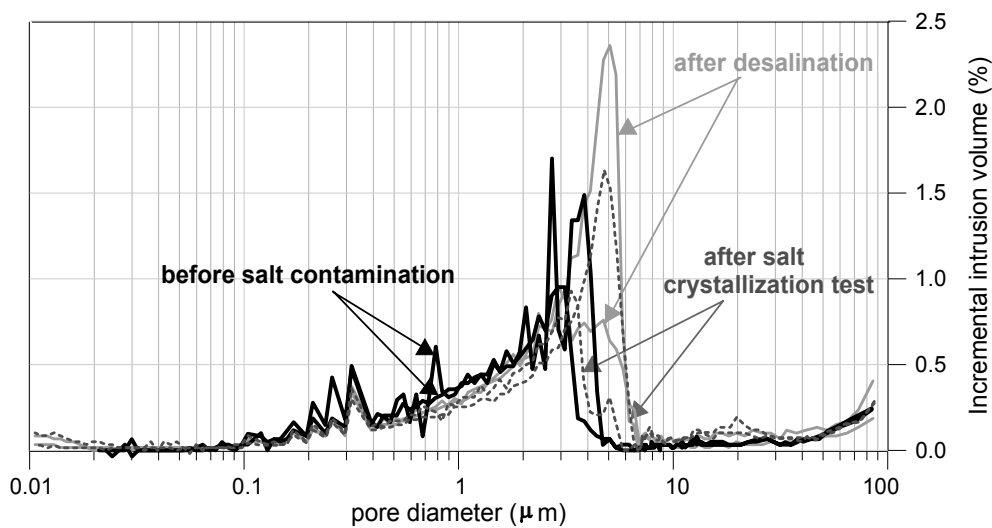
Figure 5.23 Pore size distribution of fired-clay brick samples before salt contamination, after salt crystallization test (one drying cycle at 20 °C / 50% RH) and after desalination

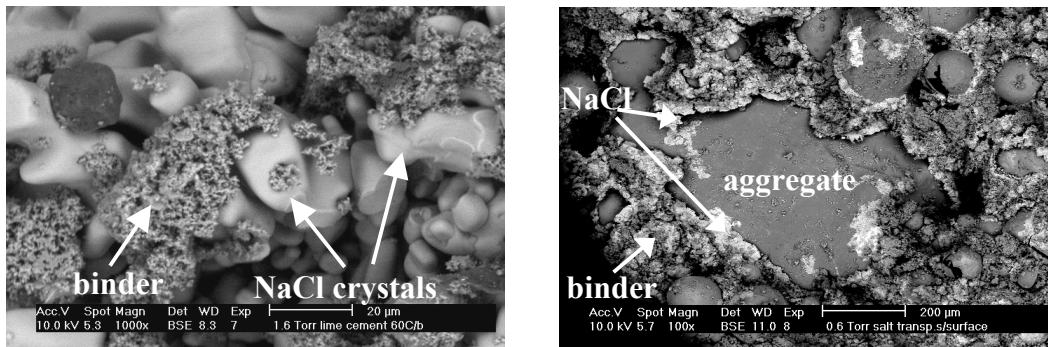
Figure 5.28 (left) ESEM photomicrograph (BSE mode) of the bottom of the bulged layer of the lime-cement mortar after 2 drying cycles at 60 °C, 0% RH

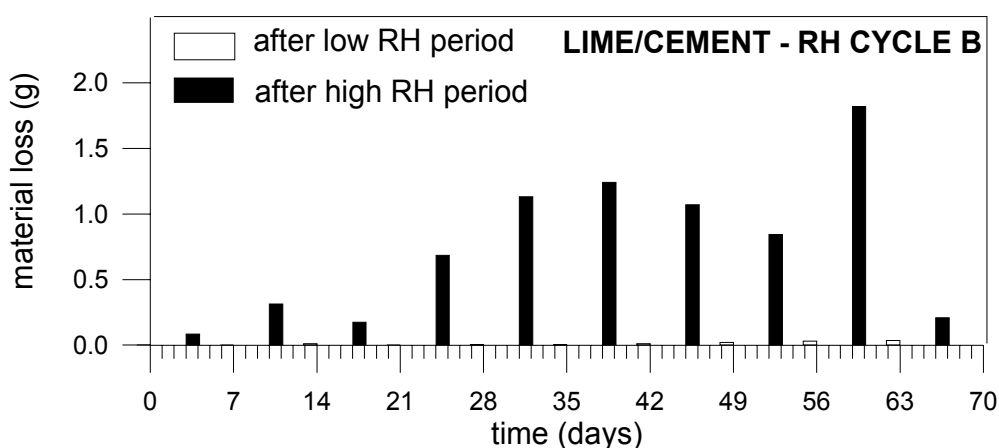
Figure 5.30 Material loss of lime-cement specimens after each low and high RH period during RH cycle type b

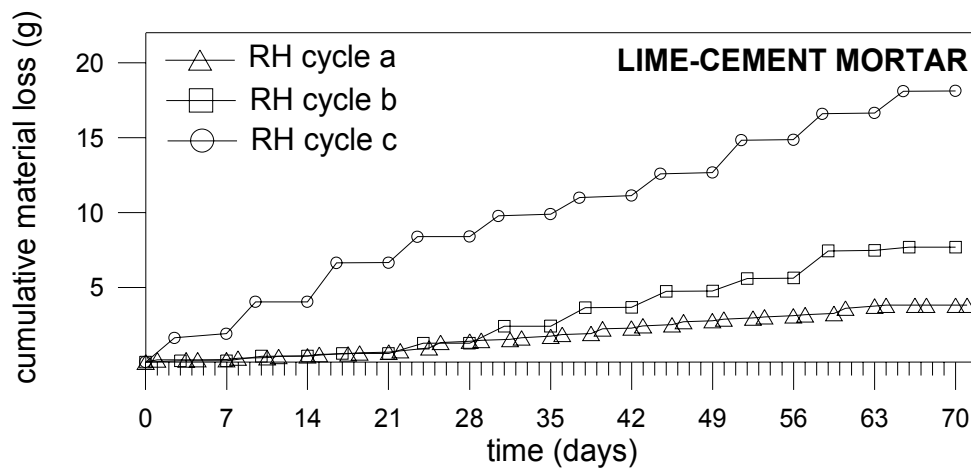
Figure 5.31 Cumulative material loss of lime-cement mortar specimens tested with different types of RH cycles

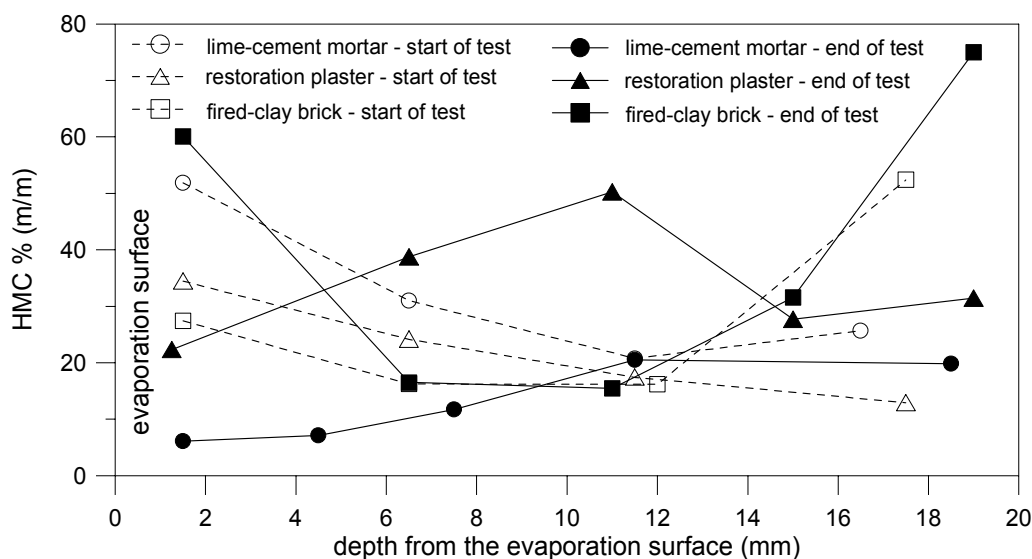
Figure 5.35 Hygroscopic Moisture Content distribution in lime-cement mortar, restoration plaster and fired-clay brick at the start and at the end of the test (RH cycle type b); evaporation surface on the left

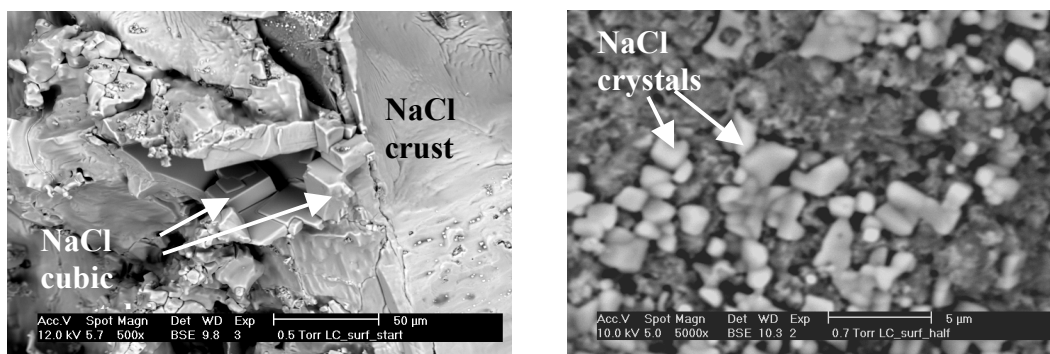
Figure 5.36 (left) ESEM photomicrograph (BSE mode) of salt crust at the surface of a lime-cement specimen at the beginning of the test; some cubic crystals are visible.

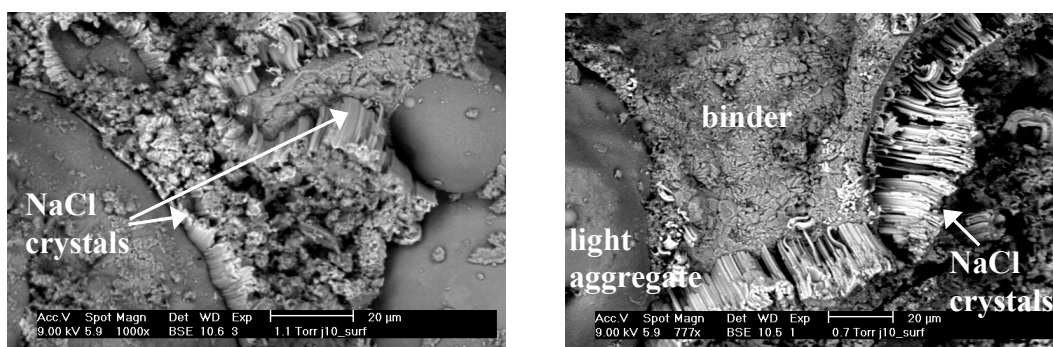
Figure 5.42 (left) ESEM photomicrograph (BSE mode) of salt crystallizing at the binder/hollow aggregate interface (surface of restoration plaster specimen after 10 RH cycles type a)

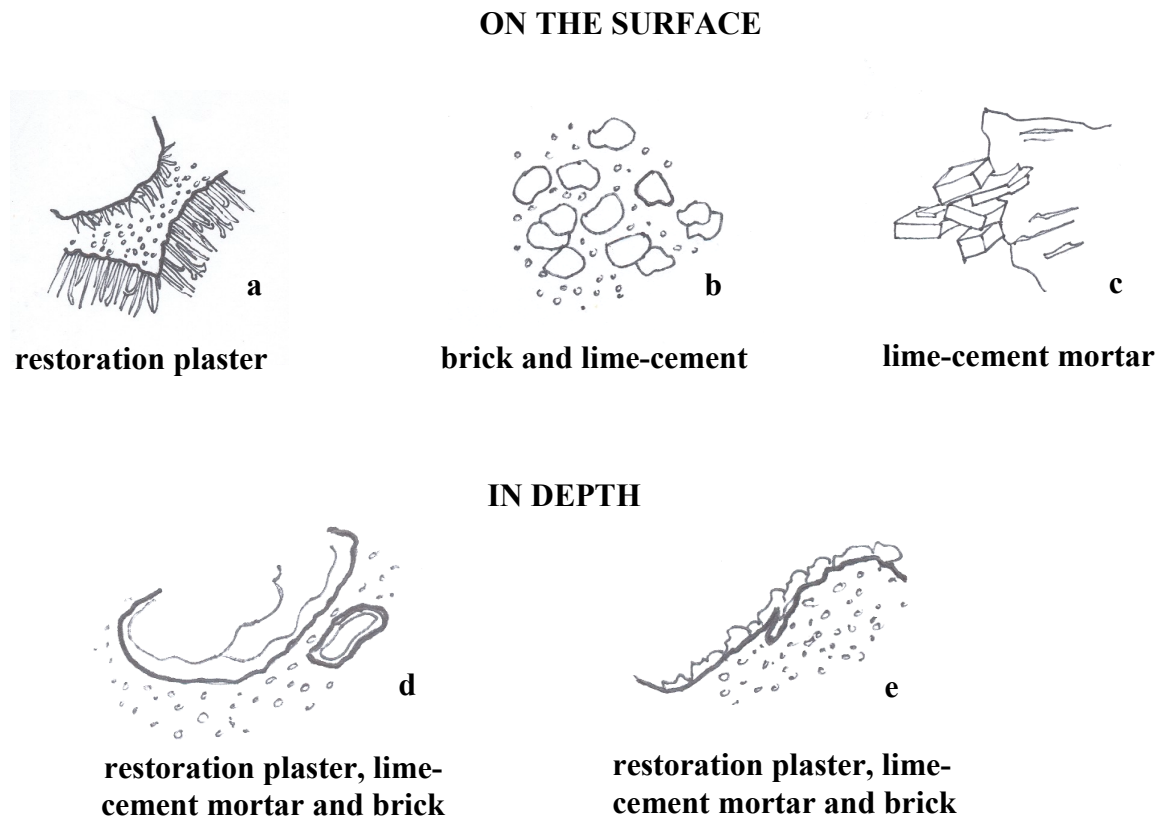
Figure 5.50 The salt crystallizes on the surface in the form of needle-like crystals (a), crystals agglomeration (b), cubic crystal and crust (c); in the cross section a layer of salt (d) or agglomeration of crystals well adhering to the pore wall (e) are observed

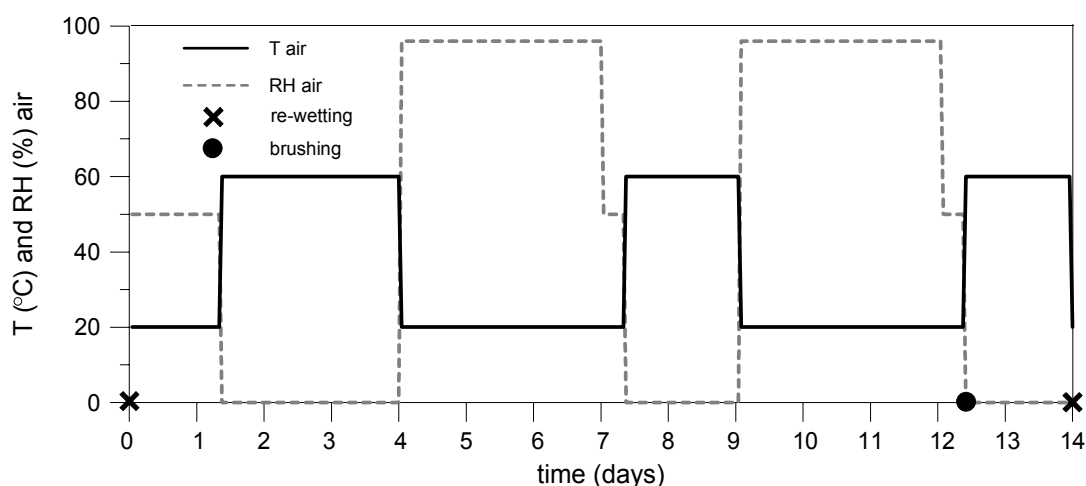
Figure 5.51 Temperature and RH cycle used in the weathering test

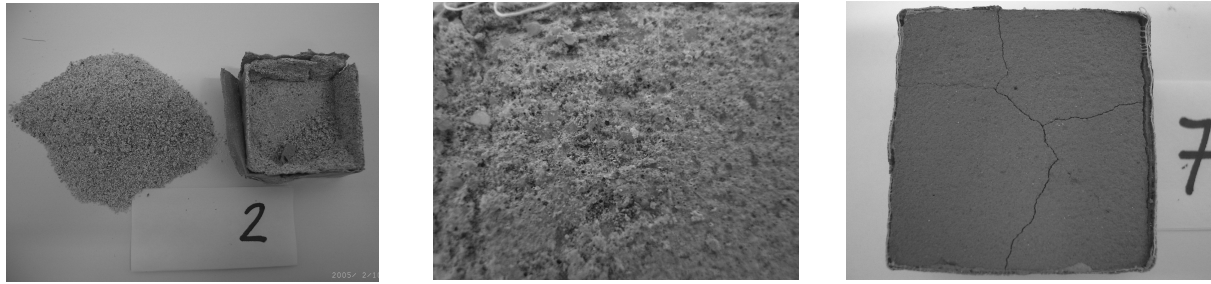
Figure 5.52 (left) Decay of the lime-cement mortar at the end of the weathering test: the specimen is completely reduced to sand

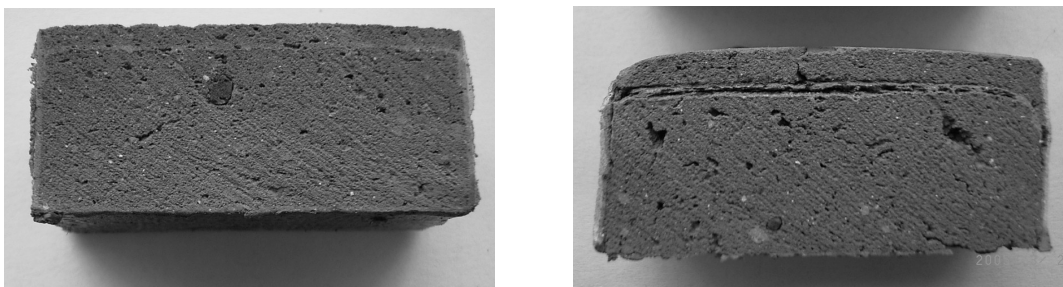
Figure 5.55 Cross section of brick specimens at the beginning (on the left) and at the end (on the right) of the weathering test

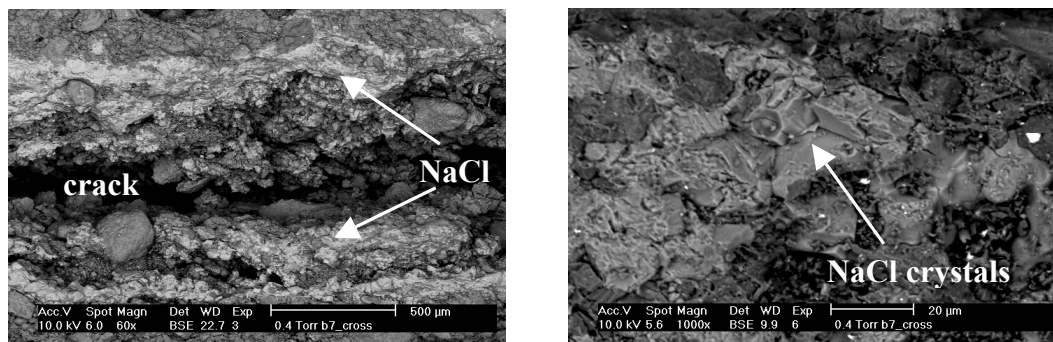
Figure 5.60 (left) ESEM photomicrograph of the crack parallel to the evaporation surface developed in the brick: salts have crystallized at both sides of the crack but not in it (cross section of brick specimen at the end of the weathering test)

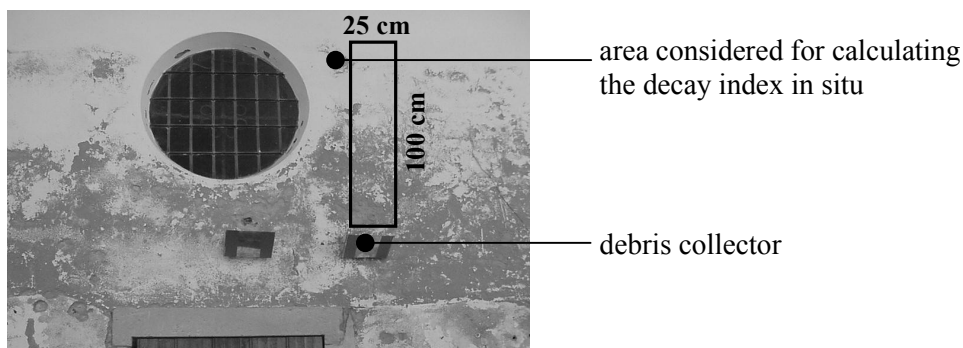
Figure 5.62 Debris collector on the decayed wall. The area considered for the calculation of the decay index in situ is indicated (church of Brouwershaven, The Netherlands)

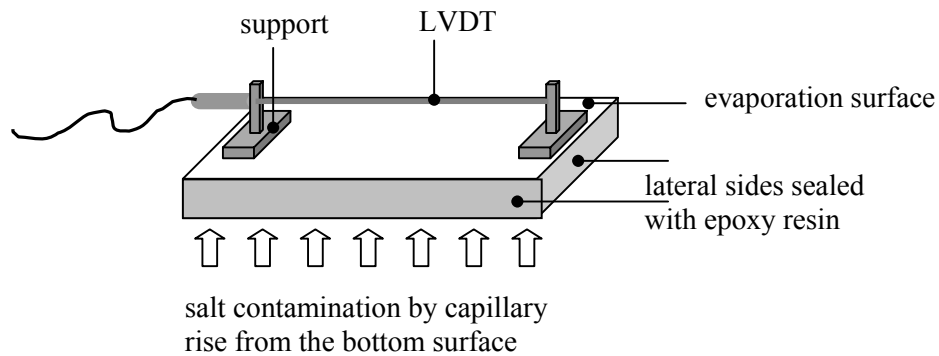
Figure 6.1 Salt contamination of the specimen

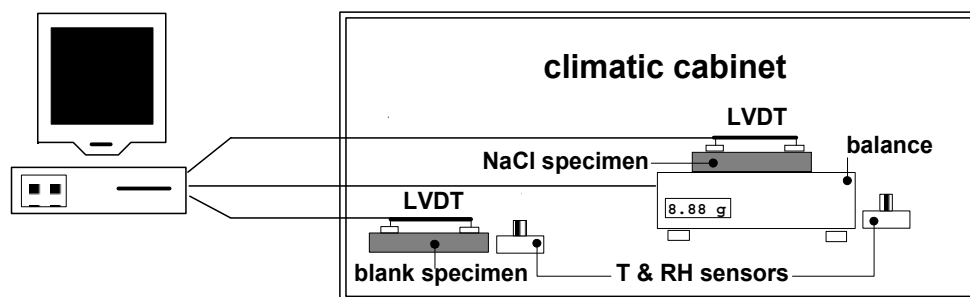
Figure 6.2 Test set up: the specimens, on which the LVDT's are mounted, are placed in a climatic cabinet. A PC collects the data on the dilation and on the mass changes. Temperature and RH sensors are used for an additional check of the environmental conditions

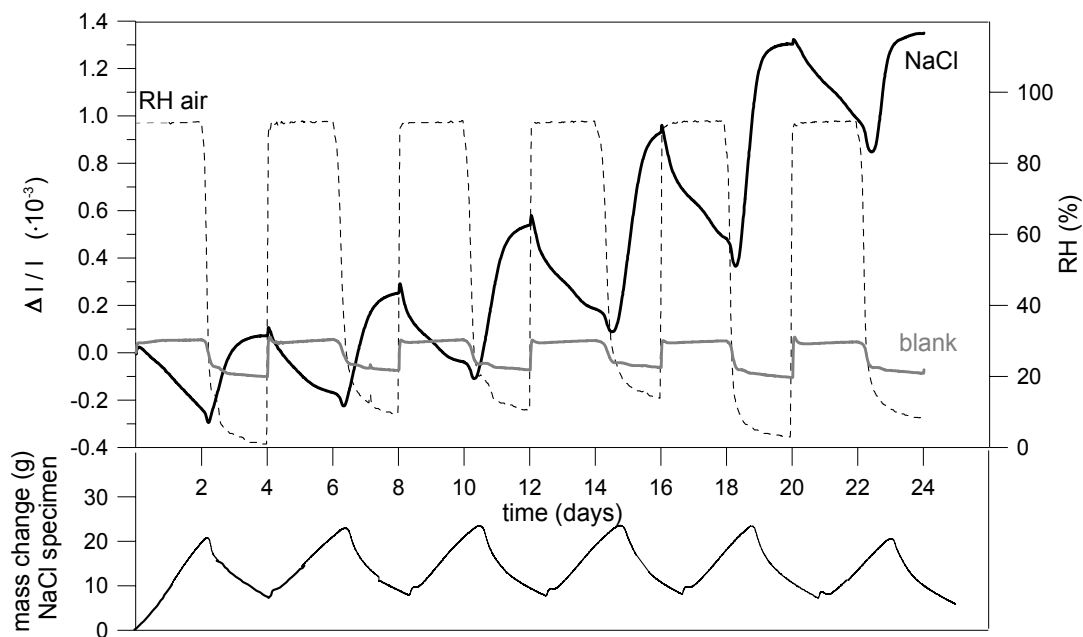
Figure 6.4 Dilation of blank and NaCl contaminated specimens (upper graph) and mass change of the NaCl contaminated specimen (lower graph) during RH cycles

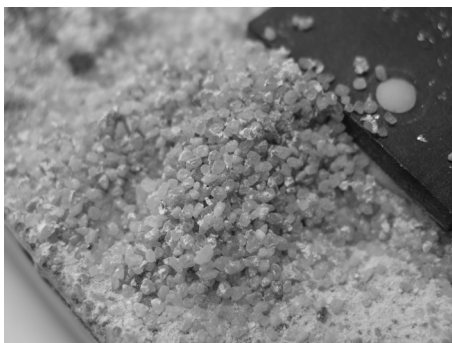
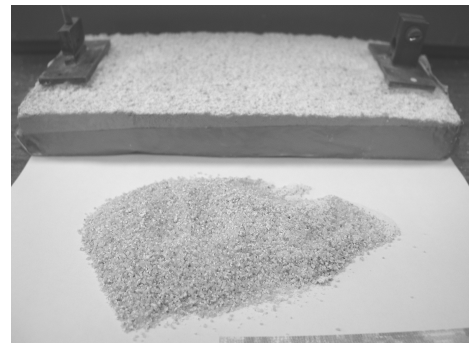
Figure 6.5a (left) Sanding of the outer layer of the mortar in the presence of NaCl after 6 RH cycles
Fig.6.5b (right) Material brushed from the surface of the mortar after 6 RH cycles

The dilation leads to a stress that is likely to exceed the low tensile strength of the plaster and in fact results, at the end of the test, in serious damage. The damage consists of sanding of the outer layer of the plaster (figure 6.5a-b); the material loss is about 7% of the initial mass of the specimen. The serious damage observed points out the importance of RH changes for the development of the salt decay in lime-cement mortars.

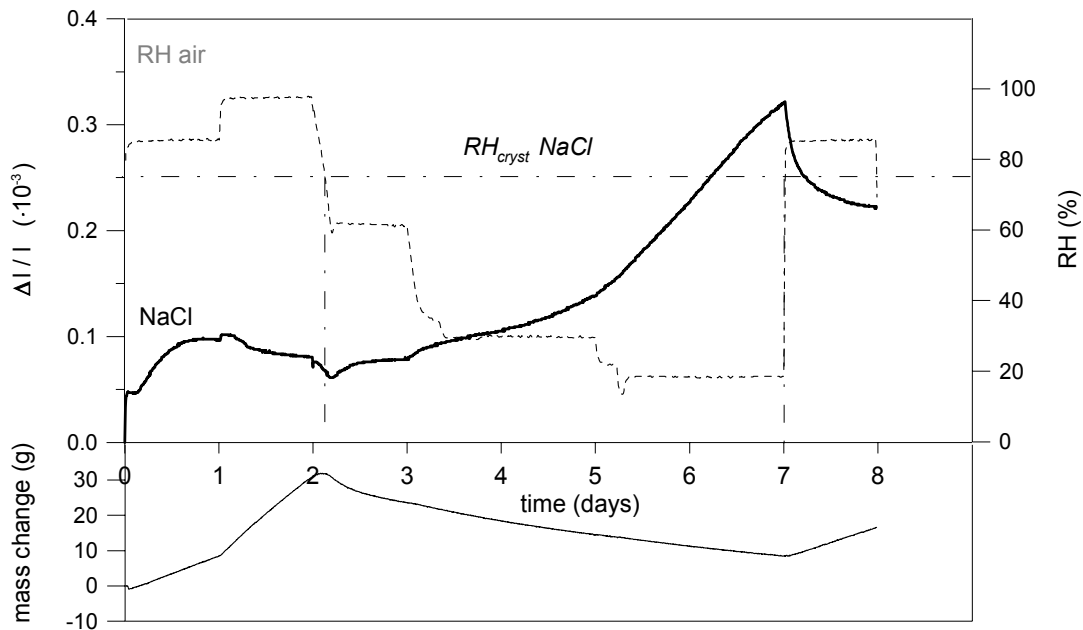
Figure 6.8 Change in length of a blank specimen during absorption of NaCl solution, subsequent crystallization and re-dissolution of the salt

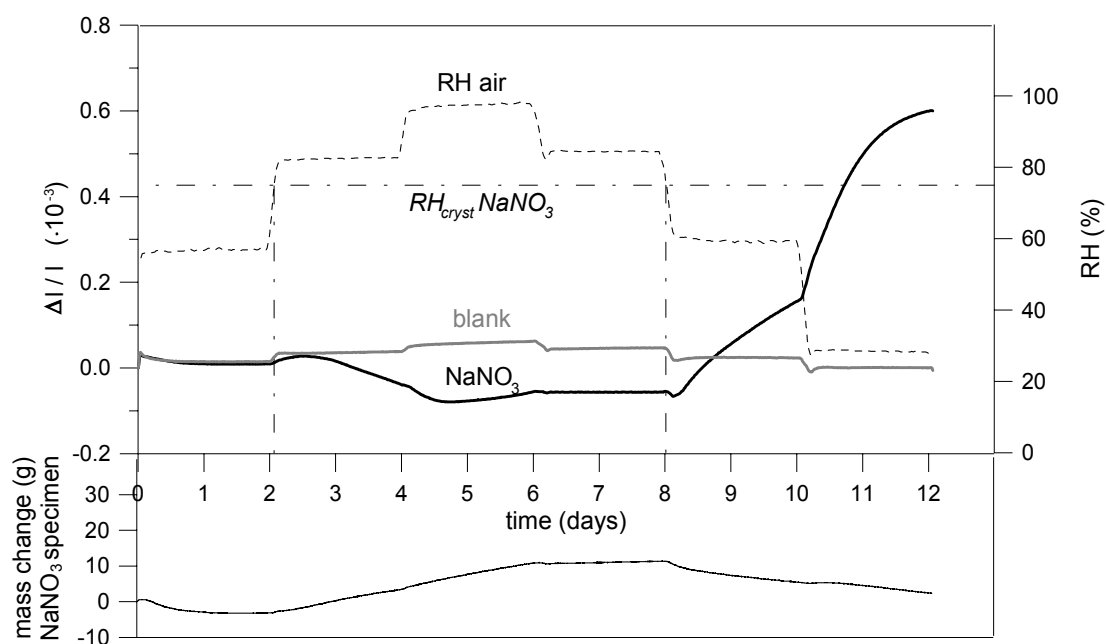
Figure 6.9 Dilation of blank and NaNO₃ contaminated specimens (upper graph) and change in mass of the NaNO₃ contaminated specimen (lower graph) during a RH cycle

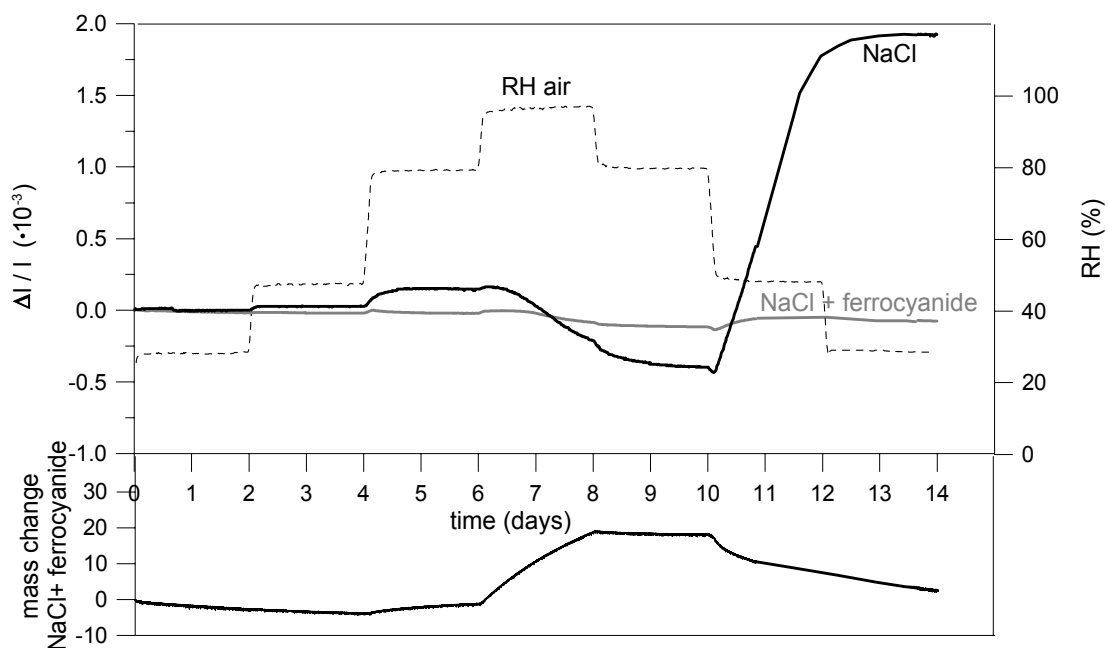
Figure 6.12 Dilatation of NaCl contaminated specimens with and without ferrocyanide inhibitor (upper graph) and mass change of the NaCl contaminated specimen with ferrocyanide (lower graph) during a RH cycle

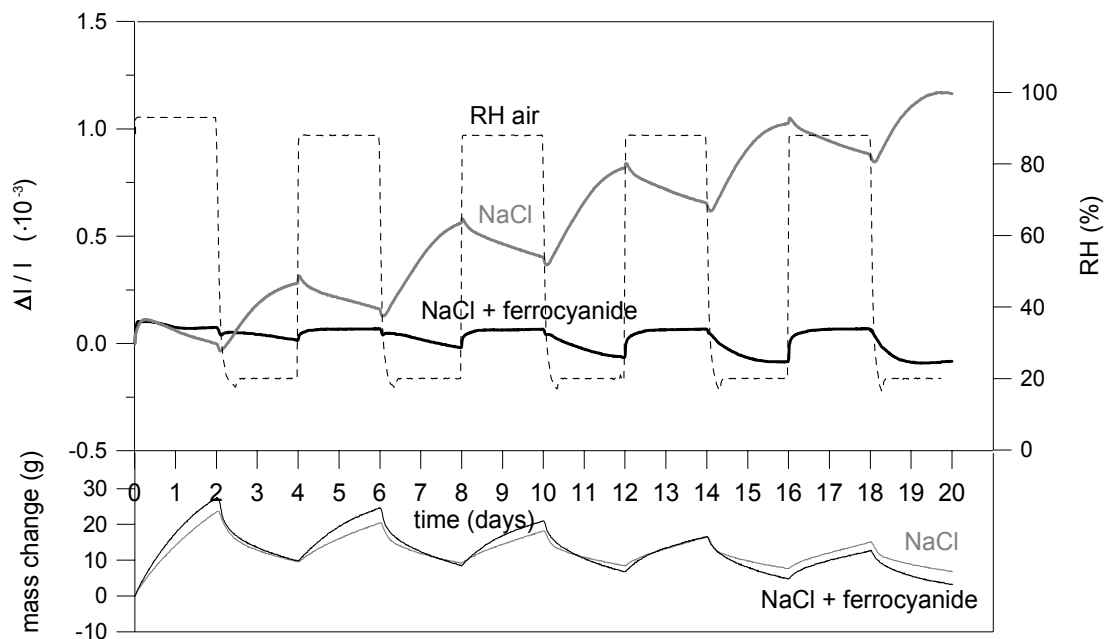
Figure 6.13 Dilation (upper graph) and mass change (lower graph) of NaCl contaminated specimens with and without crystallization inhibitor during several RH cycles

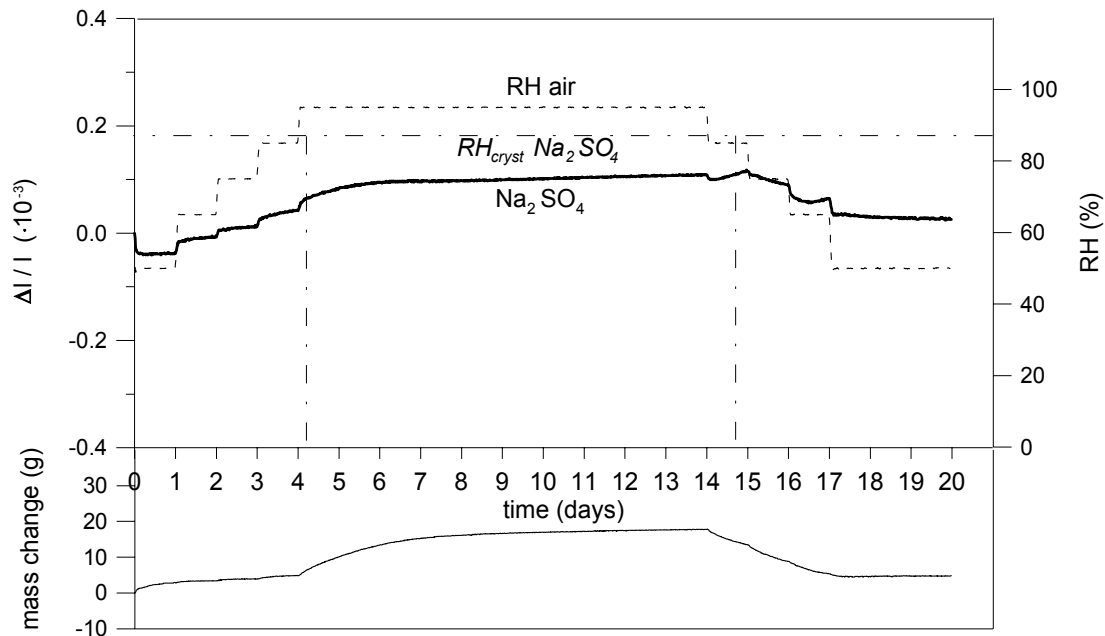
Figure 6.14 Dilation (upper graph) and mass change (lower graph) of a Na_2SO_4 contaminated specimen during a RH cycle at 40 °C

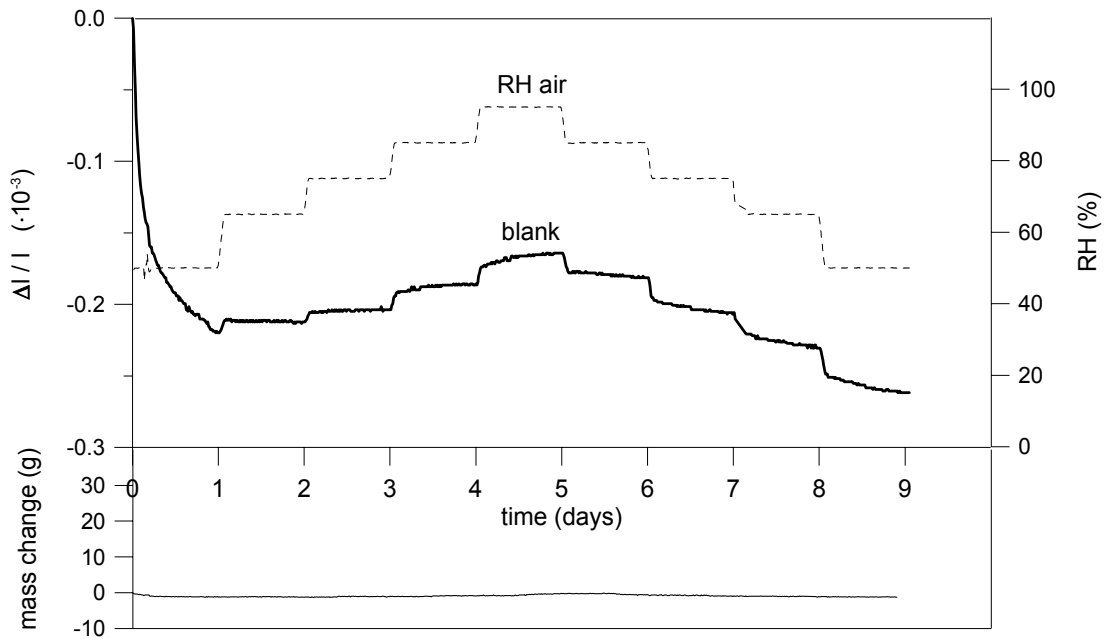
Figure 6.15 Dilation (upper graph) and mass change (lower graph) of a blank specimen during a RH cycle at 40 °C

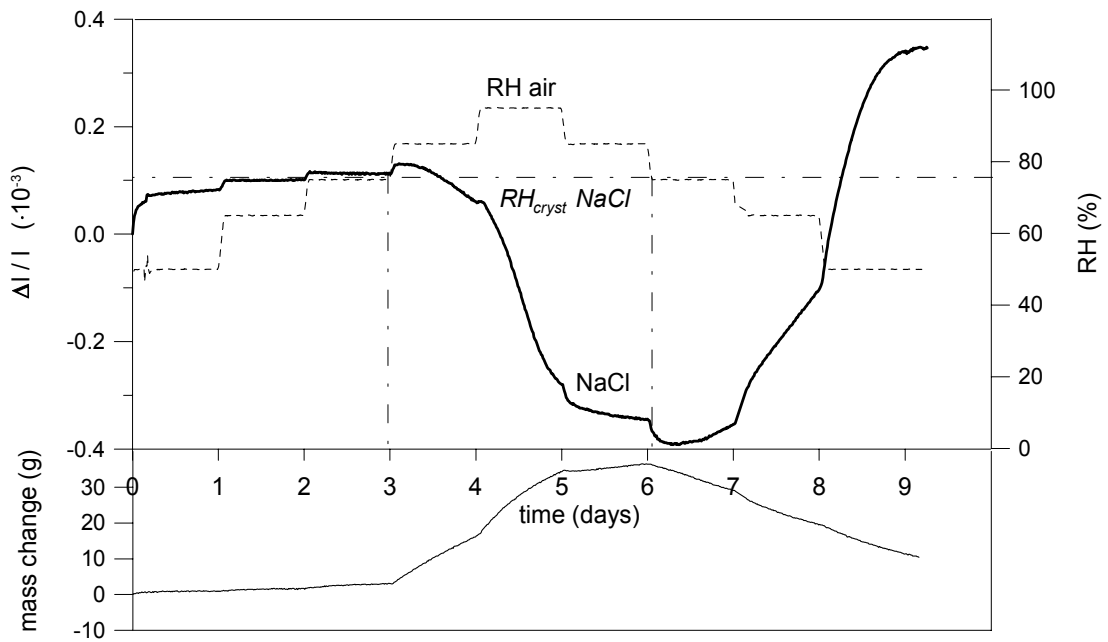
Figure 6.16 Dilation (upper graph) and mass change (lower graph) of a NaCl contaminated specimen during a RH cycle at 40 °C

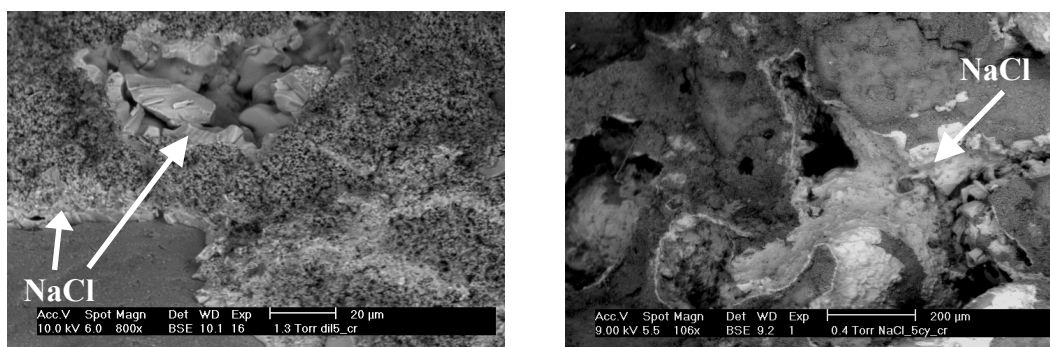
Figure 6.17 ESEM photomicrographs showing NaCl (lighter areas) crystallizing as a layer adhering to the binder and partly filling large pores (cross section of the specimen after 2 crystallization cycles, 1 mm from the evaporation surface)

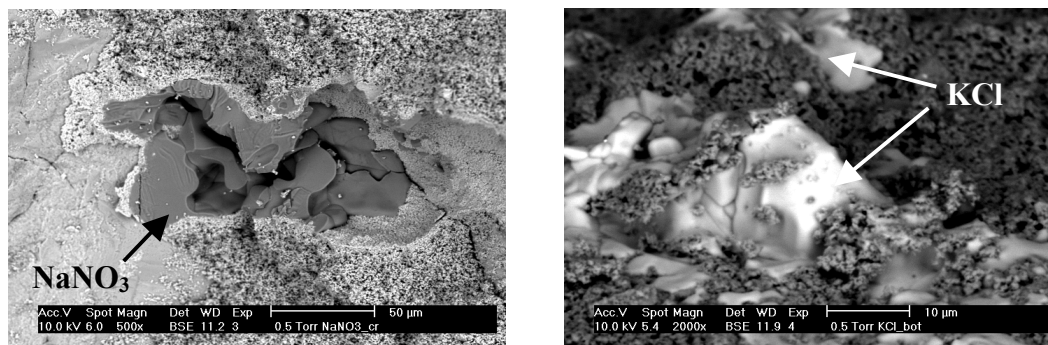
Figure 6.24 ESEM photomicrograph showing NaNO_3 (dark-grey area) crystallizing as a layer on the pore wall (cross section of the specimen after one RH cycle, 2 mm from the evaporation surface)

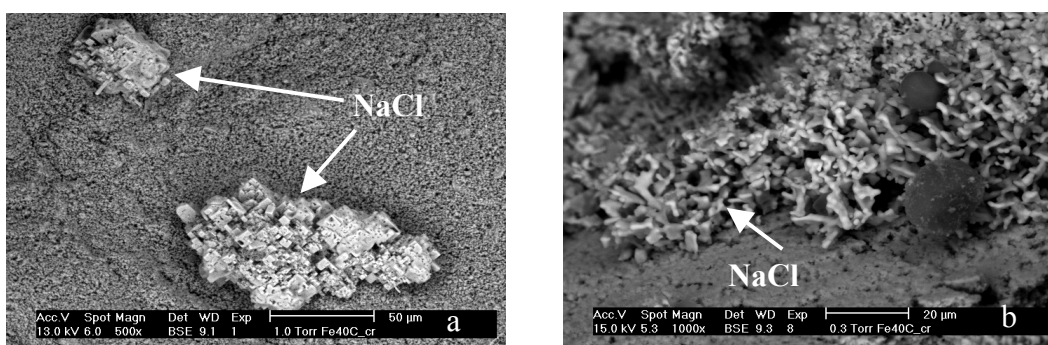
Figure 6.26 a-b ESEM photomicrograph showing NaCl crystallization in the presence of an inhibitor; crystal agglomerations (white areas) of cubic (a) or less regular crystals (b) are observed; (cross section of the specimen before the test)

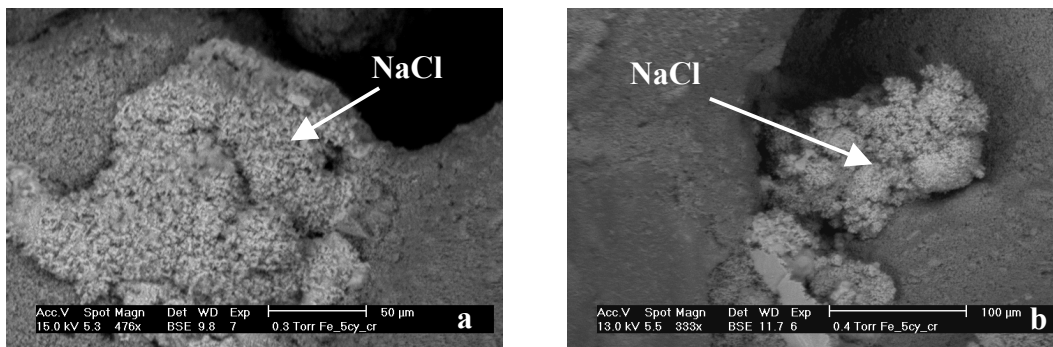
Figure 6.27 a-b: ESEM photomicrograph showing NaCl crystallization in the presence of inhibitor after repeated RH cycles. The crystal habit has not significantly changed: no salt layer is visible on the pore walls; (cross section of the specimen after several RH cycles)

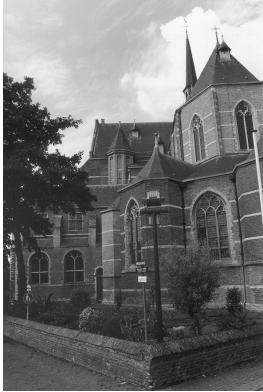
Building and location	Type of damage and material concerned	Test performed	Diagnosis
Church (Brouwersahven)

Push out of the re-pointing (exterior) Scaling of the brick (exterior) Sanding of the stone (interior and exterior) Crypto-florescences and efflorescences (interior and exterior) Peeling of the paint layer of the plaster (interior) Sanding and crumbling of the plaster (interior)	MC profiles (several locations, 3 sampling campaigns) HMC profiles (several locations, 3 sampling campaigns) RH and T (air and wall surface) monitoring Photographical monitoring of the damage Debris collection Ion chromatography on powder samples XRD on efflorescences MIP of the brick substrate and of the plaster Physical and petrographical characterization of the plaster ESEM observations on plaster scales	The damage is due to salt (mainly NaCl) and moisture. In the interior of the church the main sources of moisture are the rising damp and the RH of the air. The main source of salt is the sea-flooding occurred in 1953. The damage in the upper part of the interior walls is due to RH cycles.

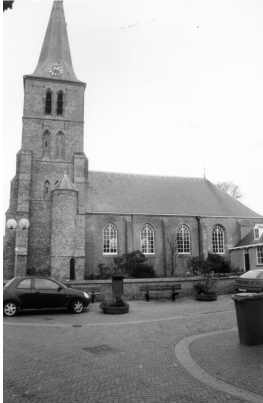
Building and location	Type of damage and material concerned	Test performed	Diagnosis
Church (Domburg)

Push out of the re-pointing (exterior) Brick blistering (exterior) Powdering of the brick (exterior)	MC profiles HMC profiles Ion chromatography on the powder samples Measurements of total porosity of brick (immersion method) MIP of the brick XRD on brick samples and on scales	The damage is due to salt (mainly NaCl) and moisture. In the exterior of the church the main sources of moisture are rising damp and rain. The main sources of salts are the ground (because of the flooding in 1953) and the sea-salt spray.

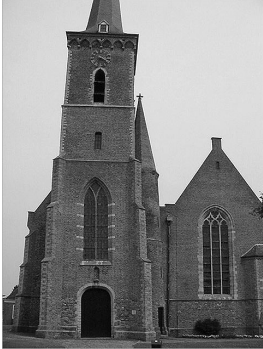
Building and location	Type of damage and material concerned	Test performed	Diagnosis
Church (Dreischor)

Powdering of the brick (exterior) Efflorescences and cryptoflorescences (interior) Loss of bond of the plaster layer (interior) Peeling of the paint layer of the plaster (interior)	MC profiles HMC profiles Chemical analyses on powder samples XRD analyses on efflorescences	The damage is due to salt (mainly NaCl) and moisture. In the interior of the church the main moisture source is rising damp. The application of a new plaster inhibiting evaporation in the lower part of the interior walls has increased the height reached by the rising damp and has caused the appearance of the damage in the old plaster.

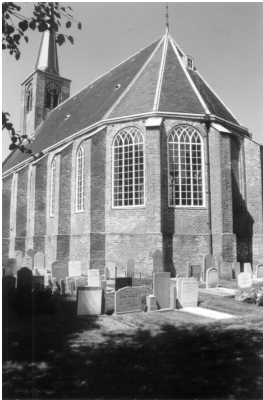
Building and location	Type of damage and material concerned	Test performed	Diagnosis
Church (Hensbroek)

Efflorescences on the brick (exterior) Push out of the pointing (exterior) Efflorescences and cryptoflorescences on the plaster (interior) Peeling of the paint layer (interior) Sanding and crumbling of the plaster (interior)	MC profiles HMC profiles Salt crystallization test on two brick/plaster cores	The damage is caused by the presence of moisture and salts. Moisture is due both to rainwater penetration (on the south side) and to presence of hygroscopic salts (on the north side).

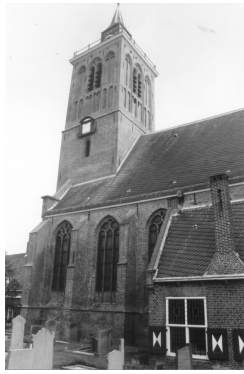
Building and location	Type of damage and material concerned	Test performed	Diagnosis
Church (de Rijp)

<p>Efflorescences on brick (exterior)</p> <p>Efflorescences and cryptoflorescences on plaster (interior)</p> <p>Peeling of the paint layer (interior)</p> <p>Sanding and crumbling of the plaster (interior)</p> <p>Loss of bond between the different layers of the plaster and between the plaster and the masonry (interior)</p>	<p>MC of damaged and undamaged areas</p> <p>HMC of damaged and undamaged areas</p>	<p>Damage is related to presence of moisture and salt. The main moisture source is rain penetration. The damage interest mainly the south wall, exposed to rain and wind. The north wall shows low moisture content and only little damage, in spite of the presence of a considerable amount of salts.</p>

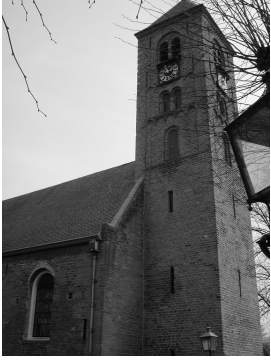
Type of building and location	Type of damage and material concerned	Test performed	Diagnosis
Church (Velsen)

Algae (exterior) Powdering of the brick (exterior) Cracks in the bricks and pointing (exterior) Voids in the pointing (exterior) Moist spots (exterior) Peeling of the paint layer (interior) Sanding, scaling and crumbling of the plaster (interior)	MC profiles HMC profiles HMC on brick/mortar/plaster cores	Damage is related to presence of moisture and salt. The main sources of moisture in the interior of the church are rising damp and rain penetration.
