SWBSS
2011 19 - 22 October
Limassol, Cyprus

Salt Weathering on Buildings and Stone Sculptures

Salt efflorescence and subflorescence in Baroque frescos and the role of bat droppings in the decay wall paintings

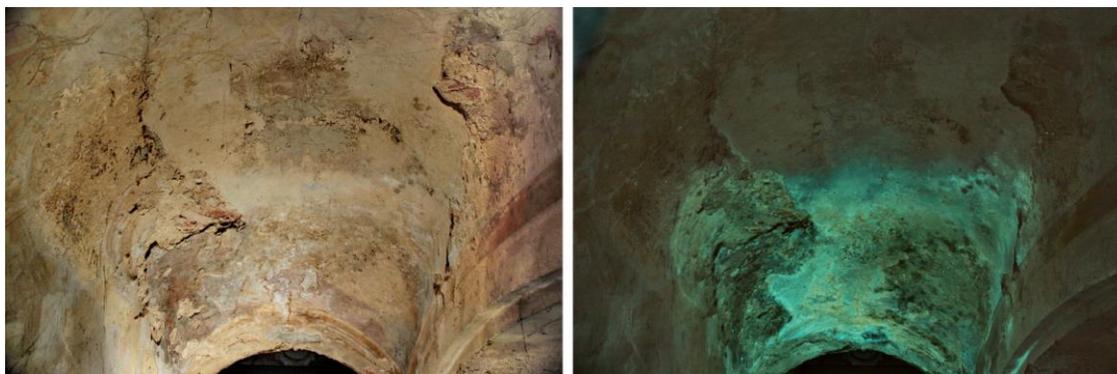
The UV luminescent images revealed that salts were precipitated on the surface of the wall painting. The salts showed strong predominantly bluish luminescence, clearly depicting the damaged areas (Fig. 3). This technique was also very useful in recording the organic discoloration related to migrating salts. Organic decomposition resulted in the formation of brownish stain. Raking light and macro photos clearly show that white salt efflorescence and brown stains on the surface (Fig. 4).

Figure 3. Normal light (left) and UV luminescence (right) image depicting the badly damaged zone (bright zones on the UV image) of the fresco, in the the NW Choir of the church.

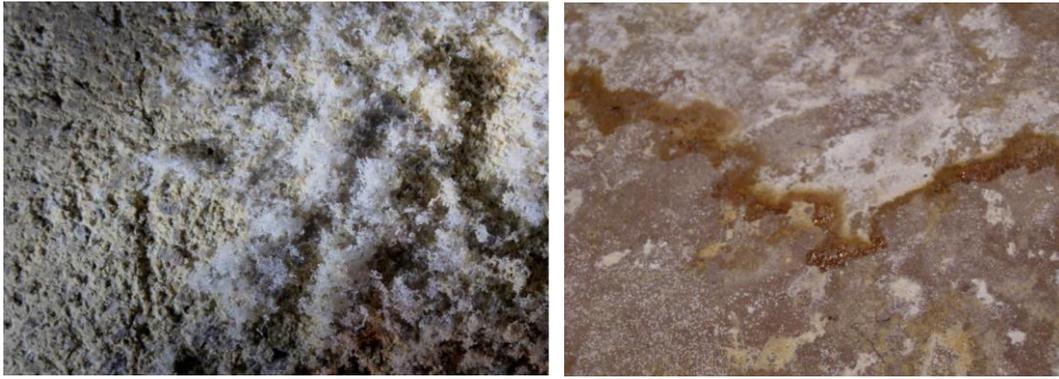
Figure 4. Macro photos of the white salt efflorescence (left) and brownish stain (right).
