**SWBSS**  
**2011** 19 - 22 October  
Limassol, Cyprus

# Salt Weathering on Buildings and Stone Sculptures

# Electrochemical desalination of the ionic mixture measured in the vault of Rørby Church– Laboratory scale

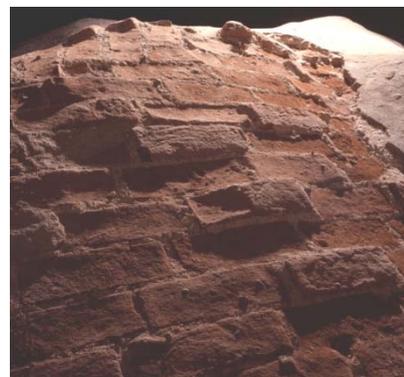
Figure 1. Bricks left uncovered, the area from which the brick powder was collected. Foto: The National Museum of Denmark, 2001.

In 1999 a part of the cement mortar was removed from the upper side of the vault leaving one quarter of the bricks uncovered. This show that a large part of the bricks had been eroded to up to 25% of their original thickness.

Brick powder collected with a brush from the same area (figure 1) in 2002, 2005 and 2011 shows a constantly ongoing deterioration of the bricks.

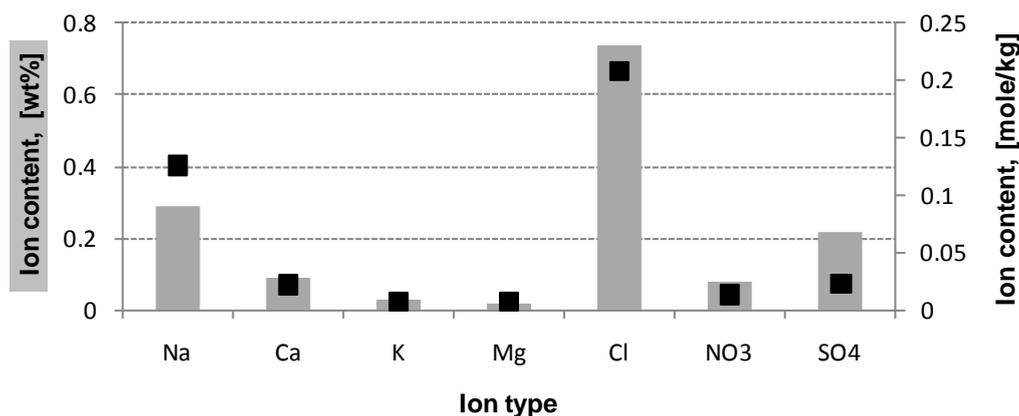
Figure 2. The ion contents in the decomposed brick material collected above the vault in Rørby church shown both as wt % (the gray bars and primary y-axis) and as mole/kg (the black squares and secondary y-axis).

The ionic contents of Na, Ca, Cl, NO<sub>3</sub>, SO<sub>4</sub>, K and Mg were measured and shown in figure 2 as the average of the contents from 2002, 2005 and 2011 (triple determination from each year) both as wt% and mole/kg. K and Mg were only measured in the brick powder from 2011 (as triple determination).

Provided the average of the sodium content from 2002, 2005 and 2011 (0.126 mole/kg) is given the relative number 1, the relative numbers of Ca, K, Mg, Cl, NO<sub>3</sub> and SO<sub>4</sub> are as shown in table 2.

The measured ion contents in the brick powder (figure 2 and table 2) can be obtained in solution by adding (in ratios) the salts shown in table 3 and is in the following termed salt mixture 1. E.g. a relative number of 1/10 for both potassium and nitrate can be represented by 1/10 KNO<sub>3</sub>. The used salts must dissolve in solution and therefore the salt's solubility is taken into account. Therefore CaSO<sub>4</sub>·2H<sub>2</sub>O was added until maximum solubility (2.4 g/L according to (Larsen 1999)) and subsequently additional sulphate was added as MgSO<sub>4</sub>·7H<sub>2</sub>O. The used salts for salt mixture 1 are by (Arendt & Seele 2001) described as common building salts.

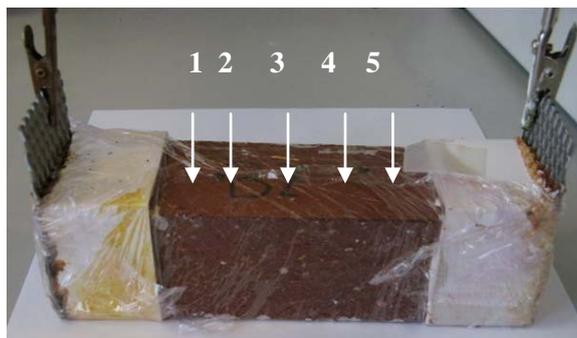
The setup consists from the left to the right of: the anode, accumulating poultice (consisting of kaolin clay, calcium carbonate and distilled water buffering the produced  $H^+$  at the anode), brick, accumulating poultice (consisting of kaolin clay and acidic acid buffering the produced  $OH^-$  at the cathode) and cathode. A constant current of 20 mA was applied across the setup.

The numbers indicate the sampling positions: 1.8 cm; 3.7 cm; 5.5 cm; 7.3 cm and 9.2 cm from the left of the brick, where left is the end next to the anode. The samples were extracted with a drill from the top through the brick specimens.

Figure 2. The experimental setup and indication of the sampling positions (the numbers).

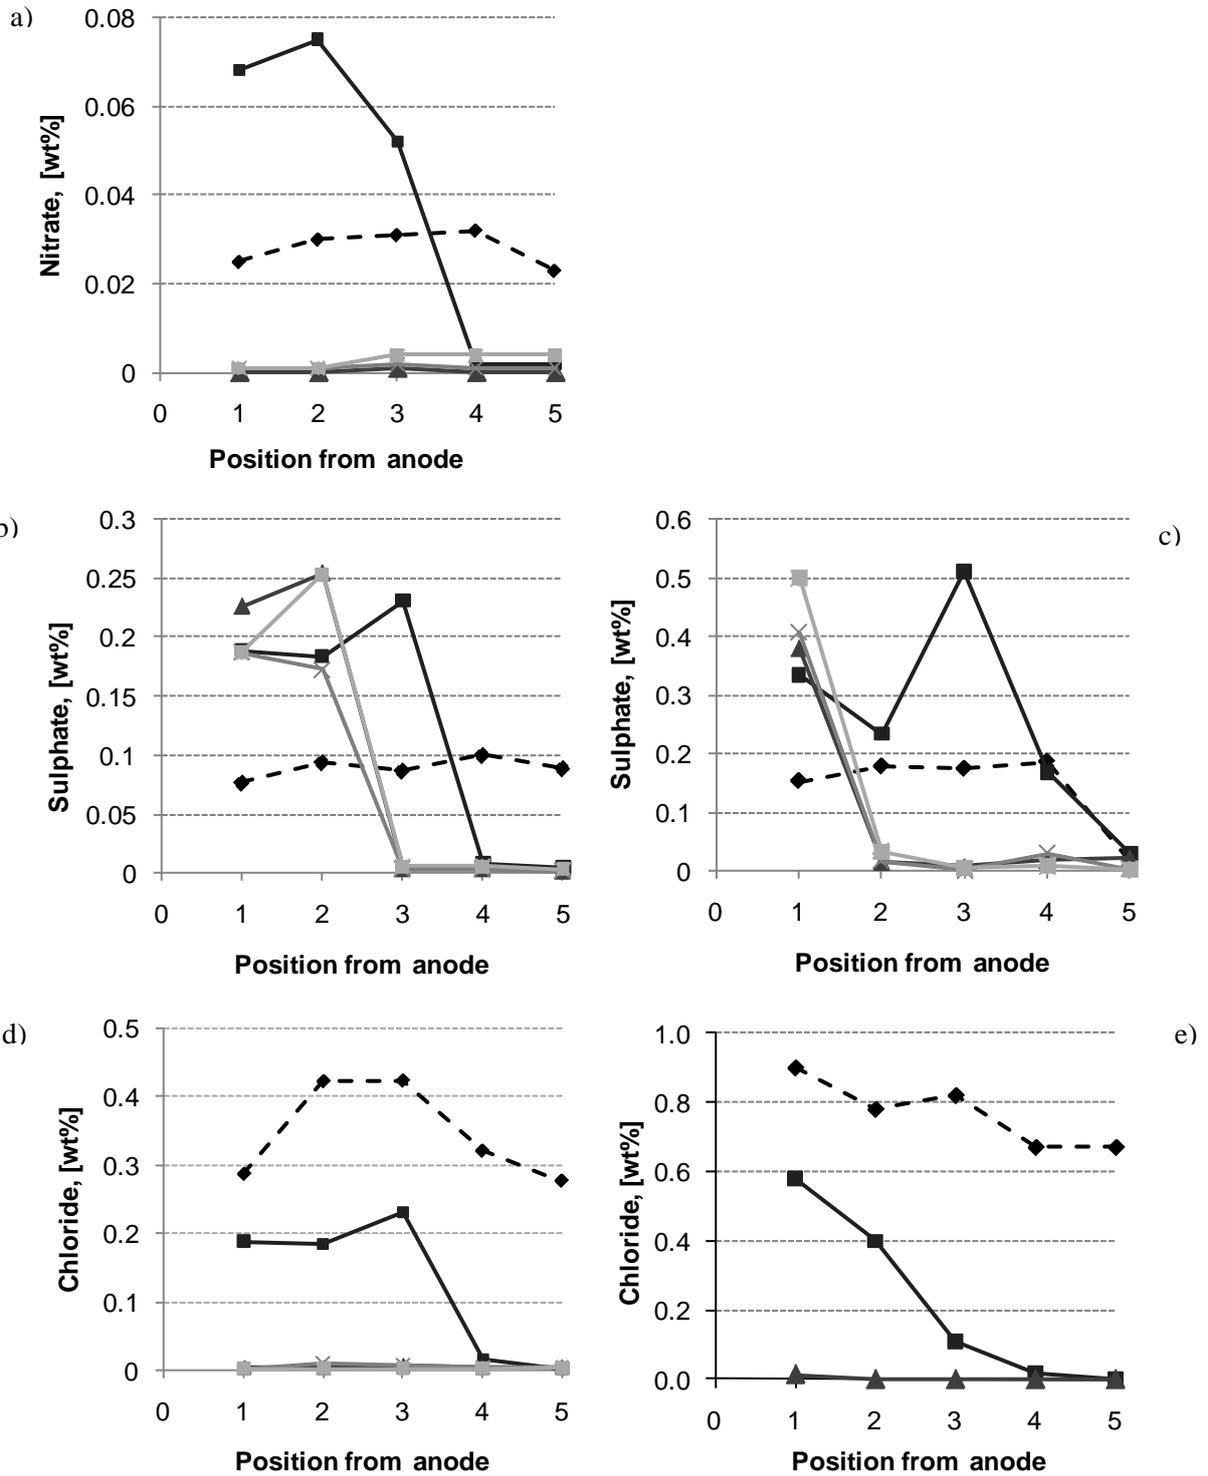
Figure 4. Development in the anion contents. ♦ reference (14 days without applied electric DC field), ■ 4 days, ▲ 6 days, × 14 days and ▣ 21 days with applied electric DC field shown for: a) nitrate (salt mixture 2), b) sulphate (salt mixture 2) c) sulphate from salt mixture 1, d) chloride (salt mixture 2) and e) chloride (the single salt sodium chloride, (Rörig-Dalgaard 2009 B)).

After application of an electric DC for 4 days across the experiments with salt mixture 2 the nitrate and chloride content was reduced significantly (figure 4a and figure 4d) compared to the reference experiment without applied electric DC field in position 4 and 5 meaning at least the 4 cm closest to the cathode (the negative electrode). After 6 days experimental duration, the

chloride and nitrate contents were reduced to 0.0048 +/-0.0013 wt% for chloride and 0.0002 +/-0.0004 wt% for nitrate throughout the whole brick. The results from the series with salt mixture

1 showed the same tendencies (not shown). A reduction to low contents of both nitrate and chloride therefore seems uncomplicated also when they are a part of a salt mixture.

In figure 4b the results from the experiments with salt mixture 2 are shown. After 4 days significant reduction in the sulphate content had occurred in position 5 (around 2 cm from the right end towards the cathode). An additional reduction occurs between 6 and 14 days, however between 14 and 21 days no further reduction was measured. The same pattern for transport of sulphate in the bricks contaminated with salt mixture 1 is seen in figure 4c. However, a higher removal was obtained after 6 days, compared with figure 4b meanwhile no significant additional reduction in the sulphate content was obtained between 6 and 21 days. This means that for both salt mixture 1 and 2, position 1 and in figure 4b, also position 2 still has high sulphate contents and indicates a general tendency. This might be caused by new formation of a heavy soluble salt, e.g. a sulfate salt ( $\text{CaSO}_4 \cdot 2\text{H}_2\text{O}$ ), which precipitates and hinders further electrochemical transport.

In figure 4d the measured chloride contents for salt mixture 2 are shown and in figure 4e the results from a previous investigation (Rørig-Dalgaard 2009 B) with the same setup, however with a salt solution consisting of the single sodium chloride are shown. By comparison of figure 4d with figure 4e it was possible to test the electrokinetic efficiency on the present mixture against the efficiency for a single salt, since the total amount of anions were the same in these two experimental series. In both cases the chloride content was in both cases reduced significantly after 4 days and was almost removed after 6 days. This suggests that presence of additional anions (and cations) do not change the efficiency of the electrochemical transport of chloride significantly. As the experiments were carried out as one off experiments, in 2 series with comparable results general tendencies was shown.
