*Salt Weathering on Buildings and Stone Sculptures. Proceedings from the International Conference. Copenhagen, 22-24 October 2008, The National Museum of Denmark.*

# Salt-induced alveolar weathering of rhyolite tuff on a building: causes and processes

*Heiner Siedel*

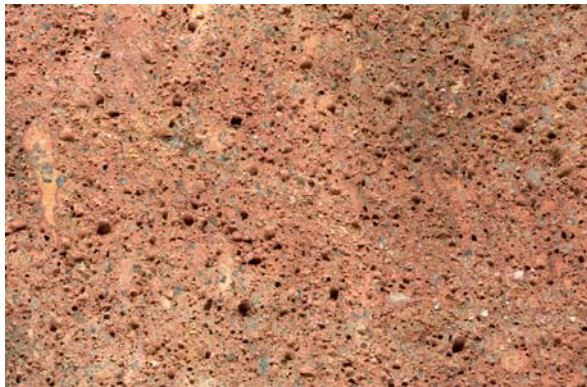
**Figure 1:** Rhyolite tuff from Rochlitz (figure width = 10 cm).

The red rhyolite tuff from Rochlitz (Saxony, Germany) has been widely used as a building stone since the 12<sup>th</sup> century (see Figure 1). The rock of Lower Permian age (Rotliegend) is a fine grained pyroclastic sediment with flat lapilli in the dimension of some mm to cm. Beside pyroclastic fragments, the stone contains quartz grains up to some mm in size, kaolinite, mainly formed by devitrification processes in the matrix as well as by degradation of feldspars, and small amounts of biotite.

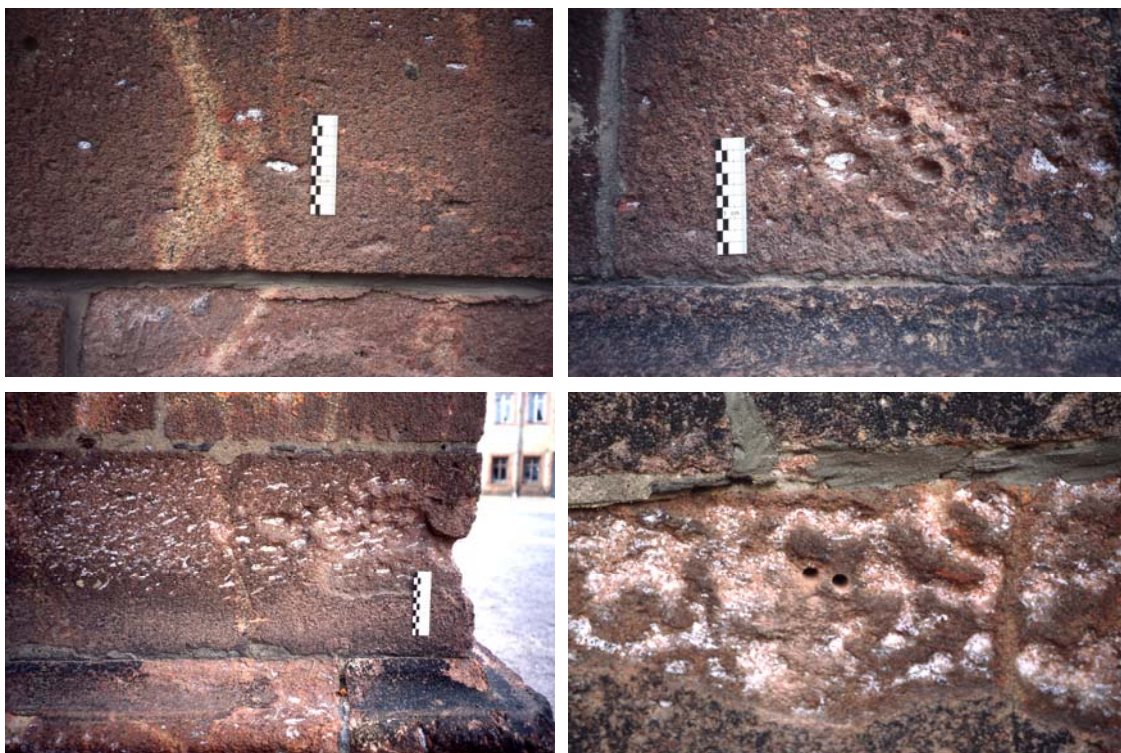
**Figure 4:** Stages of the development of alveoli at the church St. Kunigunden in Rochlitz: Weathering out of single lapilli components (above). Smaller pits can coalesce to bigger alveoli (lower left), salt efflorescence is always present. Further salt weathering forces the formation of a system of holes and ridges (lower right, with the drill holes for detailed salt investigations).

The mapping of a part of the southern façade clearly displays a typical pattern of different weathering forms at different height levels (figure 3). At the base of the wall (up to about 1 m) mainly blackening of the surface and contour scaling was observed. At somewhat higher levels (above 1 m) the dominant weathering forms are weathering out of components (partly with transition to alveolar weathering) and alveolar weathering. The same scheme could be observed on the whole southern façade. In different areas at the higher level, different intensities of weathering could be observed with transitions from local weathering out of lapilli components to the formation of alveoli. Several stages of this process are recorded in figure 4.

Initial pits caused by weathering out of single lapilli components from the matrix play a crucial role in the development of alveolar structures. Moisture and the most soluble salts will concentrate behind the pit when the stone dries slowly after a wet period [Huinink et al. 2004]. The original, non-weathered surface zone dries much faster, and less soluble salts (gypsum) are preferentially precipitated there. The salt distribution found in hole and ridge is the result of repeated moistening-drying events at the stone surface, leading to different spatial accumulation of magnesium sulphate and gypsum.

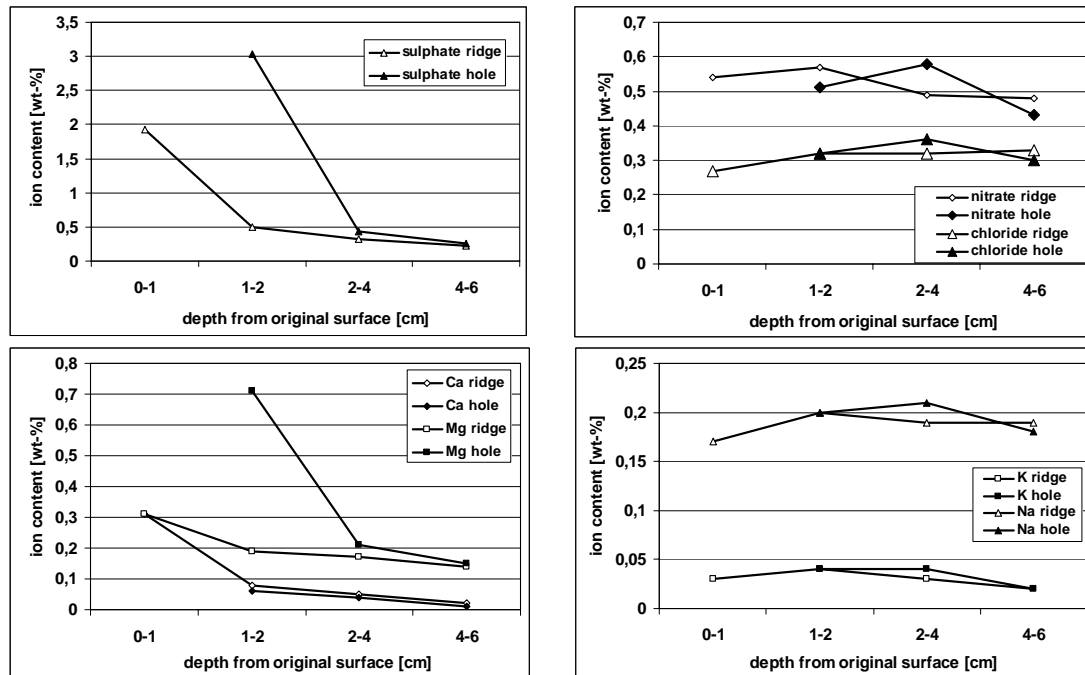
**Figure 6:** Salt distribution in a hole and in a ridge (cf. Figure 4, lower right).

Since the drill core at the height of 1.20 m was taken from a stable surface, more detailed salt investigations were carried out in an area with active alveolar weathering at the same level. A profile of drill powder samples was taken from the surface to depth on a ridge as well as at the bottom of the neighbouring hole. Results are given in Figure 6. Sulphate contents are very high near the surfaces of the ridge and of the hole as well. Nitrate and chloride, correlating with sodium and potassium, show the typical, more or less even distribution of these highly soluble salts over the whole profile depth in both ridge and hole. The spatial distribution of the cations calcium and magnesium correlates with the sulphate content, but is different for ridge and hole. Calcium (bound in gypsum,  $\text{CaSO}_4 \cdot 2 \text{H}_2\text{O}$ ) is concentrated near the non-weathered surface in the ridge whereas its content near the surface in the hole is much lower. In comparison, magnesium (bound in magnesium sulphate,  $\text{MgSO}_4 \cdot n \text{H}_2\text{O}$ ) is highly concentrated near the surface in the hole and shows significantly lower contents near the non-weathered surface of the ridge. This is in accordance with the results of XRD analyses: efflorescing salts in holes are mainly magnesium sulphates, sometimes together with traces of gypsum.

The results of salt analyses demonstrate that alveolar weathering does not occur in the zone where only gypsum is the dominant salt compound even if the the highest salt concentration at all was found there. The presence of better soluble, mobile salts beside gypsum seems to be a precondition for this weathering process. In the profiles from the alveolized area as well as in efflorescence taken from the holes, magnesium sulphate is the dominant salt. This is in a good accordance with results obtained from investigations of alveolar weathering on sandstone buildings in Saxony [Siedel 2008]. The presence of magnesium sulphates is due to accelerated weathering of the dolomitic joint mortars under the environmental conditions of the last century with high pollution of air and rain water by sulphur [Klemm & Siedel 2002].
