Environmental control for mitigating salt deterioration by sodium sulfate on Motomachi Stone Buddha in Oita prefecture, Japan

This study aimed to develop an appropriate interior environment to mitigate the deterioration by sodium sulfate crystallization on Motomachi Stone Buddha in Oita prefecture of Japan. This Stone Buddha is carved on the fragile welded tuff and has been covered by a shelter for the preservation. On this site, salt crystallization, especially in winter, is a major deterioration factor of this Buddha. In previous studies, the crystallization of sodium sulfate and calcium sulfate were identified by XRD. The temperature and relative humidity were measured both indoor and outdoor. Water quantity analysis of the groundwater near the Stone Buddha has been conducted revealing a higher solute content near the Buddha than in the general groundwater in Japan. According to the temperature and humidity measured inside the shelter in winter, it was suggested that the solubility of sodium sulfate decreased greatly with dropping in interior temperature and phase change from mirabilite to thenardite (sodium sulfate anhydrate) caused the deterioration of the statue. Hence, the

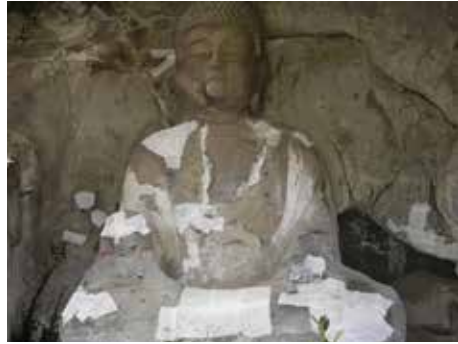
Figure 1: Motomachi stone-cliff Buddha

The Motomachi stone-cliff Buddha is located in Oita prefecture, Japan. It was engraved onto a cliff of soft welded tuff around the 11th to 12th centuries and was covered by a shelter which was built during in the 20th century (*Figure 1 and Figure 2*). The entrance of the shelter faces east. Salt crystallisation especially in winter is the most important cause of deterioration. Powdering and scaling occur at the surface of the stone. A previous investigation identified thenardite, mirabilite and gypsum by X-ray diffractometry (XRD).^{8,9} Furthermore, a past study showed that sulphate, calcium and sodium ions, that are the origins of thenardite, mirabilite and gypsum, are detected in the groundwater near the site. And the content is higher than in the general groundwater in Japan.⁹ Although a drainage tunnel and well were built in order to lower the groundwater levels (*Figure 3*), an increase in the amount of salt was reported after this construction. A past study also suggested that drop in inside temperature in winter due to door-opening of the shelter and water leaking into the high-water-content stone could be causes of salt crystallisation at the Motomachi stone-cliff Buddha.⁹ Therefore, the shelter was improved by setting door closer, double glass windows and boards to reduce ventilation frequency and to block the direct solar radiation to the Buddha in November 2015 by the Oita-city board of education.

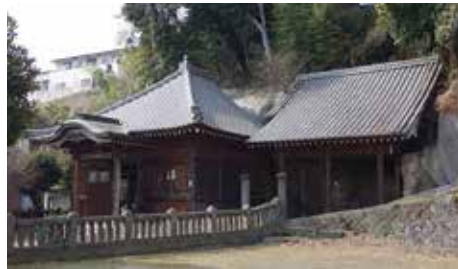
Figure 2: Exterior of the shelter

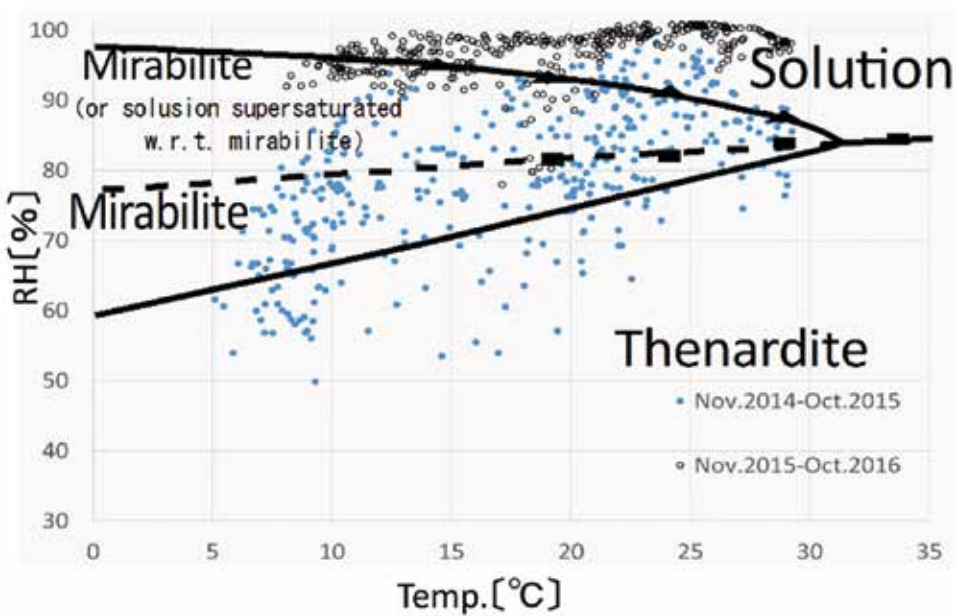
Figure 6: Phase diagram for sodium sulfate and temperature and relative humidity of daily average inside the shelter (based upon data from⁴) Blue dots are before improvements Temp. and RH, on the other hand white dots are after improvements.

Figure 5 illustrates a phase diagram for sodium sulfate and temperature and relative humidity of daily average inside the shelter. The continuous lines indicate the boundaries of the stable phases.⁴ This diagram suggests that the interior environment before the improvements (November 2014–October 2015) mainly varied in both thenardite and mirabilite stable conditions. Previous studies showed the damage by sodium sulfate occurs because thenardite dissolution can produce solutions highly supersaturated with respect to mirabilite, so that precipitation of this phase can lead to large crystallization pressures.^{5,10} Thus, it is important for the conservation of the Buddha that crystallization of sodium sulfate should be reduced, cycles of crys-

tallization and dissolution of sodium sulfate should be avoided and phase change to thenardite should be suppressed even if mirabilite crystallizes. Figure 5 indicates that the interior environment after the development of the shelter (November 2015–October 2016) were mostly under solution of sodium sulfate stable phase, even though sometimes in mirabilite stable phase. This results shows that the improvements reduced the risk of precipitation of thenardite. Furthermore, the indoor temperature before and after improvements in winter is shown in Table 2. The temperature in winter increased 3.4°C after the renovation, which could lead to inhibit decreasing solubility of
