Diagnostic investigations to define the possibility and the effectiveness of desalination with the poultice-technique – a case study

Hans-Jürgen Schwarz¹, Erwin Stadlbauer², Rolf Niemeyer²

Abstract

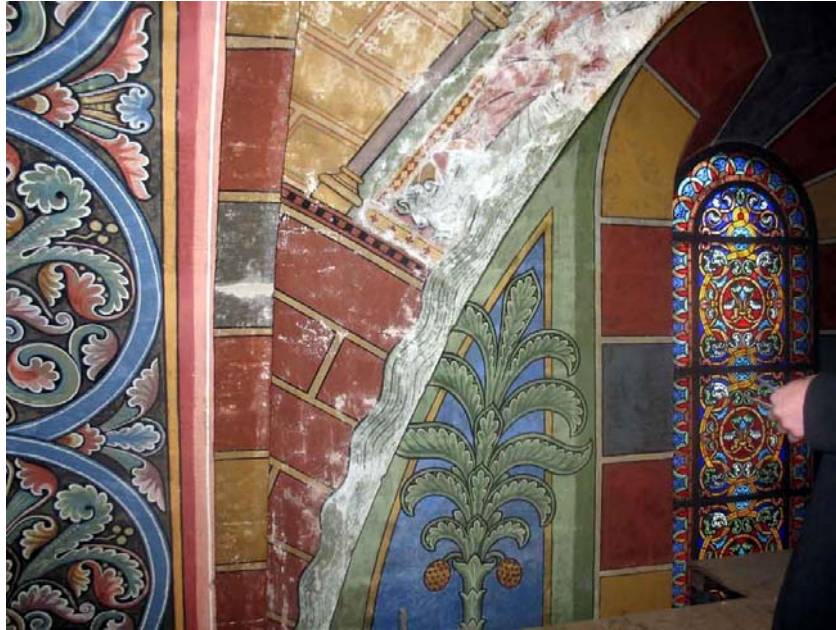
Figure 1. Salt damage of the wall paintings in the cathedral in Königslytter

In 1974 large amounts of cement suspensions were injected into the walls to stabilize the static of the building. The wall paintings were previously treated with an acrylic resin in order to protect the surface. However while the static consolidation succeeded the protection of the wall paintings failed. Comprehensive diagnostic investigations started around 1990 and it was evident that as a consequence of the injected suspension the masonry was intensively penetrated with moisture. The damaging process was essentially caused by the mobilisation and the crystallisation of salts (Rösch 1996).

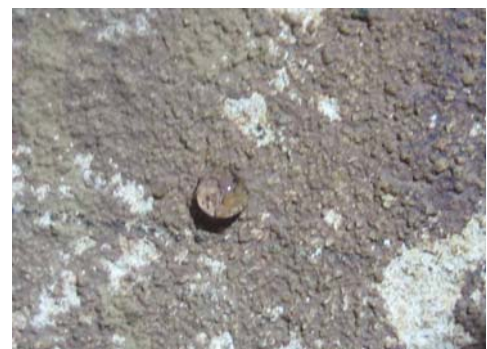
Figure 3: The droplet method

With the droplet method around 10 µl of water were offered to the surface which has to be tested. The time until total absorption of the water droplet is a quantitative measure of the water absorption velocity i.e. the hydrophobic / hydrophilic properties.

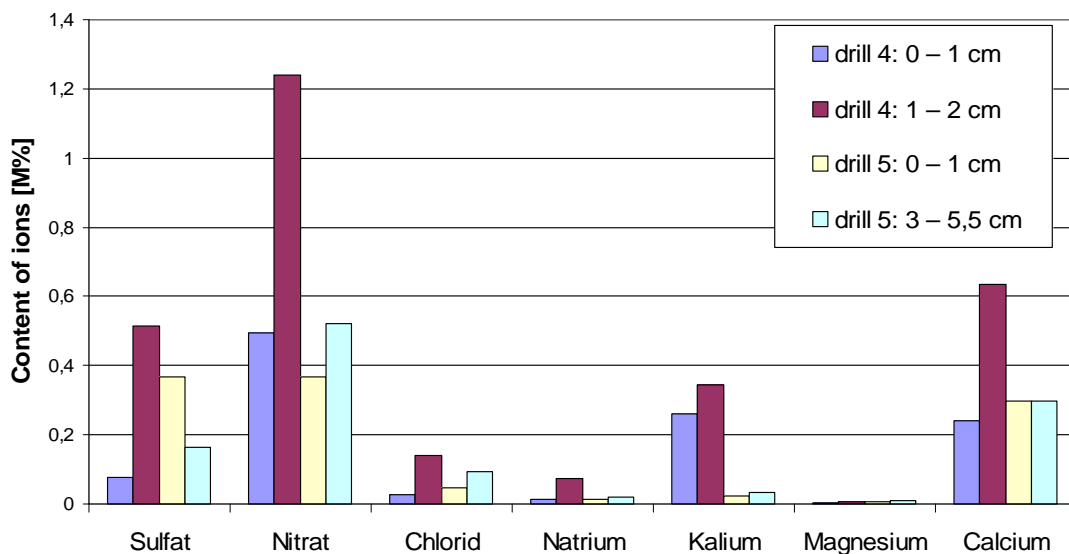
Figure 5: Niter and nitrates dominated samples

On the other hand salts like niter will easier than gypsum migrate again to the surface, which could be observed at places on a new repair mortar, where after some days thin needles of niter are visible.

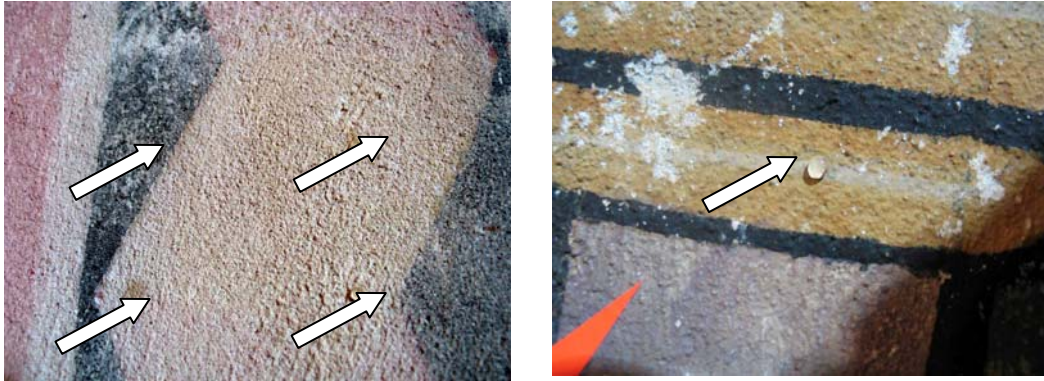
The greatest water absorption show surface defects and gilded areas but only sometimes the 10 μ l droplet is taken up in a few seconds. Most it takes 1 –10 minutes. In some places e.g. the green regions in the “SO Fluss” the droplets were visible even at more than 40 minutes (hydrophobic surface).

Figure 6: The droplet method was used for 15-20 measurements for each model area

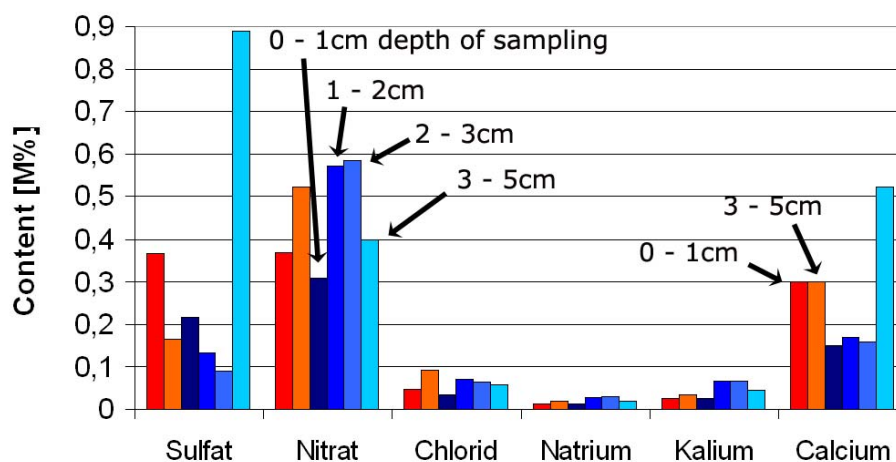
Figure 9: S-transept : Distribution of salt forming ions with depth of sampling before (red columns) after salt reduction (blue columns).

In the first centimetre a slightly reduction of the salt content could be found, but looking to deeper regions in the plaster nearly no salt extraction could be observed (fig. 9, 10).

Looking to the final results of the analyses a clear success of the salt reducing methods could not be found.

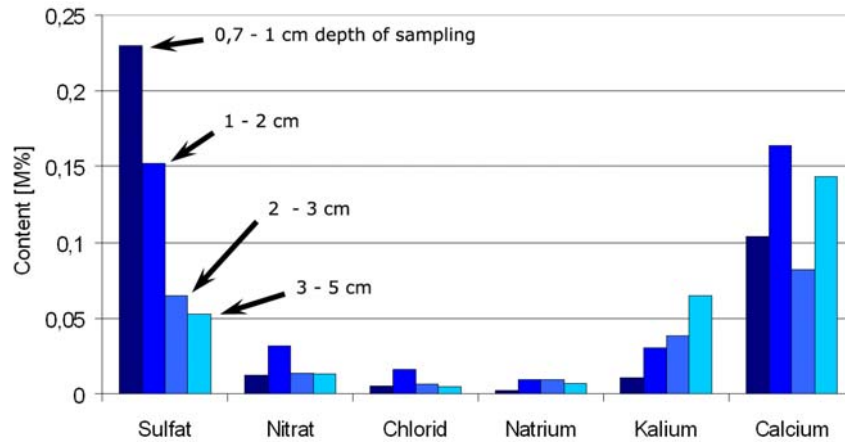
Figure 10: Distribution of salt forming ions with depth of sampling after salt reduction in the test area “NW-Fluss”. A decrease can only be observed with the good soluble salts made of Na^+ , K^+ , Cl^- , NO_3^- .

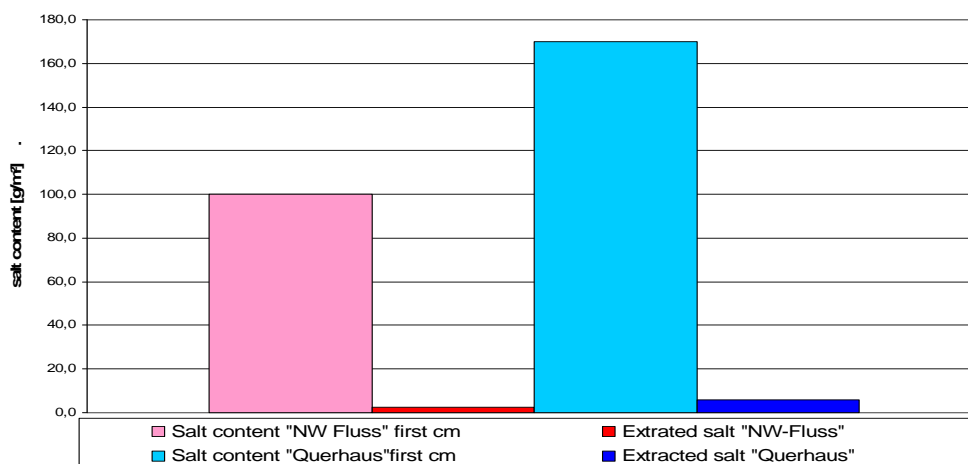
In the first centimetre of the surface in the SW corner of the S-transept 170g salt/m² were found while by the short time poultices only about 1g salt/m² and the drying poultice about 5g salt/m² (fig. 11) could be extracted, mostly very soluble salts and not gypsum.

In the first centimetre of the surfaces of the „NW-Fluss“ of the choir vault about 100g salt/m² were analysed. The short time poultice has extracted 0,5g salt/m² and the drying poultice about 2g salt/m².

Figure 11: The efficiency of the salt reducing methods at the two model areas.

All together with the applied methods only 5% of the salts could be extracted. The poultices do not reach depths of more than 1 cm.
