Tracing back the origins of sodium sulfate formation on limestone as a consequence of a cleaning campaign: the case study on Charité and Espérance sculptures of Chartres cathedral

In 2012, five years after cleaning by Mora paste, sodium sulfate related deterioration was noticed on two XVIIIth century limestone sculptures of Chartres cathedral. This paper presents the results of the diagnostic study and of the conservation intervention performed on these sculptures, with a focus on trials to determine the salt phases responsible for their deterioration. The methodology chosen includes mineralogical and chemical analyses of samples collected on the sculptures during the diagnostic phase and after kaolin-based poultice desalination (XRD, quantification of soluble salts, SEM-EDS), but also mineralogical analyses of the salts extracted from the poultices.

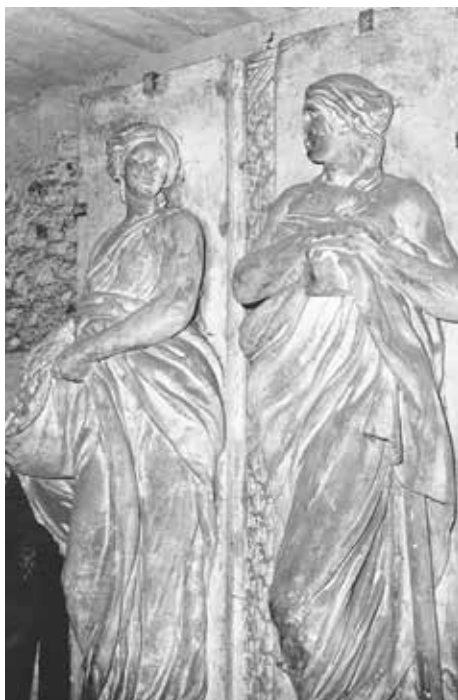
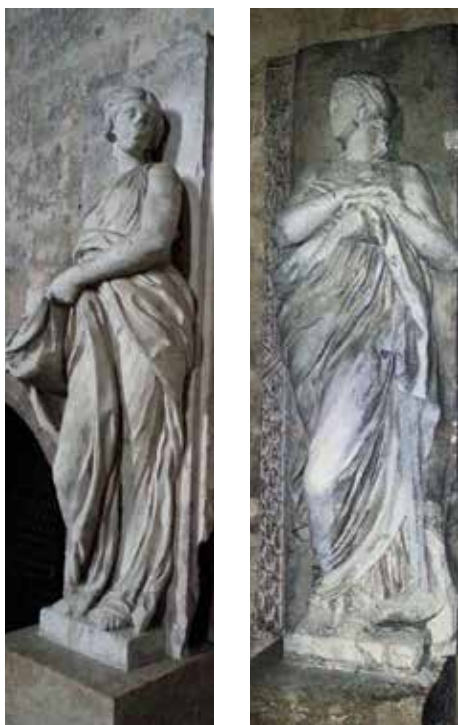
Figure 1: Charity and Esperance sculptures: presentation at Chartres Musée des beaux Arts in 1998 (left), and into the cathedral in 2012 (right)

In 2007, the four sculptures reintegrated the cathedral, where they were placed on pedestals ca.1 m height, back to the walls but without any contact with the masonries (*Figure 1*). Before being reinstalled, Charity and Esperance were cleaned using "Mora" paste, while Faith and Humility did not undergo any intervention, apart the application of a limewash, clearly visible to the naked eye on their surface. It is believed that this intervention was performed to give the two sculptures an homogeneous colour, as this paint layer covers pollution black crusts.

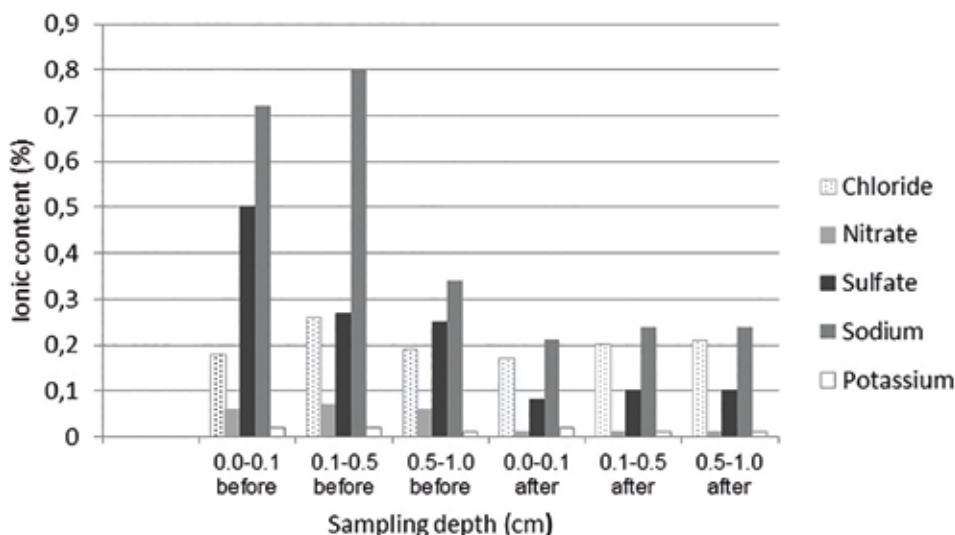
Figure 5: Results of the soluble salts quantification on the sculpture "Espérance". Location of sampling to be found on Figure 3 (ref. "desal")

poultice removal, but the overall results were considered positive, as salt contamination was strongly reduced by the conservation intervention (*Figure 4*). Kaolin relicts adhering to the surface were gently removed from the surface using a soft brush. Tonnerre limestone having a very light creamy colour, the slight and local whitening due to the presence of minute proportions of kaolin left after brushing did not impair the overall aspect of the sculptures.

The poultice desalination was evaluated on the basis of quantification of soluble ions from zero to 1 cm depth.⁷ It appears that the main ions sodium and sulfates have clearly decreased while chlorides contents, relatively high before desalination, remained unchanged as a result of poulticing.

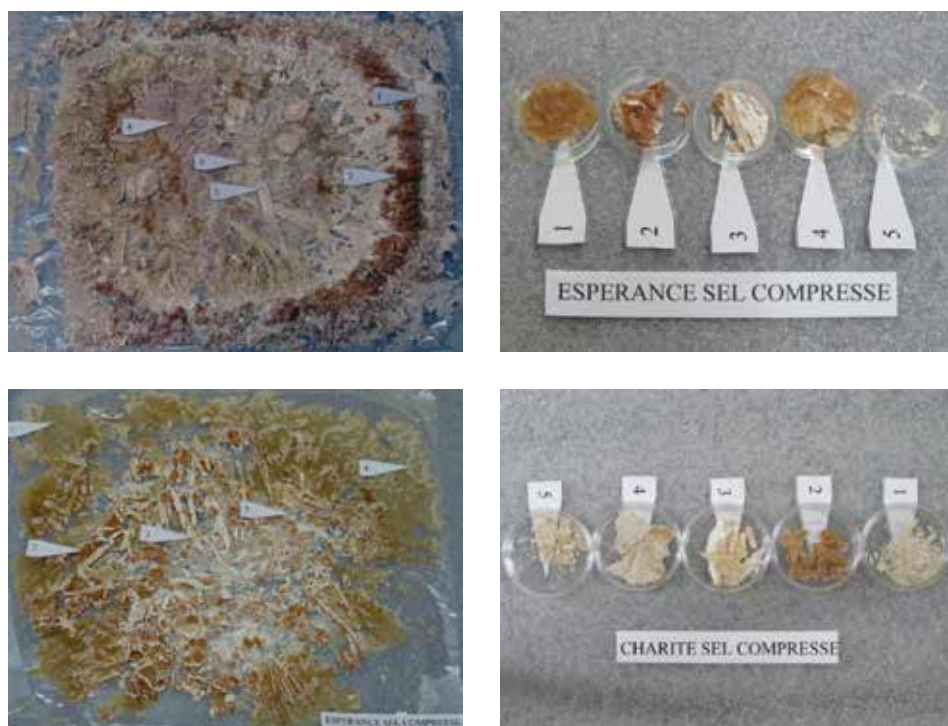
Figure 6: General aspect of the evaporates, and overview of the sampling.

The salts extracted from the two sculptures looked pretty much the same (*Figure 6*): a light brown colour, and a ring shape sequence of crystals. Samples collected from the outer to the inner ring were characterized by X-ray diffraction (*Table 2*).

The evaporates contain mainly thenardite. The other major phase is an unidentified phase (ref “unident phase b”), different from the unidentified phase (ref unident phase “a”) found on surface samples collected on the sculptures before the desalination intervention. Three other phases are locally abundant: gypsum and halite, and the unidentified phase “a”. Calcic EDTA is found in four samples. Interestingly, the sample containing the higher amount of calcic EDTA also contains high amounts of the two unidentified phases. The sample Charity 3 was collected on big flat quadrangular white crystals visible in the two evaporates, suggesting that they are thenardite (or rather mirabilite dehydrated into

thenardite). Other crystal shapes cannot be attributed clearly to a single phase, although it is clear that the cauliflower-like brown crystals (ref. Charity 2 and Esperance 2) in both evaporates are essentially made of the unidentified phase “b”.
