Poultices and mortars for salt contaminated masonry and stone objects

Michael Auras

Institute for the conservation of stone, Mainz, Germany

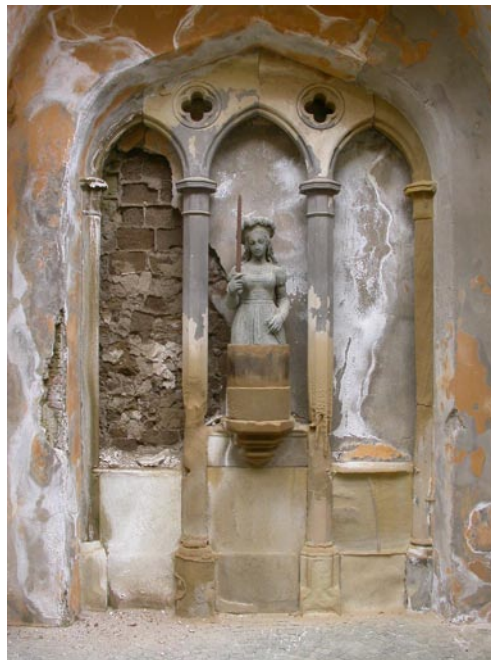
Figure 1: The metallic sculpture of Joan of Arc resists salt crystallisation while sandstone archery and lime rendering deteriorate at the garden wall of Stolzenfels Castle.

Historic buildings and monuments made up of natural stone or brick often show deterioration phenomena caused by soluble salts (Fig. 1). Whenever water penetrates porous building materials the available soluble salts are mobilised. The different salts, their transport mechanism and the deterioration processes caused by them are discussed elsewhere in this volume. Two possibilities to handle salt contaminated objects are discussed. The main topics covered are the application of poultices and the selection of appropriate mortars and renderings.

As another example, Stolzenfels Castle should be mentioned. On the ruins of a mediaeval castle a summer residence for the later King of Prussia, Friedrich Wilhelm IV, was built in the years 1832 – 1842. Mortars used both in the Middle Ages and in the 19th century are mixtures of hydraulic lime with an aggregate of sand, greywacke fragments and large amounts of pumice. The latter gives rise to nearly omnipresent efflorescence of sodium sulphate, since sodium is extracted from pumice wherever water penetrates the masonry. Most of sulphate probably was deposited as air pollutant as the Rhine valley in which Stolzenfels is situated was an important travel way for cars, trains and ships and correspondingly air pollution was quite high in the 19th and 20th century. Part of the sulphate even might originate from the oxidation of pyrite which is an accessory mineral in the greywacke used as building stone. In the garden wall, which is focussed here, additionally high amounts of nitrates are present. The garden wall is several meters high and about 2 m thick. Its crest had been leaking for many years. Water penetrated the wall and led to salt efflorescence and severe damage on renderings and sandstone elements (fig. 1).

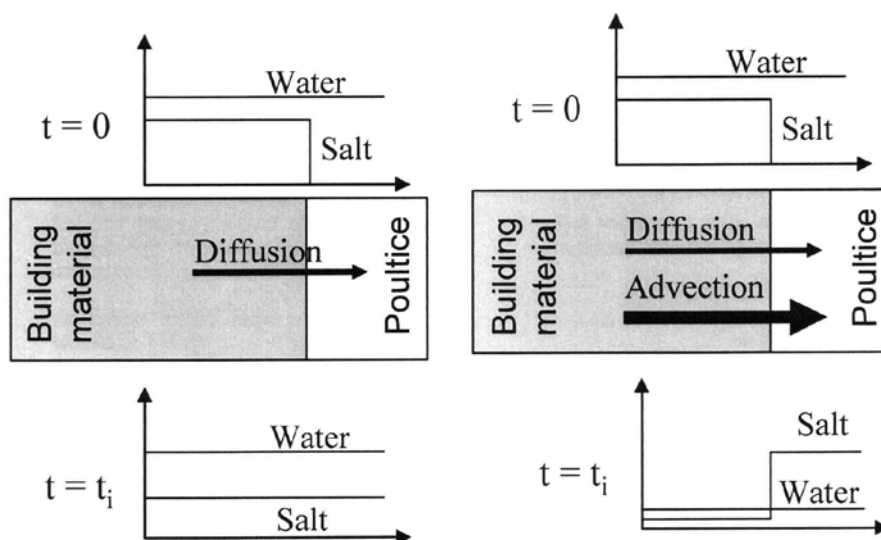
Figure 2: Functional principles of poultices: wet poultice (left), drying poultice (right). From WTA-Recommendation 3-13-01/E.

Covering a poultice with polyethylene foil after application prevents the loss of water by evaporation. In the first stadium part of the water is sucked off from the poultice into the stone substrate by capillarity. Crystalline salts present in the pore space dissolve in the infiltrating water. In the second stadium the prevention of evaporation keeps the water content in the poultice and in the stone nearly constant. Part of the dissolved salts is transported into the poultice by ionic diffusion (Fig. 2, left side). Ionic diffusion through the pore space of natural stone is very slow and thus salt reduction takes its time. A regular replacement of the poultice every few days is recommended to keep the gradient of salt concentration between masonry and poultice high. An exchange is also necessary to avoid mould. The proportion of salt which can be removed by poultices depends on the ratio of the amounts of water in the poultice and in the stone substrate.

Drying poultices shift the zone of evaporation of water from the stone surface (or subsurface) into the poultice. Thus salts crystallize in the poultice where pore water evaporates. The salts are transported into the poultice by capillarity as well as by ionic diffusion (Fig 2, right side). When the drying process continues, water supply from the stone into the poultice declines and the evaporation front slowly moves from the surface of the poultice into its interior parts and finally back into the stone surface. Then the poultice should be removed, because the salt supply from the substrate into the poultice is finished. Usually the drying of the poultices takes three or four weeks.

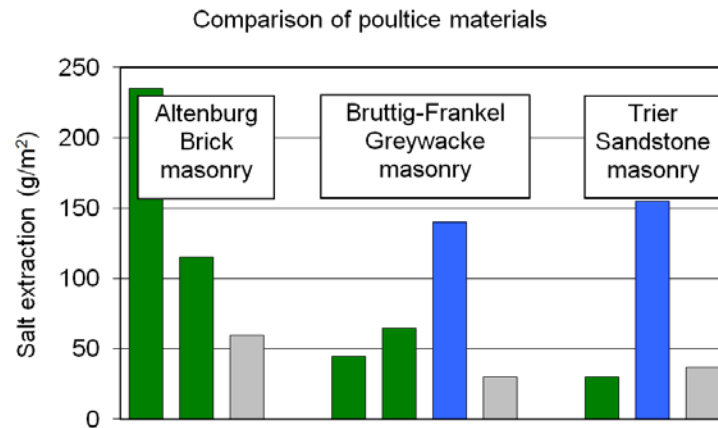
Figure 3: Comparison of salt extraction by different poultice materials: bentonite (green), kaolinite (blue), cellulose fibres (grey). Results of field experiments on masonry made of brick (Altenburg, sum of 2 poultice cycles), greywacke (Bruttig-Frankel, 1 cycle, data from Egloffstein & Auras, 2000) and sandstone (Trier, 2 cycles, data from Auras & Melisa, 2002).

Poultices must be very water absorbent. They have to retain water to a certain extent to regulate the evaporation velocity. They should also have high specific surfaces and a high ion exchange capacity to adsorb salts. In most cases effectiveness of salt extraction is higher for poultices containing clay minerals than for those containing only cellulose fibres (Fig. 3).

Figure 3 shows the results of three field tests with different poultice materials. The diagram shows that kaolinite seems to work somewhat better than bentonite. To confirm this, laboratory tests have been carried out in a cooperative project with the University of Weimar (Goretzki & Terheiden, 2003). Sandstone prisms were first immersed in saturated solutions of different salts. The prisms were then sealed on five sides and on the sixth side they were covered by a poultice. Evaporation could only take place from the side with the poultice. After several weeks the weight of the samples remained nearly constant. The poultices were then taken off and their salt content was analysed. The sandstone prisms were cut into slides and their salt content was analysed at different depths. The results showed that the difference between kaolinite and bentonite depended on the kind of salt used. Figure 4 shows two exemplary diagrams.

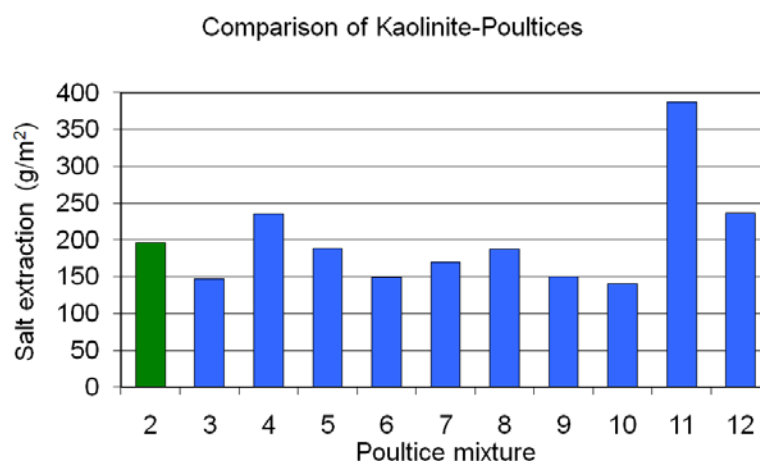
Figure 5: KNO_3 content in kaolinite poultices of different compositions after drying of salt contaminated sandstone prisms in laboratory tests. Number 2 and 3 are commercial bentonite and kaolinite poultices. The composition of the other poultices is given in table 1.

In the next step, with a similar test set-up as described for figure 4 some variations of the mixture of kaolinite poultices were tested. Two commercial poultices on base of bentonite (Nr. 2) and kaolinite (Nr. 3) were included. For the other poultices the proportions of kaolinite, cellulose and sand were varied systematically (table 1). In two poultices quartz sand was replaced by pumice. Also two types of cellulose fibres have been compared: According to the manufacturer's indication, Arbocel BC 1000 has an average fibre length of 700 μm and a water absorption of 990 wt.-%. For Arbocel BWW 40 the fibre length is 200 μm and the water absorption is 580 wt.-%. After 6 weeks of evaporation, the salt content of the poultices was determined by electrical conductivity of aqueous eluates. Additionally tests on leaching and washing out pumice have been carried out to exclude an influence of soluble ions set free from pumice. Figure 5 shows minor variations of the poultice mixture having minor influence on the result of salt extraction. The replacement of sand by pumice, however, has a significant effect.

Table 1: Composition of poultices shown in figure 5.

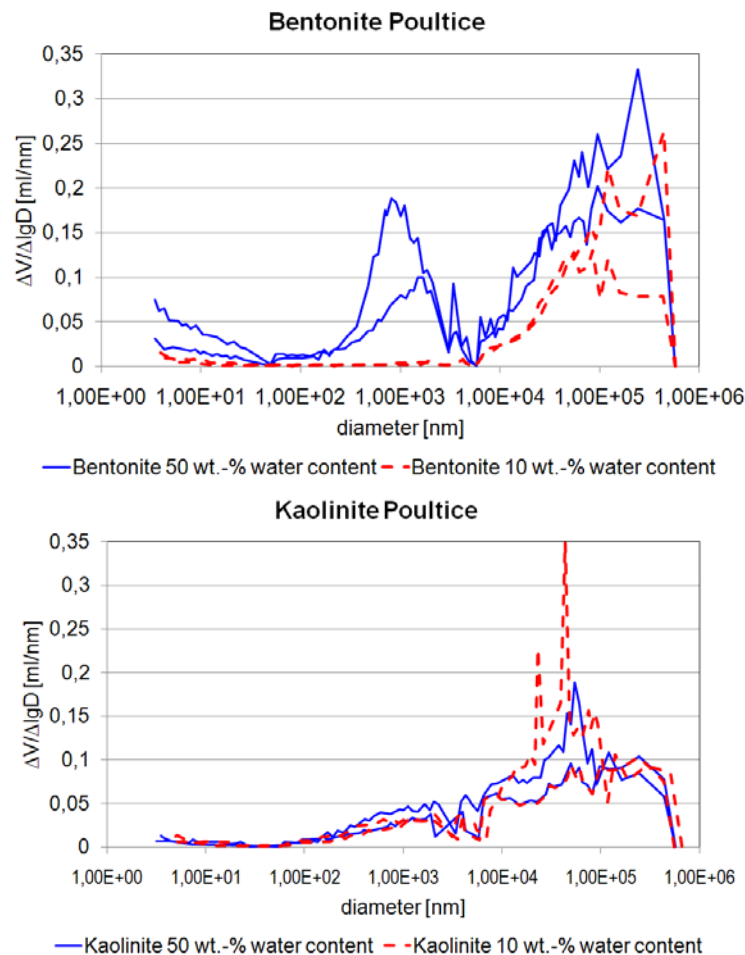
Figure 6: Pore size distributions of bentonite (upper) and kaolinite poultices (lower diagram) of different moisture content. Two of four measurements for each material and moisture content are shown. Data: Geological Institute of the University of Karlsruhe.

Institute of the University of Karlsruhe. Both poultices had been composed of similar proportions of quartz sand, cellulose fibres and bentonite or kaolinite. In Figure 6 for each material and water content two curves are drawn to show the scatter of single measurements. Despite this variation some observations are possible. The main difference between the two poultices seems to be a distinct change of total porosity and pore radius distribution of the bentonite poultice during drying. Especially the pores of micrometer size vanish. The pore radius distribution of the kaolinite poultice in the wet state is similar to the bentonite poultice but total porosity is lower. Unlike bentonite the pore size distribution of the kaolinite poultice remains nearly constant during drying and the pores of micrometer size remain stable. Because the small pores exert high capillary pressure it is expected that the soaking of moisture from the stone into the kaolinite poultice remains active at low moisture content during drying.

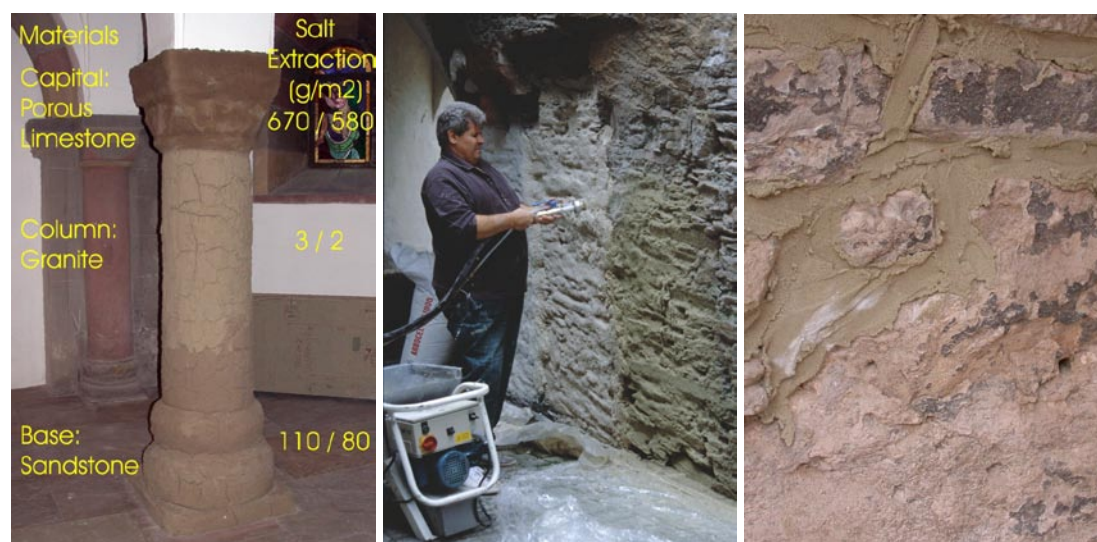
Figure 7 (left): Salt reduction at a column in the crypt of the church of St. Goar. Numbers show the amount of salts extracted by the first two cycles of bentonite poultices.

Figure 8 (middle): Application of different types of poultices with a plastering machine (from Egloffstein & Auras, 2000).

Figure 9 (right): Desalination of joints with bentonite poultice.

Some experiments have been made with the application of poultices by plastering machines (Egloffstein & Auras, 2000; Auras & Melisa, 2002; see also Fig 8). While manual application is preferred for sculptures and other pieces of art, application by plastering machines allows the treatment of larger parts of a building.

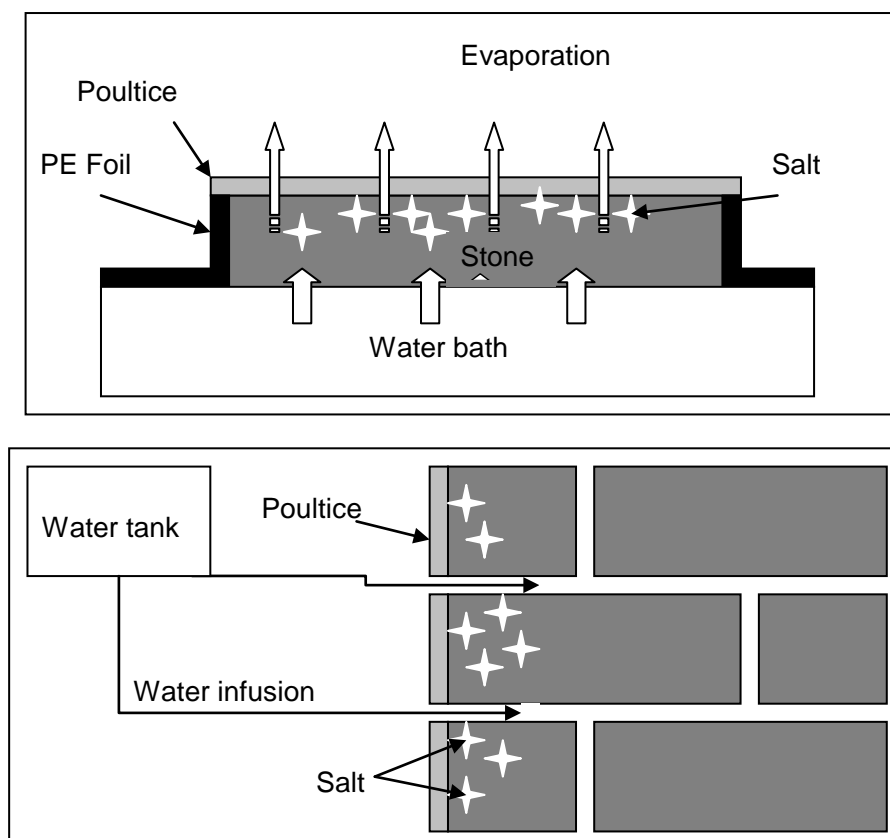
Figure 12: Pictorial schematics of unidirectional water transport through stone objects into a poultice from water bath (upper picture) and by water infusion (lower picture).

The most effective enhancement of salt extraction by poultices seems to be the installation of unidirectional water transport through the stone into the poultice. Figure 12 shows pictorial schematics of some possible variations. Examples have been published by Ettl & Schuh (1992), Friese & Hermoneit (1993) and Siedel (2005). Also, if salt is extracted by immersion in a water bath it is recommended to apply poultices during evaporation.

The best way to enhance the efficiency of salt extraction is the combination of poultices with water advection from the rear side through stone into poultice (fig. 12).

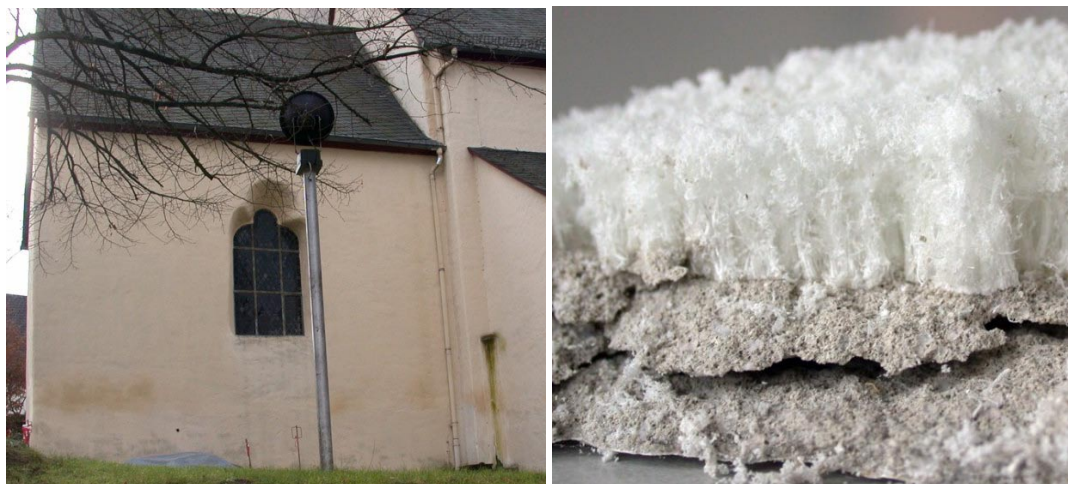
Figure 13 (left): Humidity and salts ascend behind a cementitious renovation rendering and now have reached the zone above the newly rendered basal zone.

Figure 14: Porous renovation rendering spalled off the wall by efflorescence of mirabilite.

So far the theory. In practice, these renderings often work successfully for a long time if the supply of water and salt is low. But if water availability remains high, evaporation in the pore space and water vapour diffusion through the pore space is not able to remove all the water. In this case, the water content in the masonry can increase slowly until humidity rises over the zone rendered with these materials. Then humidity, salt solutions and damage reach zones further up in the facade which had often been intact before (fig. 13). The newly added material, i.e. the renovation mortar remains intact while the historic and often original materials get destroyed. Furthermore, if water supply is rather low but salt content is very high, new damage can occur in the form of spalling or flaking of the new rendering (fig. 14).

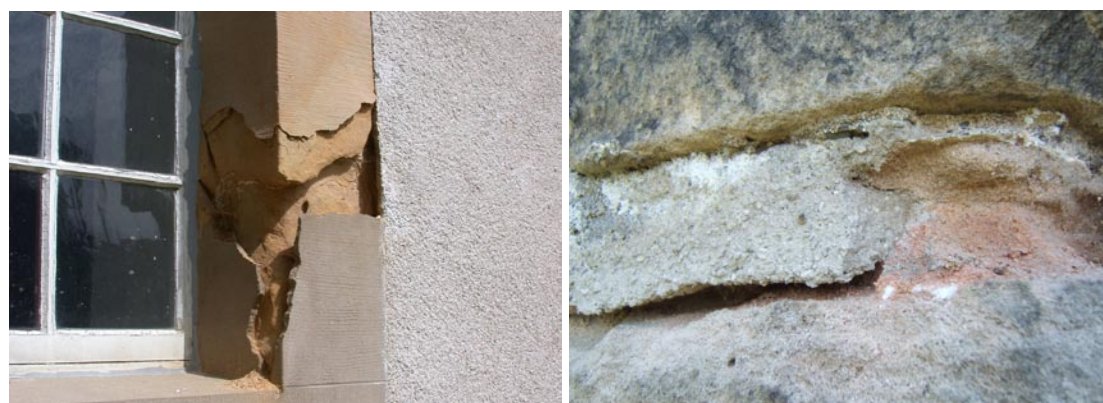
Figure 15 (left): The wall is covered with a water-repellent rendering, deteriorated parts of the sandstone elements had been replaced by dense cementitious mortar. The sandstone frame is the only place where water can evaporate, so transport of water and salt is redirected into the sandstone. Severe damage is the result of the high concentration of salt in the sandstone.

Figure 16 (right): Deterioration of sandstone in contact with cementitious repointing mortar.

Another problem arises on facades where rendered areas are combined with unrendered parts like ashlar or door frames of sandstone or other materials of high capillarity. On surfaces covered by hydrophobic plaster the evaporation of moisture can only proceed slowly by water vapour diffusion through the pore space of the plaster. In sandstone, moisture is transported much faster to the surface by capillary forces and evaporation takes place at the surface. As a consequence the transport of water and salt in the masonry is redirected into the zones with high evaporation rates. After a while salts get enriched in these uncovered sandstone elements, and deterioration proceeds in an accelerated way (Fig. 15).

usually are denser and stronger. Repointing often is carried out with dense and hard cementitious mortars. In many cases they are put on the surface of joints filled with porous, weak and capillary active lime mortars which were used as original building material. Water transport from the interior parts of a wall to the surface is reduced. In such cases water and salt usually find a way through the stone alongside the joint if the stone is porous. This can lead to severe damage of the stone in contact to the joints (Fig. 16).

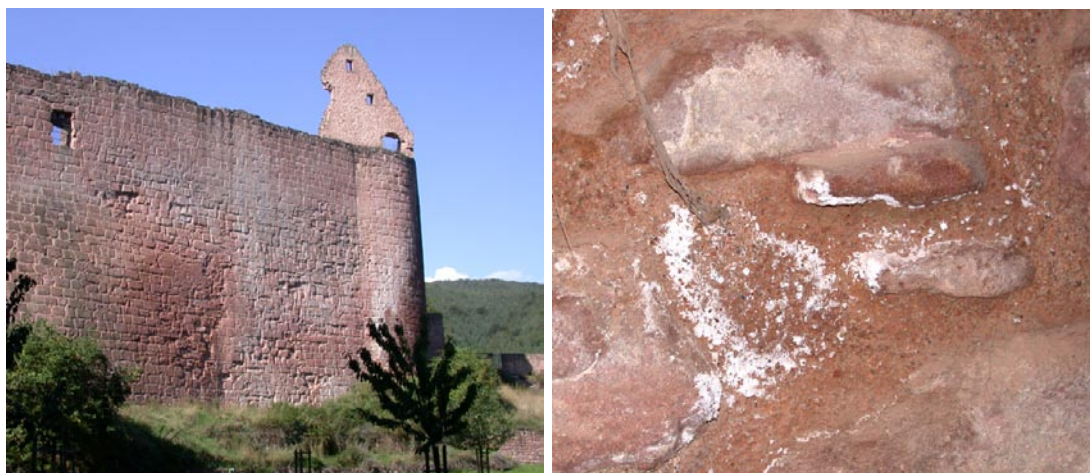
Figure 17 (left): Sandstone wall from Hardenburg Castle with salt efflorescences and hygroscopic moisture stains.

Figure 18: Salt efflorescence occurs predominantly on the surface of repointing mortar.

At Hardenburg Castle, large areas of sandstone masonry had to be repointed in the 1990s. Most of the masonry was contaminated by salts, predominantly nitrates (Fig. 17). Because very large areas had to be treated, repointing by machine was preferred to manual application. In many similar cases where mortars based on cement and trass had been used, severe damage of sandstone blocks had been observed after years because these mortars had been very dense and strong. Therefore it was decided to work with lime mortar.

Repointing was carried out as shotcrete, but for the first time – at least in our region - a NHL mortar instead of cementitious mortar was used in this way. Brick-dust was added to obtain a reddish colour correspondingly to the sandstone. Samples taken from a test area were examined. The high pressure application led to an intensive compression of the mortar which in turn gave rise to an increase of compression strength up to about 5 MPa after 28 days of curing. After more than 10 years a detailed inspection was carried out. Some problems had occurred at the wall crest. These seem to be caused by thermal effects and the absence of expansion joints. On the whole the mortar and the masonry was in a good condition. In salt loaded areas salt efflorescence occurred predominantly on the surface of mortars but only to a minor extent on sandstone surface (Fig. 18). It is evident that porosity and capillarity of the lime mortar is still there despite the high pressure application. But due to this application the strength of the mortar is high enough to withstand salt crystallisation until now.

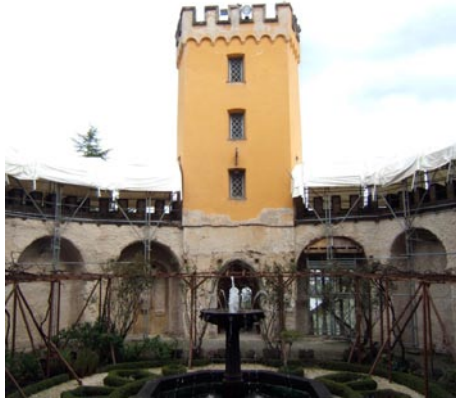
Figure 19 (left): Garden wall of Stolzenfels Garden protected by a sacrificial rendering of NHL mortar.

Because actual reinstatement work outside the garden will take about a year, the salt contaminated render from the 19th century was taken off to enhance drying of the wall and the wall crest was protected against rain by a tentlike roof. While drying, the wall is covered by a NHL render which was applied as a sacrificial layer (Fig. 19). Parts of the medieval plaster are preserved under the NHL plaster. Between historic and sacrificial rendering a paint of slaked lime was applied to allow easy removal of the sacrificial layer. After seven months some samples were taken from the sacrificial layer to check salt ingress. Figure 20 shows that at different parts of the wall various proportions of alkaline nitrates, sulphates and chlorides had migrated into the sacrificial layer.

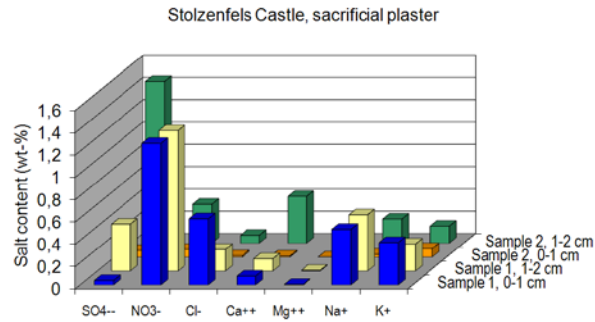
Figure 20 (right): Salt content of sacrificial lime rendering after seven months.

In zones with new efflorescence or hygroscopic moisture, amounts of salts between 80 and 800 g/m² are found in the upper centimetre of the lime render up to now. After removal of the sacrificial layer the walls will be repointed and rendered either with modified kinds of renovation mortar according to WTA or with NHL mortar, depending on their specific salt and moisture content. The final layer will be NHL renderings whose colour, grain size and surface structure is adapted to the different kinds of historic renderings. In many zones with less pronounced moisture and salt load, historic renderings will be preserved and complemented with NHL mortar.

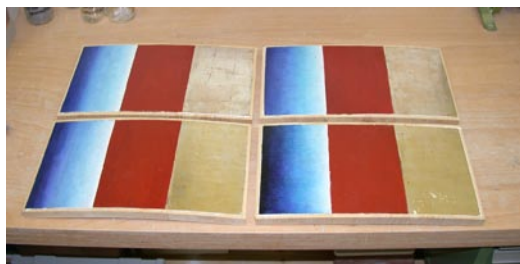
Figure 21: Dummies for desalination tests.

Various materials were tested as back side coating suitable for salt extraction. Finally test specimen of wooden panels with canvas, chalk grounding and different paint layers were prepared by Wehrsig (Fig. 21). Silver gilding was selected as the material with lowest permeability, red egg tempera correlated best with the original paint and a blue and white field of tempera and watercolour simulated the retouching of the 1970s. These dummies were contaminated with a saturated salt solution which contained a mixture of ions similar to the one found in the old coating. After drying two materials which had performed best in the pre-tests were applied on the back side of the dummies. The compositions of the two coatings are given in table 3.

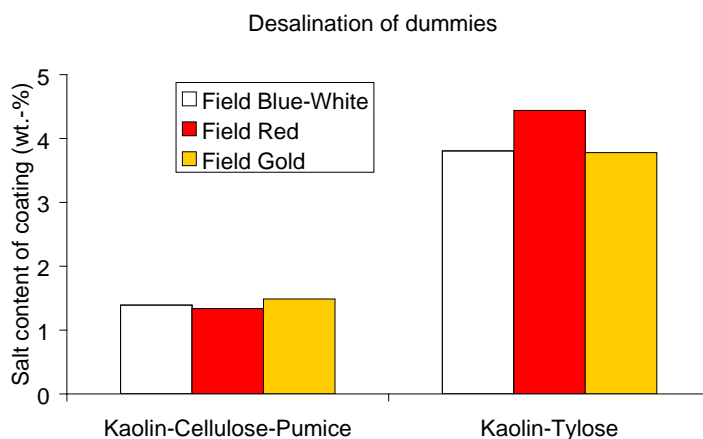
Figure 22: Salt content in the coating of dummies.

After a drying phase of several weeks under laboratory conditions (23°C / 65 % rh) the coatings were removed from the dummies and their salt content was analysed. From the results shown in figures 22 and 23 it becomes evident that kaolin with tylose worked better than the coating composed of kaolin, cellulose fibres and pumice. About 60 wt.-% of the extracted salt was nitrate. The sort of paint layer on the front had a minor influence on the salt reduction.

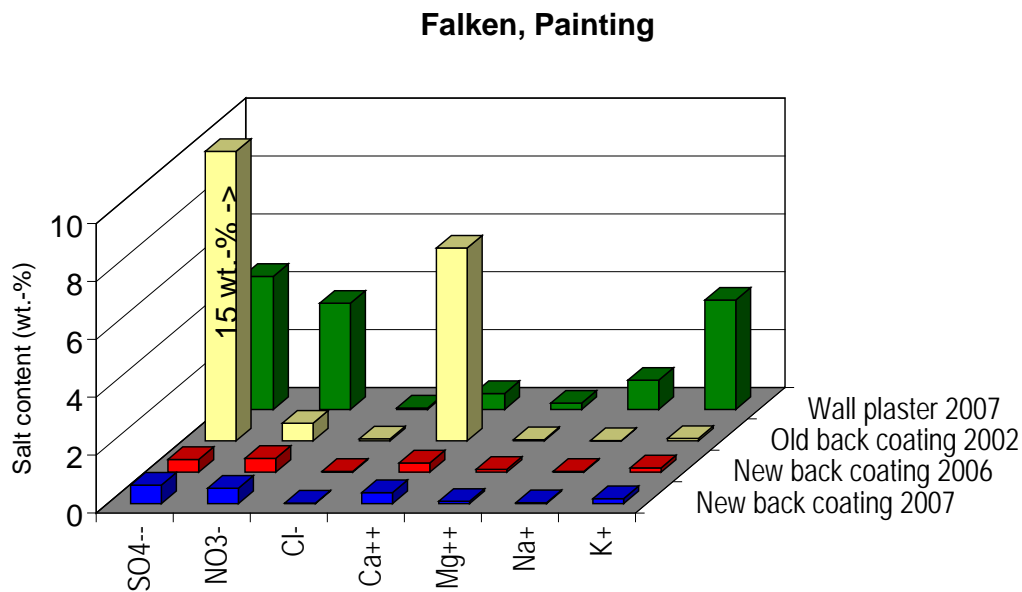
Figure 23: Salt content in the wall plaster and in the old and new backside coatings of the painting.

Based on these results a new kaolinite-tylose back side coating was applied in 2005 when the painting returned to the church after restoration. In 2006 and 2007 samples of the coating were analysed (Fig. 23). A continuous migration of salts from the wood into the coating was observed, and so the coating was exchanged again in 2007. The state of the painting and the progress of desalination have to be controlled thoroughly for the next years.
