EXAMPLES OF STONE DECAY DUE TO SALT EFFLORESCENCE

A. E. Charola,* S.Z. Lewin**

DETERIORATION AND PRESERVATION OF STONES

Proceedings of the 3rd International Congress

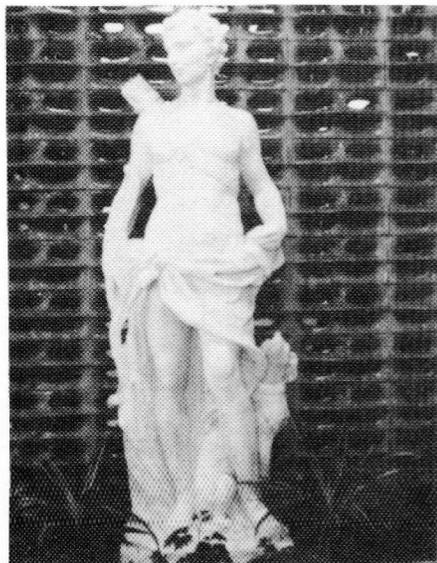
Figure 1 shows two recent, life-size sculptures of finegrained Italian limestone that were mounted indoors in close proximity to potted plants and a water-curtain type of recirculating fountain. During the first ten years after installation of this statuary, there were no signs of any decay. During the tenth year, the surface of the stone was cleaned with solutions of sodium hypochlorite and detergent; shortly thereafter surface blistering began to be noticed, and within a period of about three months the kind of massive decay shown in Figure 2 developed.

Fig. 1A - Male figure in Italian limestone, with water-curtain at rear and plantings near base.

Thus, it becomes clear that water spray from the recirculating fountain had leached sodium sulfate from the soil, and capillary action drew this salt solution into the stone. The fact that the stone decay is most severe at the base, diminishes with increasing height, and had increased progressively with time, further support this interpretation.

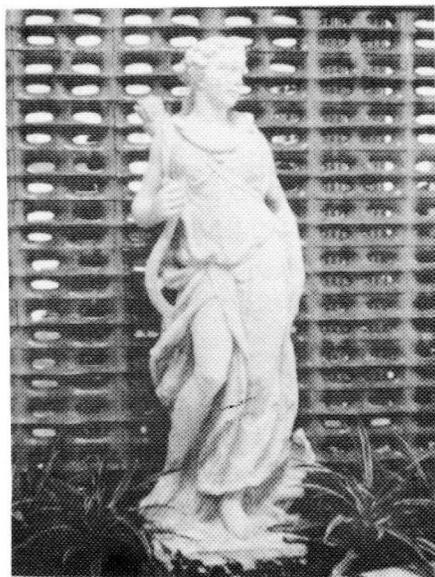
Fig. 1B - Female figure at other side of water-curtain.

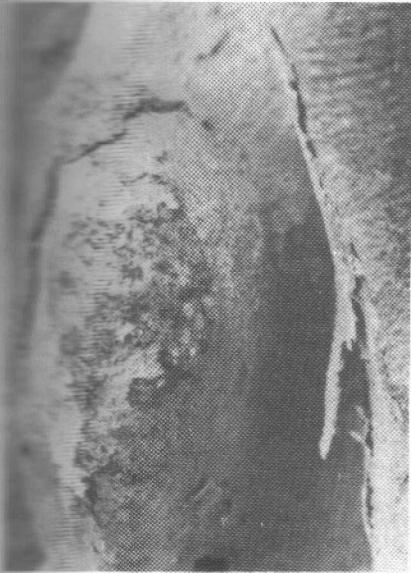
Fig. 2A – Detail of the salt decay near base of statue of Figure 1A.

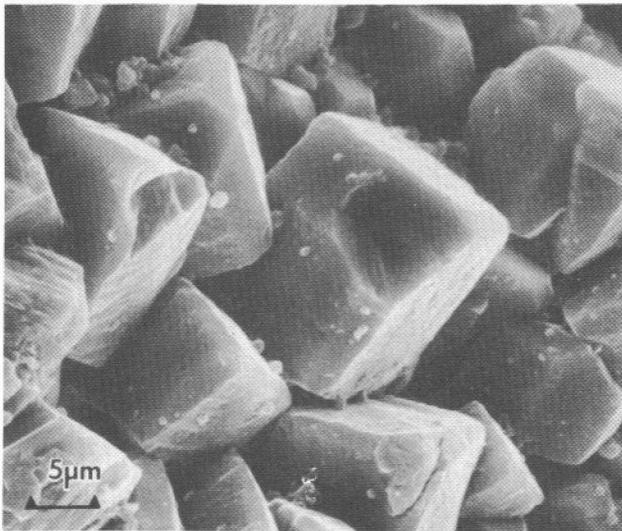
Analysis of the stone showed it to be a quite pure calcitic limestone, with only trace amounts (less than 1%) of quartz and clays. The calcite crystals are well-developed and about 10 micrometers in dimensions in some parts of the stone (Fig. 3A), and very imperfectly formed and small, 0,2-1 μm (Fig. 3B), in other parts. The calcite grains are weakly indurated, and the stone is quite porous.

Fig. 3A – Coarse calcite crystals composing parts of the stone of the statuary of Fig. 1A and B.

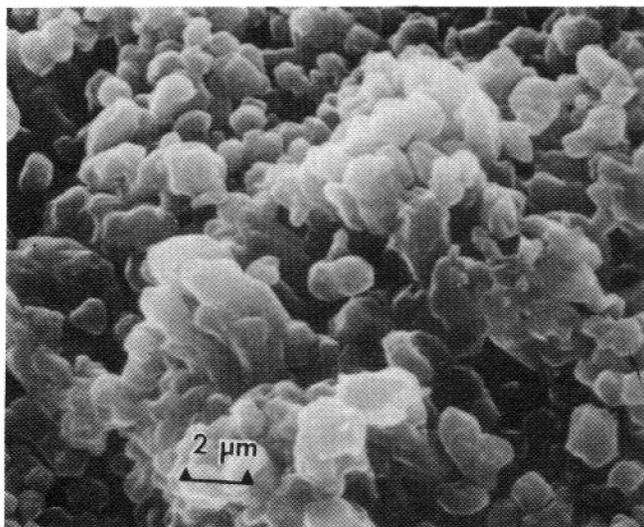
Fig. 3 B. – Finer calcite crystals composing bulk of the stone.

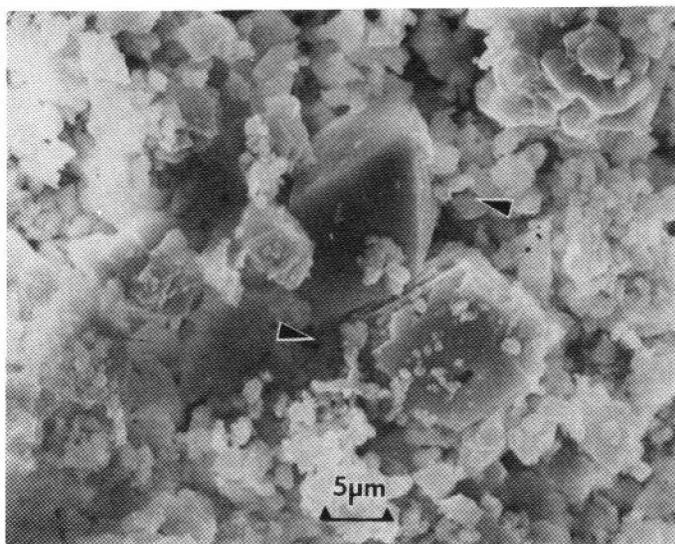
Examination of exfoliation flakes and scrapings of the surface efflorescence disclosed the presence of thenardite, Na_2SO_4 . The presence of crystals of this salt in the pores of the stone flakes is evident in the micrograph of Figure 4. Positive identification was based upon the x-ray diffraction pattern and wet chemical analysis. No other substance was found in the decayed parts.

Fig. 4. – Crystals of thenardite (arrow) in pores of limestone statuary damaged by efflorescence.

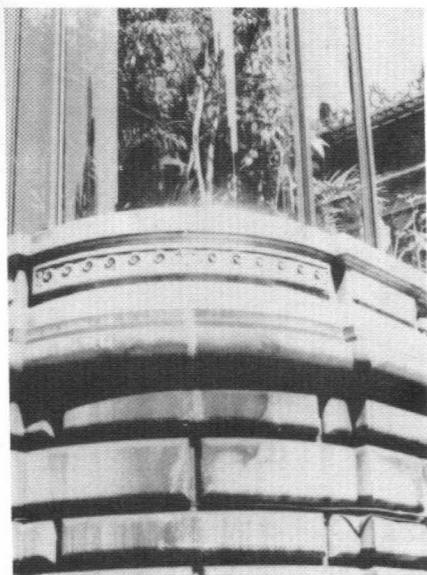
Figure 5 shows a view of a granite wall that is being severely damaged by blistering. This wall supports an indoor conservatory for potted plants. The granite is a good grade of dense, crystalline stone, composed of quartz, feldspars, and micas.

Fig. 5A – Conservatory above granite wall at Cooper-Hewitt Museum, N.Y.C.

Thus, it is clear that the source of the granite decay is dicalcium phosphate that was leached out of the soil in the flower pots housed directly above the victimized stone.

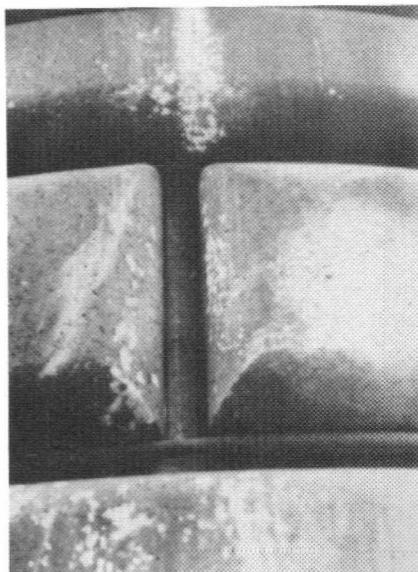
X-ray powder diffraction patterns showed the presence of brushite, $\text{CaHPO}_4 \cdot 2\text{H}_2\text{O}$, and that this was the sole nonindigenous material detectable in the stone flakes or in aqueous extracts from these flakes. (It should be noted that components present to the extent of less than about 1-3% by weight generally do not contribute detectable lines to the x-ray pattern).

Fig. 5B – Detail of stone decay due to phosphate-containing leachings from flower pots in conservatory.

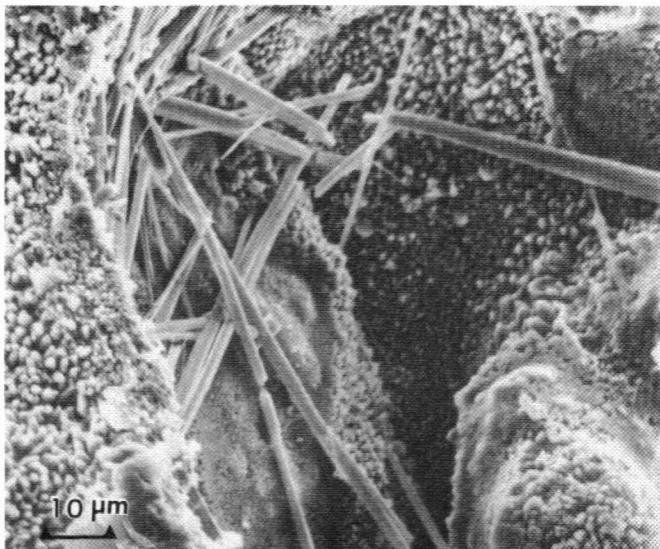
Fig. 6A – Micrograph of brushite efflorescence on granite. The needle-like habit is similar to that commonly noted for gypsum in efflorescences, particularly on siliceous substrates.

The microscopic appearance of brushite in efflorescences is also indistinguishable from that of gypsum, as shown in the SEM micrographs of Figure 6.

Thus, it is clear that the possible presence of dicalcium phosphate should be considered in stone decay problems, and care must be taken to avoid confusing it for gypsum, and *vice versa*. For this reason, it is recommended that the phosphomolybdate test be employed whenever gypsum is suspected.

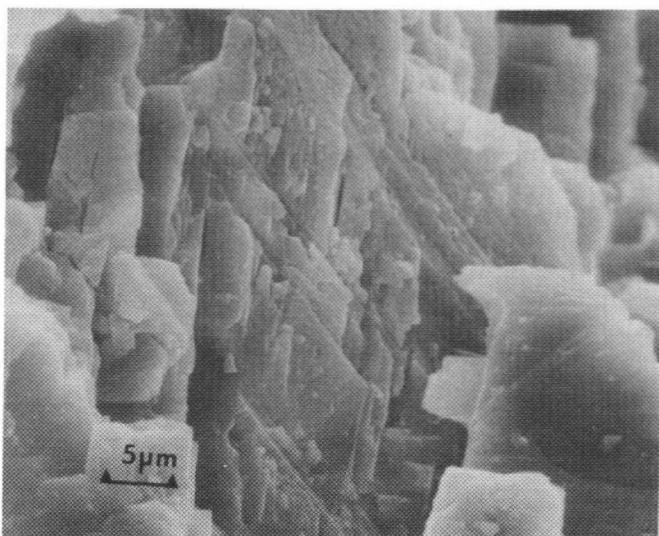
Fig. 6B – A second habit of brushite on granite is similar to the rhombic plates and prisms commonly seen in gypsum deposits on calcitic substrates.

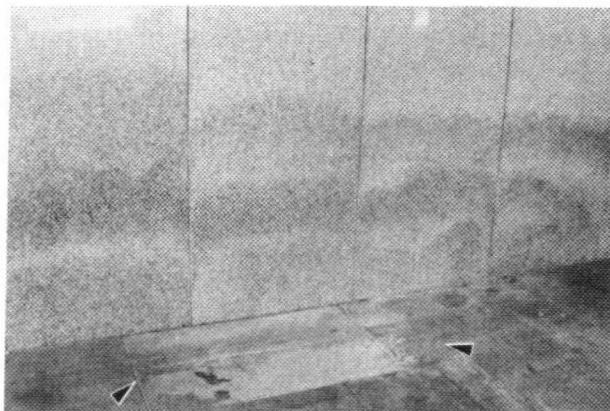
Figure 7 shows an example of the deterioration of high quality, black, polished granite in an office building courtyard due, in one section, to the migration into the stone of leachings from bags of

portland cement which had been stored adjacent to the wall while repairs were being made elsewhere. The decay consists in a roughening and discoloration of the stone surface from the base upwards for a distance of about 0.5 meters. At the top of this zone the granite shows a line of white, feathery efflorescences and of exfoliation.

Fig. 7. – View of wall of granite panels disfigured by efflorescences due to cement bags (arrow shows cement residue on floor) and de-icing salts.

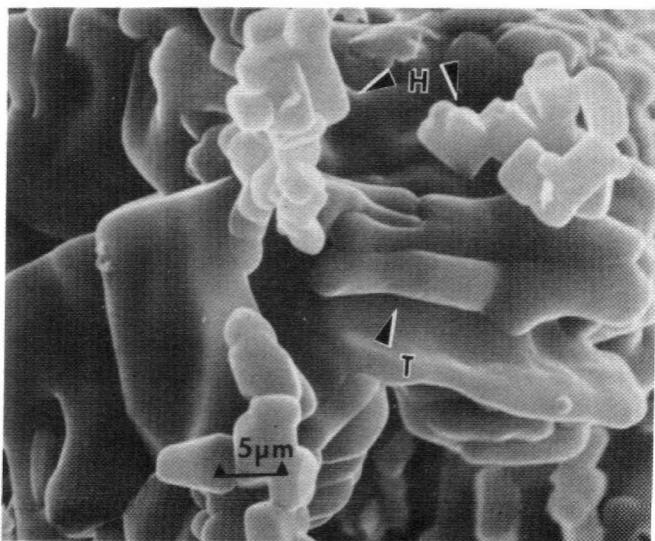
X-ray powder diffraction analysis of these efflorescences discloses the presence of trona ($\text{NaHCO}_3 \cdot \text{Na}_2\text{CO}_3 \cdot 2\text{H}_2\text{O}$), apthitalite ($\text{K}_3\text{Na}(\text{SO}_4)_2$), sylvite (KCl), and halite (NaCl). Figure 8 shows the appearance of some of these scrapings.

Fig. 8. – Micrograph of the efflorescence on granite wall near where bags of cement had been stored, showing alkali halide (H) and trona (T) crystals.

We have shown previously¹ that trona and aphthitalite efflorescences are characteristically the result of water percolating through cement. Aphthitalite may also come from other sources, but trona does not. The other components of the efflorescences, viz., the alkali halides, have as their origin the salt that was employed to melt snow and ice in the courtyard during winter weather. The efflorescences are found on all the wall panels; the efflorescence containing trona is only found on panels near where the cement bags had been stored.

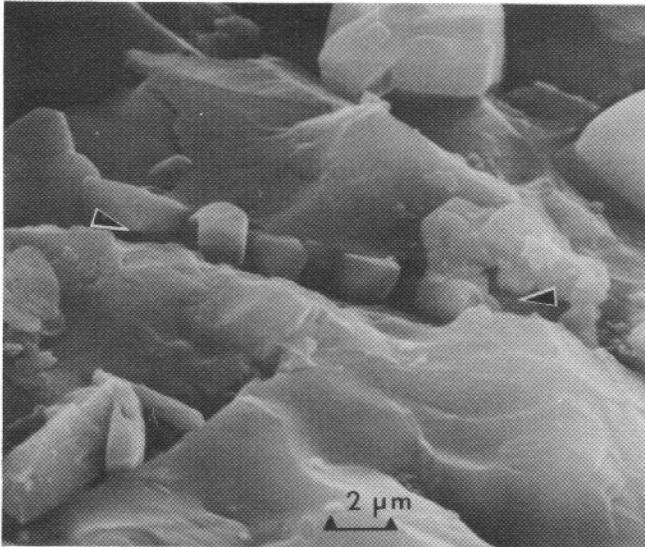
Fig. 9 – Micrograph of underside of a granite exfoliation flake, showing a row of cubic alkali halide crystals (arrow) in a crack in the stone.

This case shows how damaging any source of soluble, crystallizable material can be, even to mechanically strong and chemically stable stones, such as granite. Figure 9 shows a portion of an exfoliation flake of this granite, taken from an area where the alkali halides were the predominant salt in the efflorescence. A row of these cubic crystals is present in a crack; it is in fact the formation and growth of such crystals that creates and enlarges cracks, and produces the eventual decay.
