Numerical analysis on salt damage suppression of the Buddha statue carved into the cliff by controlling the room temperature and humidity in the shelter

Abstract

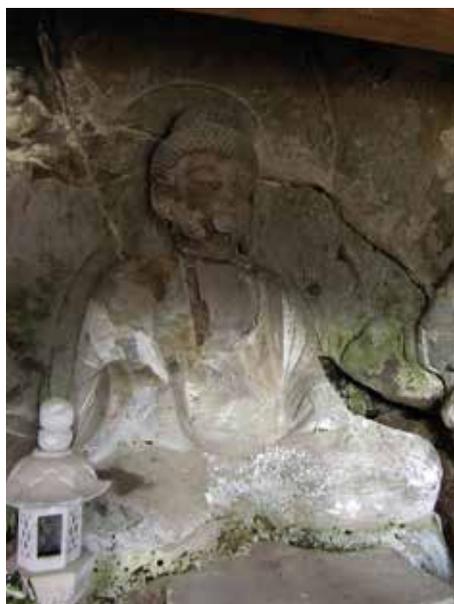
Figure 1: Motomachi Sekibutsu

Motomachi Sekibutsu (Fig. 1) is a stone statue of Buddha that consists of tuff and was carved into a cliff in Oita City, Japan, during the 11th or 12th century. The statue is constantly affected by the hygrothermal environment in the room and heat and moisture transfer through the cliff (from which it cannot be separated). Therefore, the statue has suffered salt damage, exfoliation and growth of mould and bryophytes.¹ Salt damage, caused by so-

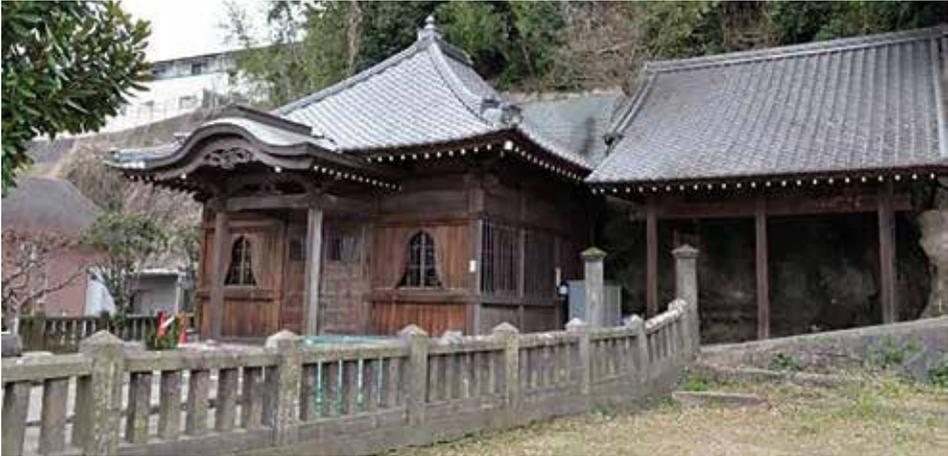
Figure 2: Shelter exterior

dium sulphate, has long been a concern. To prevent these deteriorations, various preservation measures have been undertaken from 1986 to 1996 and again from 2011 onward. These include constructing a shelter (Fig. 2), boring a tunnel behind the statue to reduce groundwater and renovating the shelter. Salt damage by sodium sulphate is considered to be halted as a result of the shelter renovation during November 2015.²

At Motomachi Sekibutsu, the shelter was renovated twice, in 1995 and in 2015. In 1995, various construction works were done to improve thermal insulation, such as insulating the wall by a thermal insulation material and installing a windbreak room at the entrance.¹ In 2015, the renovations focused on salt damage due to sodium sulphate and aimed to protect from solar radiation, improve the performance of thermal insulation and improve the airtightness of the windows.² During that renovation, thermal insulation was improved, a door closure was mounted, the windbreak room was mounted, and the windows were covered with solar shading sheets. In this study, we refer to that renovation as 'the renovation'.

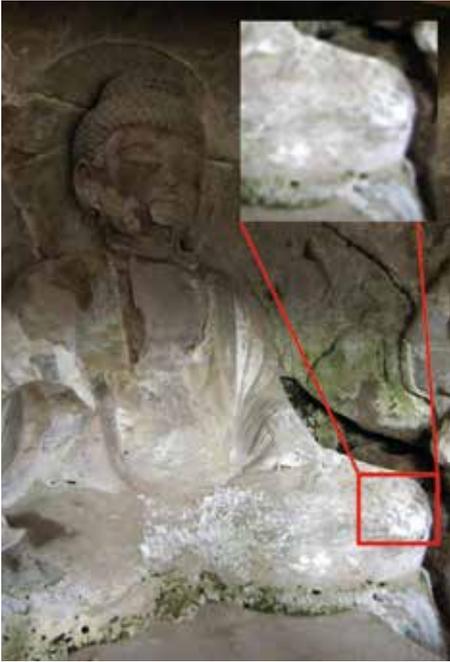
Figure 11: The knee of the statue

At Motomachi Sekibutsu, salt damage can be seen at the knee of the statue (Fig. 11). In this section, we plot the calculated temperature and relative humidity at the surface of the statue on the phase diagram of Na₂SO₄ and examine the possibility of the resulting salt damage. Figure 12 shows the results of Case 1, Case 3 and Case 4, and Fig. 13 shows that of Case 1, Case 2 and Case 5. In Case 2 and Case 5, which are decreased-ventilation-rate cases, the phase change from Na₂SO₄ to Na₂SO₄·10H₂O rarely occurs because the
