Influence of Brick Properties on Salt Crystallization Damage

B. Lubelli^{1,2}, R.P.J. van Hees^{1,2} and J. Larbi¹

¹ TNO Building and Construction Research, Delft, The Netherlands

The paper describes a case study where different bricks, exposed to the same environmental conditions, show a considerable difference in their resistance to deterioration by salt crystallization. Using the condition survey of the church tower in Oostkapelle, the possible relation between the damage and the physical and chemical properties of the bricks was investigated. Bricks showing very serious damage (orange bricks) as well as bricks showing no damage (purple bricks) were sampled and characterized mainly by polarization and fluorescence microscopy. The type and the quantity of salts present in the different bricks were also investigated. The observed damage was evaluated in the light of the results obtained from the analysis performed and a relation between the quality of the original material and the firing conditions of the brick to its susceptibility to salt decay could be drawn.

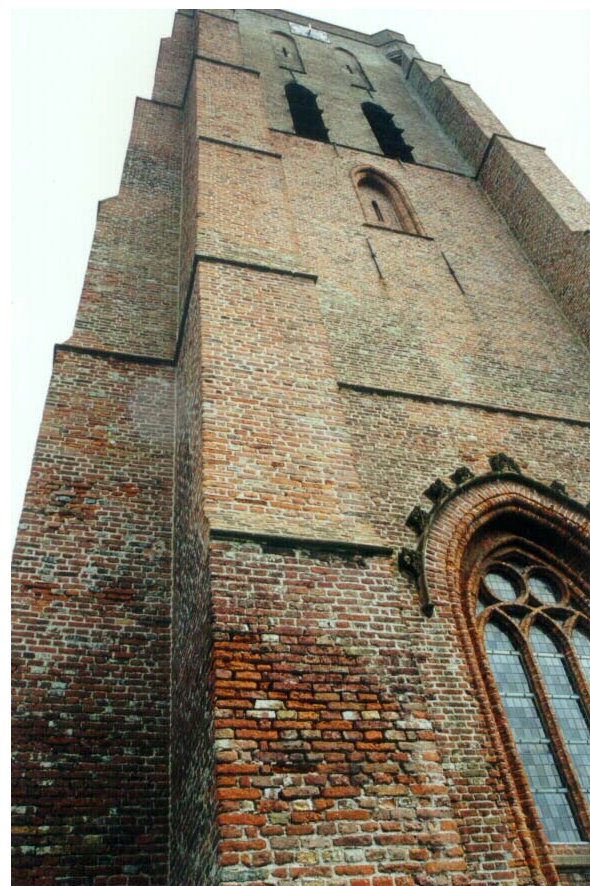
Figure 1: Tower of the church of Oostkapelle

The study object was the tower of the church in Oostkapelle, in the province of Zeeland, in the south west of The Netherlands. This province was flooded by the sea several times over the centuries. The last severe flooding took place in 1953. The tower (Fig. 1), erected at the end of the 14th century, is the most ancient part of the church. Although the water did not reach the church and the tower during the flood, thanks to their position on an artificial slope, a high sea salt concentration is supposed to be still present in the soil. Therefore, after 1953 sea flooding the tower underwent a last restoration in 1954-57.

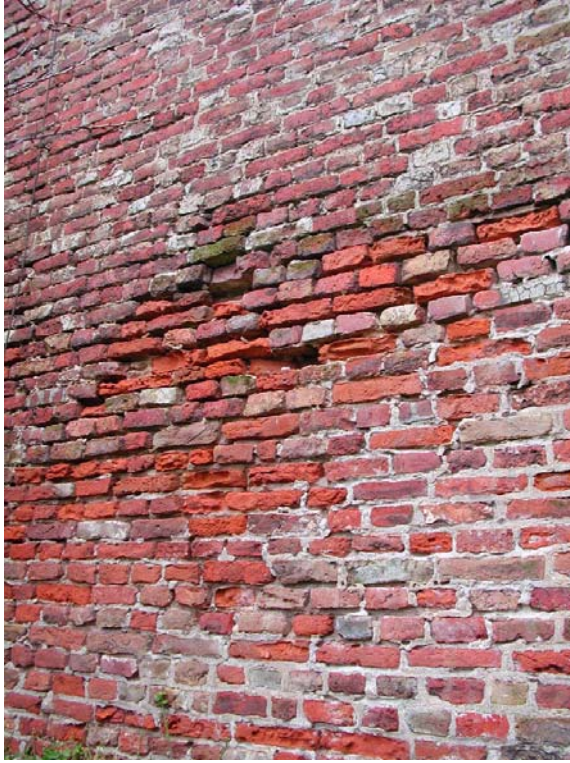
The most serious damage is visible on the west side of the tower, at a height of about 3-4 m where the mortar has been completely lost and the bricks fall apart. In all the affected parts of the tower, a difference in damage can be noticed between the darker (purple) and the lighter (orange) coloured bricks: the first showing no damage, the second suffering powdering and erosion (Fig. 2, 3).

Figure 2: Damage occurring on the west wall of the tower

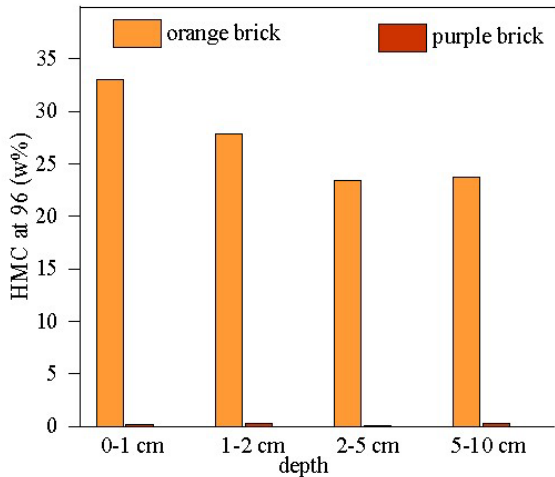
contaminated with hygroscopic salt (for example NaCl) are able to absorb moisture from the air if the RH of the air is higher than the equilibrium RH of the salt (75.5 % in case of NaCl [2]). The HMC is not a quantitative method, but gives a fairly good indication of the presence of hygroscopic salts. The results obtained in this case are reported in Fig. 4. The purple brick had very low hygroscopic moisture content, while the orange brick showed a high hygroscopic moisture content decreasing slightly from the surface towards the interior of the brick. From the high values of the HMC measured in the orange brick, hygroscopic salts, like NaCl, are sup-

Figure 4: HMC at 96 % RH measured on orange and purple brick

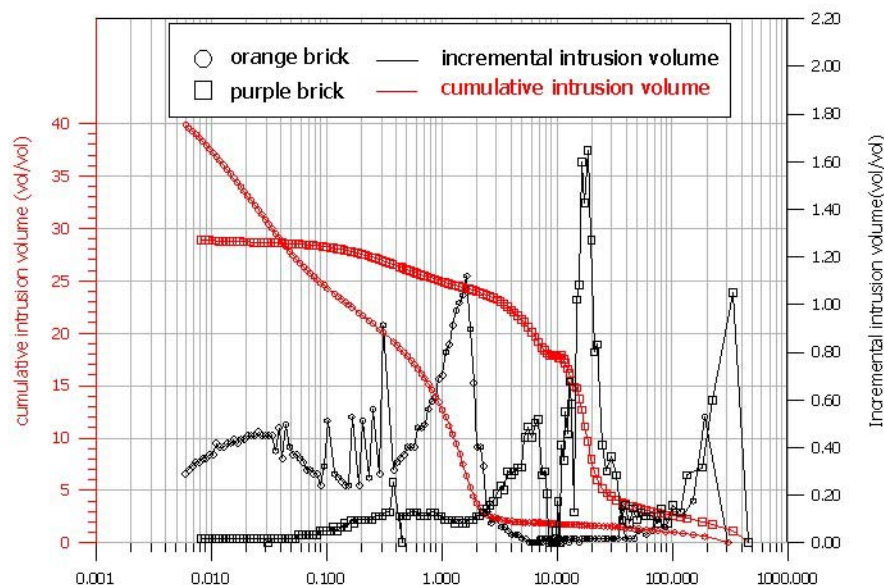
At first the total porosity and the density of both orange and purple bricks was determined by immersion of desalinated brick samples: these measurements showed a very high porosity (40 %) in case of the orange brick and lower values (33 %) for the purple one. However, the total porosity is not a sufficient parameter to evaluate the quality of a brick: also the pore size distribution has to be known to allow the formulation of hypotheses regarding the susceptibility of the material to damage mechanisms. The pore size distribution was measured by means of mercury intrusion porosimetry (MIP) and the results are reported in Fig. 6. The difference between the bricks is very clear:

- the orange brick has a high porosity (40 %) and very fine pores, smaller than 2 μm . A high percentage of the pores is in the range in which capillary condensation is possible ($< 0.1 \mu\text{m}$);
- the purple brick has a lower total porosity (29 %) and coarse pores, in the range of 5 up to 20 μm .

Figure 6: Pore size distribution of orange and purple brick as determined by MIP

The high porosity measured in the orange brick and the presence of very small pores can explain the considerable uptake of salt and the ensuing serious deterioration. The high porosity allows a high moisture (and salt solution) uptake; the presence of small pores slows down the drying while allowing capillary condensation at RH lower than 100 %. Consequently, the material stays wet for a longer time with all the negative consequences that this can have on the damage (susceptibility to frost damage, reduced mechanical strength, possibility of biological growth, etc.). Moreover, the presence of salts in the pores makes the material susceptible to RH changes through the crystallization and dissolution cycles occur whenever the RH of the air crosses the equilibrium RH of the salt; these cycles generate pressure in the material which, if the mechanical strength of the material is overcome, will lead to damage phenomena like powdering. Materials with a high number of pores having sizes between $0.1 \mu\text{m}$ and $1 \mu\text{m}$, like the orange brick considered here, are more susceptible to salt damage [4, 5]. It should also be noted that a high porosity as measured in the orange brick (40 %) often corresponds to a low mechanical strength and therefore to a low resistance to crystallization pressure.
