Edited by
Masaru Abuku, Nobumitsu Takatori

Proceedings of SWBSS ASIA 2023

First International Conference in Asia on
Salt Weathering of Buildings and Stone Sculptures

Nara National Research Institute for Cultural Properties
Nara, Japan

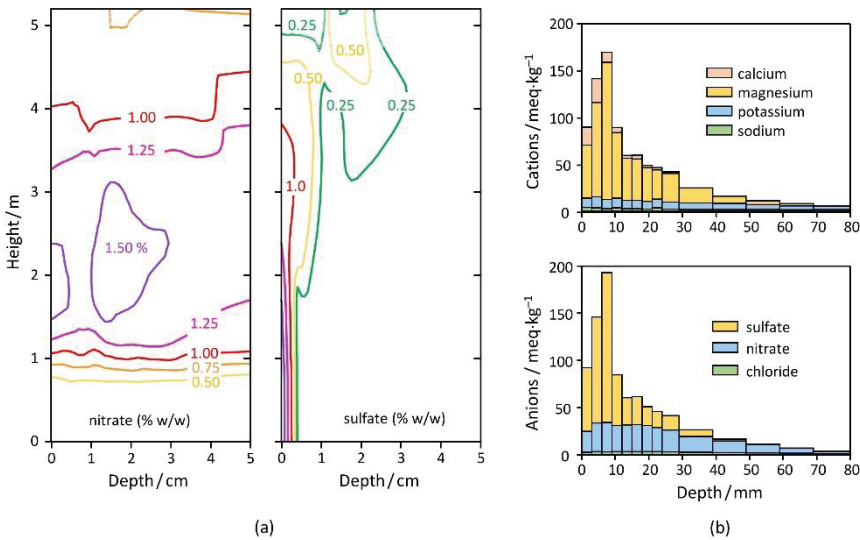
Figure 3: (a) Distribution of sulfate and nitrate in masonry affected by both rising damp and deposition from the atmosphere (Birkenfeld Convent). (b) Depth profile of salts in sandstone masonry with distinct maximum of salt load below the stone surface (Weissenstein Castle, Pommersfelden, modified from reference [1]).

or roof run-off waters, rising damp etc.) and the drying behaviour of the materials lead to distinct distributions patterns of salt in masonry with pronounced horizontal and vertical gradients. Some examples are shown in Figure 3.

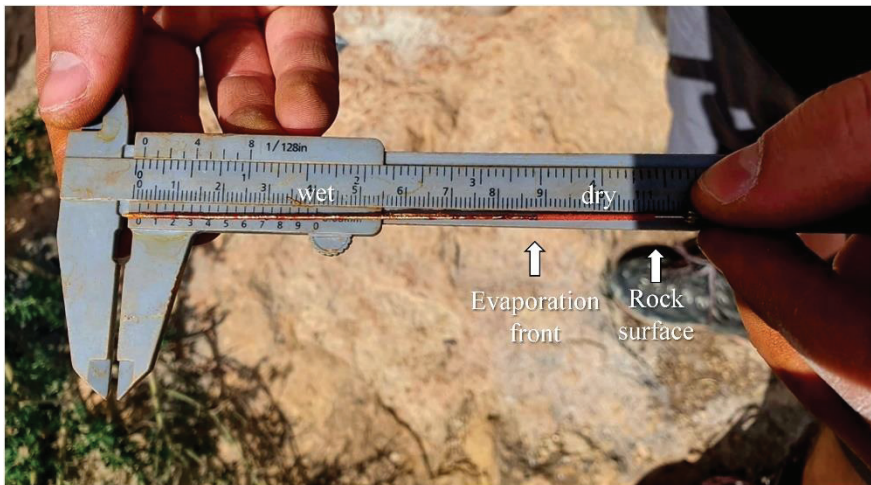
Figure 2. Uranine probe used to measure the depth of the capillary water. Probe is wet from 2.5 cm inwards, proving the location of the Evaporation front.

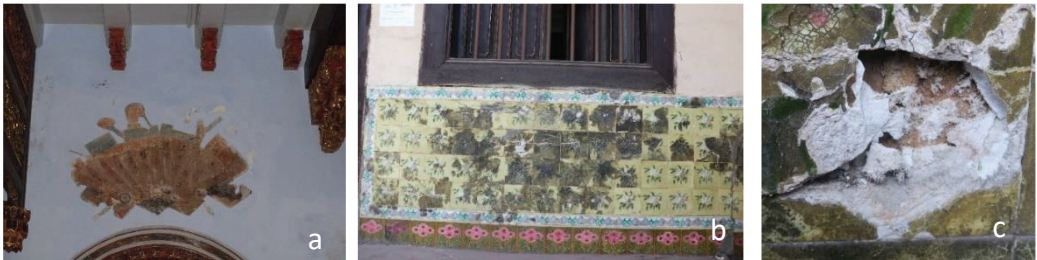
Figure 2: a- example of redistributed salt damage on a mural above an internal window; b- concentrated salt crystallization damage on dado tile below an internal window; c- close up view of damaged glazed tile

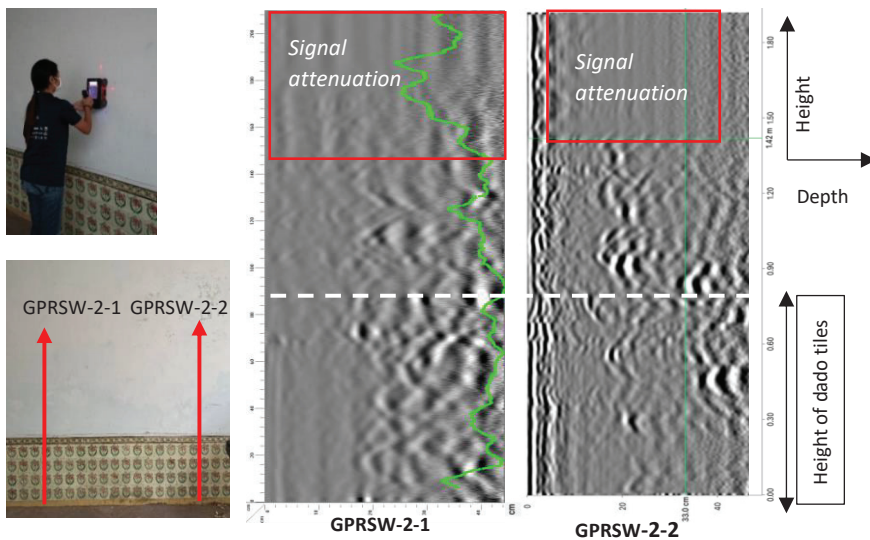
Figure 10 Results of Ground Penetrating Radar

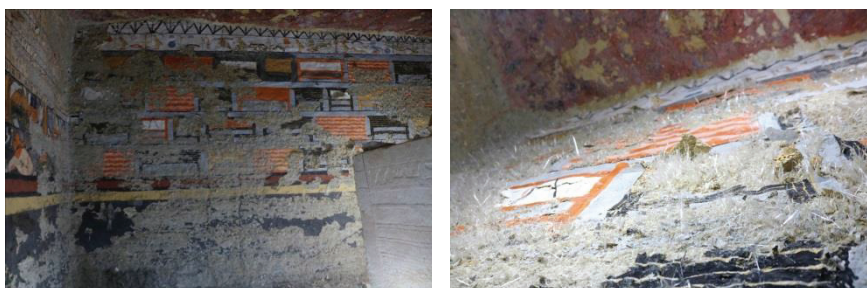
Figure 4: Wall Paintings of *Memi* underground burial chamber.

High humidity in the underground burial chamber and soluble salts in the bed rock are the most important factors for the degradation. Recrystallized salts inside and at the surface of the painted plaster layer, cause the detaching the plaster layers and the painted layers.

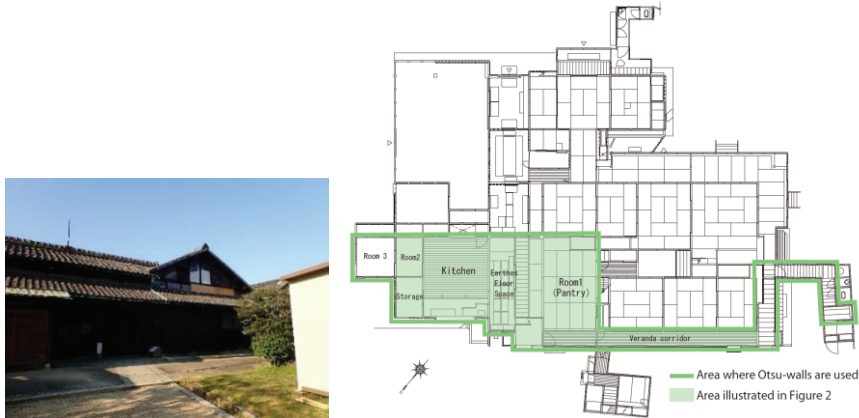
Figure 1 Nishio house (left: outside view, right: plan of the main building ^{note1}; the area within the solid line frame indicates where the Otsu walls are used. The hatching area shows the area illustrated in Figure 2).

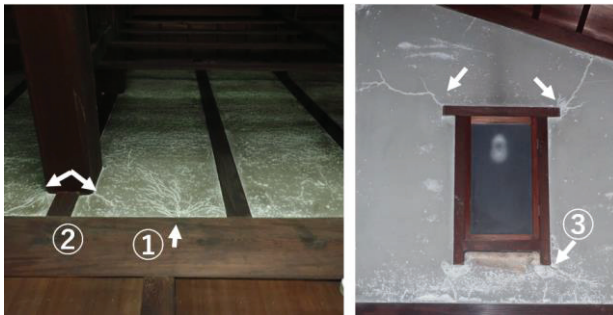
Figure 5 Linear deterioration (left Figure 2i, right Figure 2d)

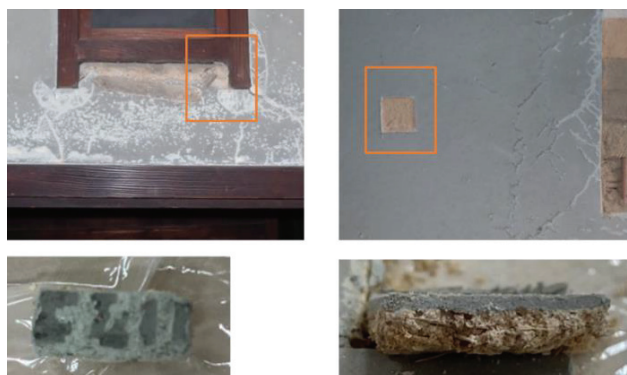
Figure 7 Sample and the collected part (upper-left: the collected part of sample A; bottom left: sample A; upper-right: the collected part of sample B; and bottom right: sample B where the deterioration is not evident)

Samples for SEM/EDX analysis were obtained from the bottom of the lighting box shown in Figure 2d (Figure 7, left, sample A), where deterioration was significant, and from the sidewall of the veranda corridor shown in Figure 2c (Figure 7, right, sample B), where no crystallisation occurred.

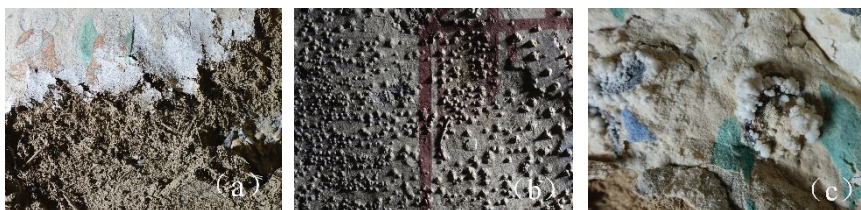
Figure 1: Salt damage of wall paintings at Mogao Grottoes; (a) plaster disruption; (b) crater eruption; (c) salt efflorescence.

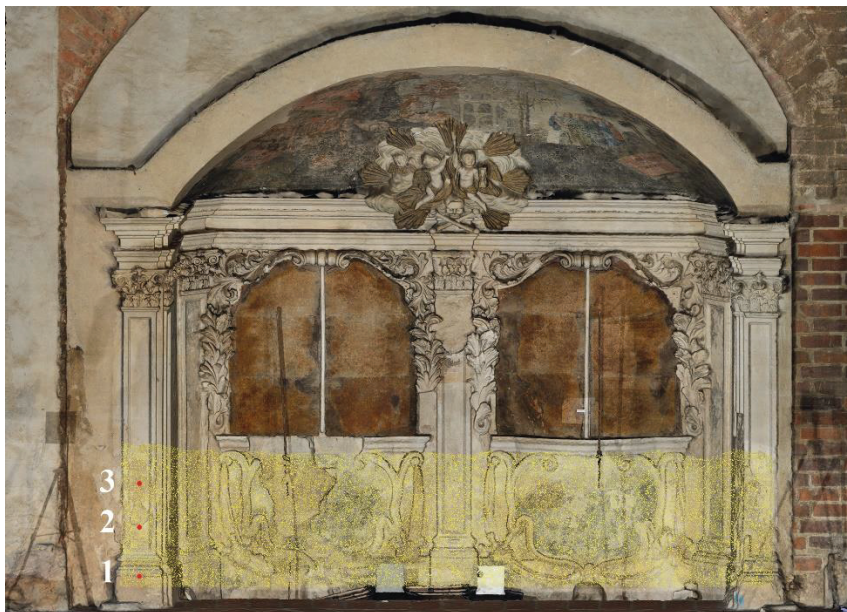
Figure 2: Baroque tomb, moisture and salt damage (highlighted in yellowish) in the lower area of the tomb, on the left are marked the drill powder extraction points for the quantitative analyzes in one height and three depth profiles

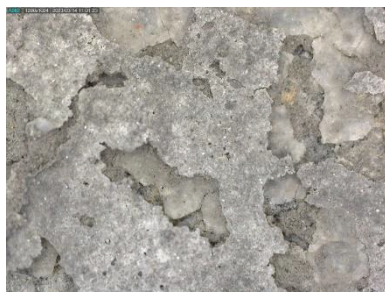
Fig 4. Photomicrograph of the surface coating

There is a clear layer of coating on the surface of the Bell Tower base. Take coating samples from west, south and east sides of the base respectively. The components are analyzed by infrared spectrum, while the surface bonding condition is observed by microscope (seen in Figure 4). It is observed by microscope that the surface has been painted with multiple coatings.

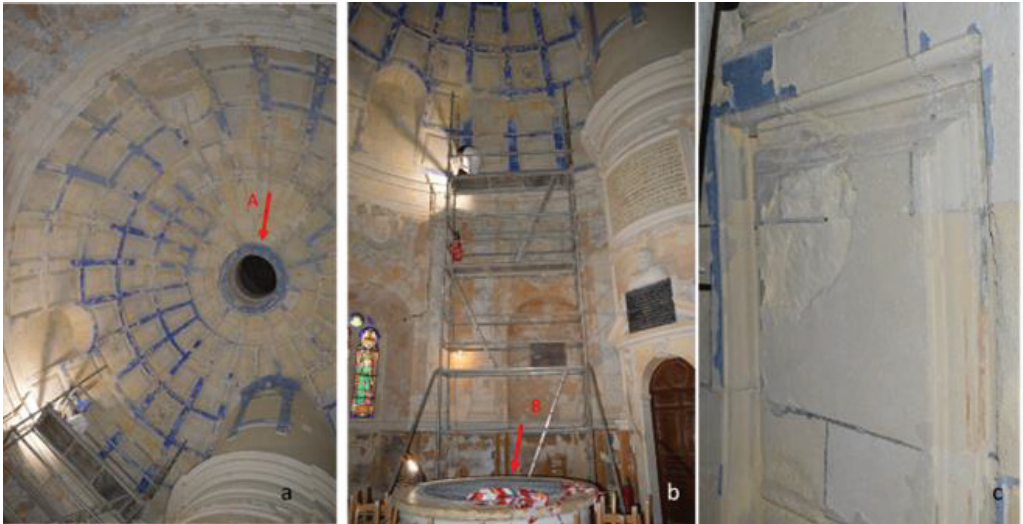
Figure 1: Interior of the chapel (a) view of the overhead dome, the arrow (A) indicates the oculus at the peak. (b): southern part of the chapel, the arrow (B) indicates the oculus on the floor of the chapel. (c): details of natural stone decay, granular disintegration, powdering and scaling are seen in the chapel. (Picture ECMH)

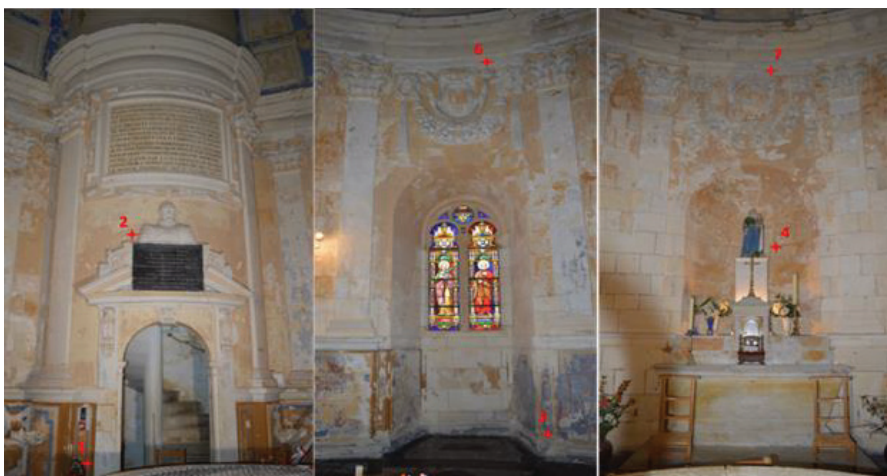
Figure 2: Location of the stone samples for analysis in the lower section of the wall and cornice of the spherical vault (Picture ECMH)

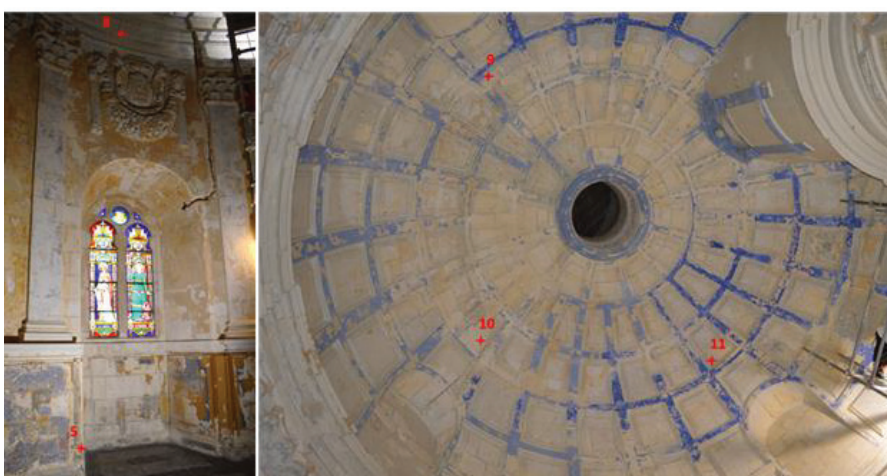
Figure 3: Location of the stone samples for analysis in the base and interior of the caissons of the spherical vault (Picture ECMH)

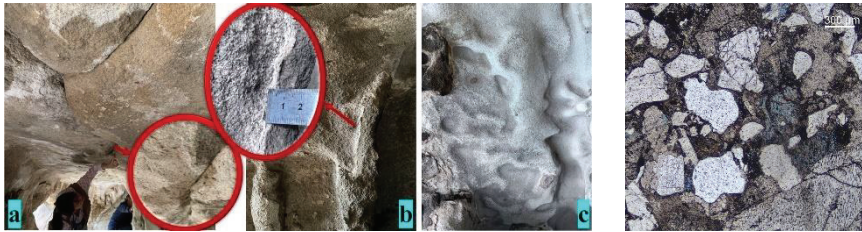
Figure 3: a. Seepage is seen near a fissure in the roof, b. Typical deterioration pattern on no fissures area, c. North wall in Cave 4 has been weathered to tafoni

3). Some parts of the walls were in a worse state of preservation, such as the carvings on the north wall that were weathered to tafoni (Fig. 3c). There was seepage near a fissure on the roof (Fig. 3a) and efflorescence around fissures on each wall. Figure 3b shows typical efflorescence in the area without fissures with large amounts of white precipitates appearing a few millimeters beneath the surface.

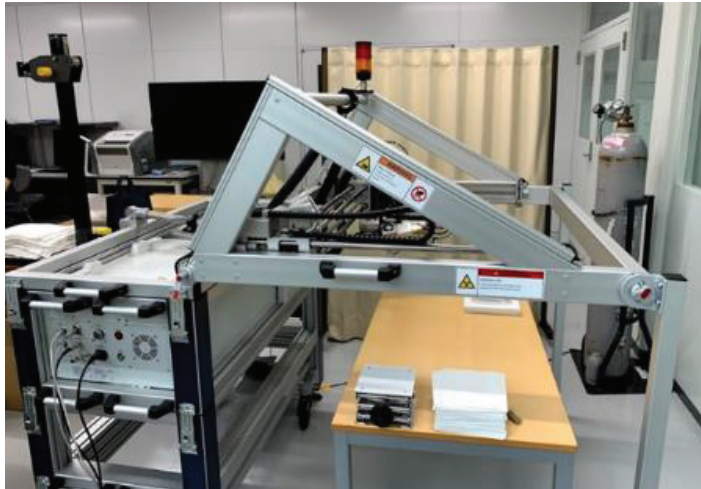
Figure 1: M6 JETSTREAM energy-dispersive XRF analyzer.

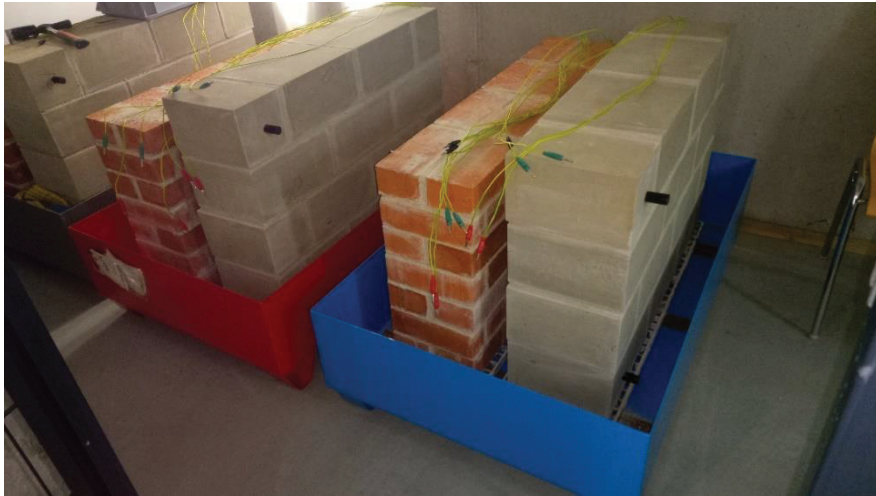
Figure 1 Stored test specimens in steel profile troughs.

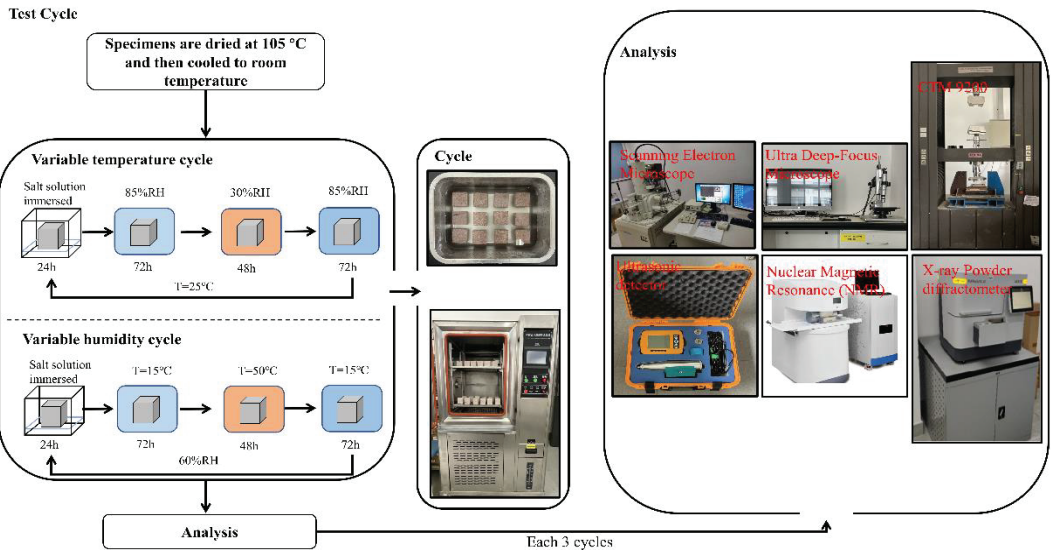
Figure 3: Variable temperature and humidity cycling tests on Yungang sandstone under sulphate (Na_2SO_4 , MgSO_4) solution.

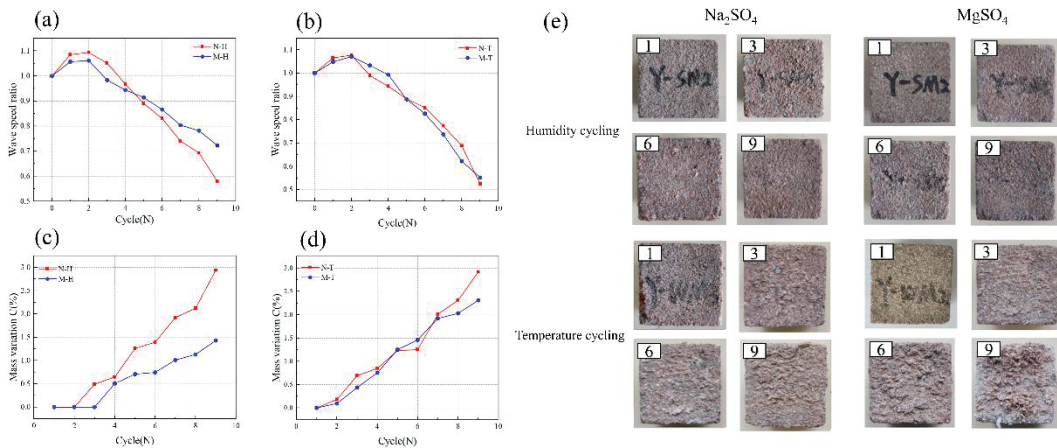
Figure 7: Variation of ultrasonic velocity and mass of specimens under different temperature and humidity cycles: a) Humidity group wave speed variation; b) Temperature group wave speed change; c) Moisture cycle group mass loss; d) Temperature cycling group mass loss; e) Surface morphology of sandstone during temperature and humidity cycling.

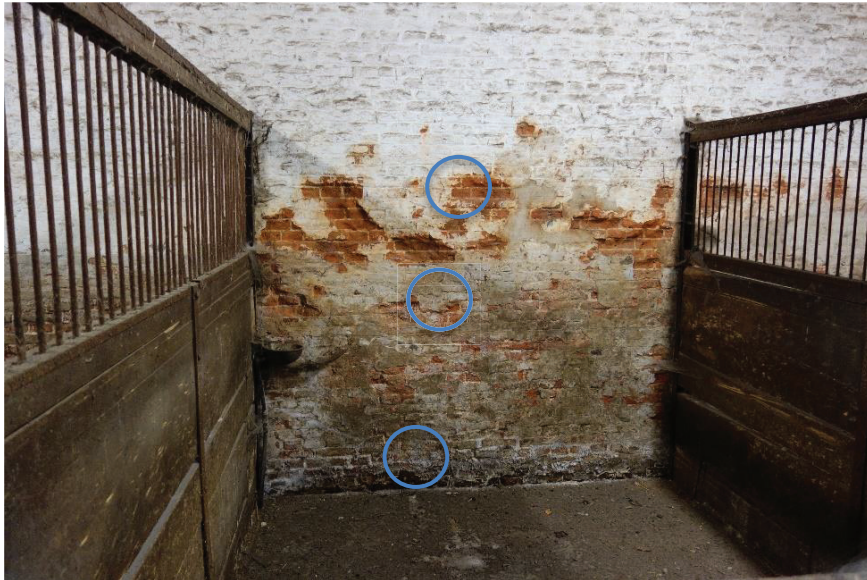
Figure 1: The 18th century stable wall before the treatment. Samples were taken in the three indicated zones at 20, 115 and 200 cm above floor level.

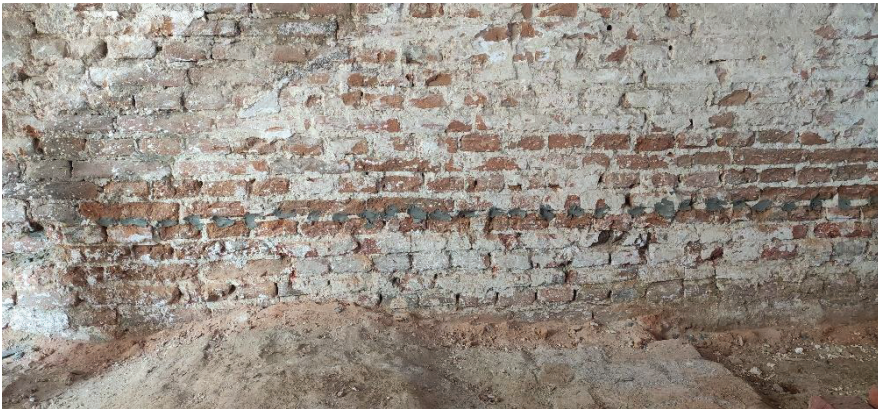
Figure 2: The stable wall showing the drill holes used for the injection with the damp-proofing agent after they were plugged with hydrophobic cement.

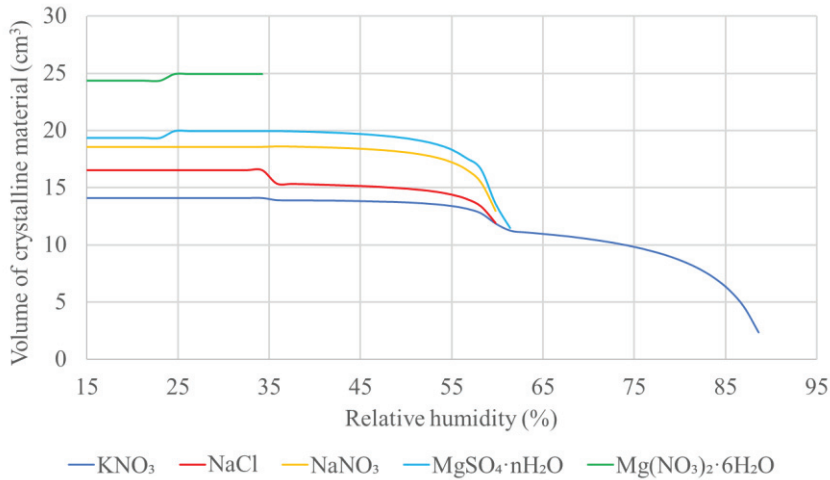
Figure 6: ECOS/RUNSALT output for the crystallisation behaviour at 15 °C of the ion mixture in the first two centimetres of the brick at 115 cm above floor level, excluding equimolar contents of calcium and sulfate ions.

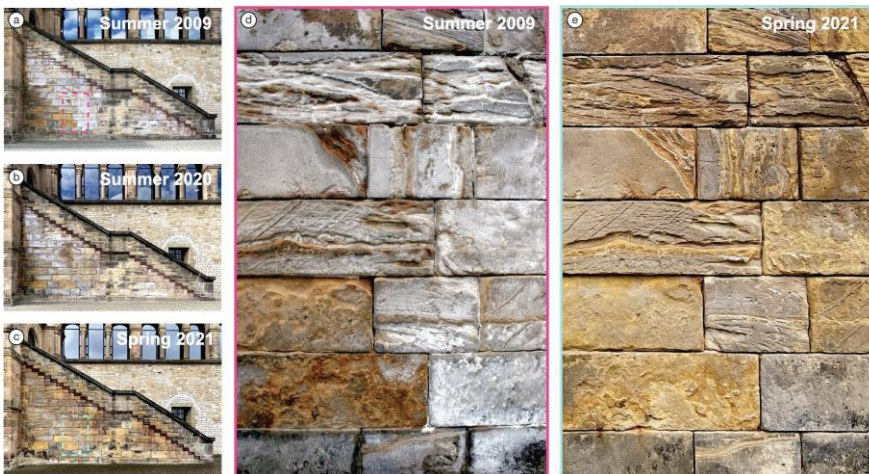
Figure 2: a) the Staircase in summer 2009, b) in summer 2020 and c) during springtime 2021. d) Detail area in summer 2009 and e) the same area in 2021.

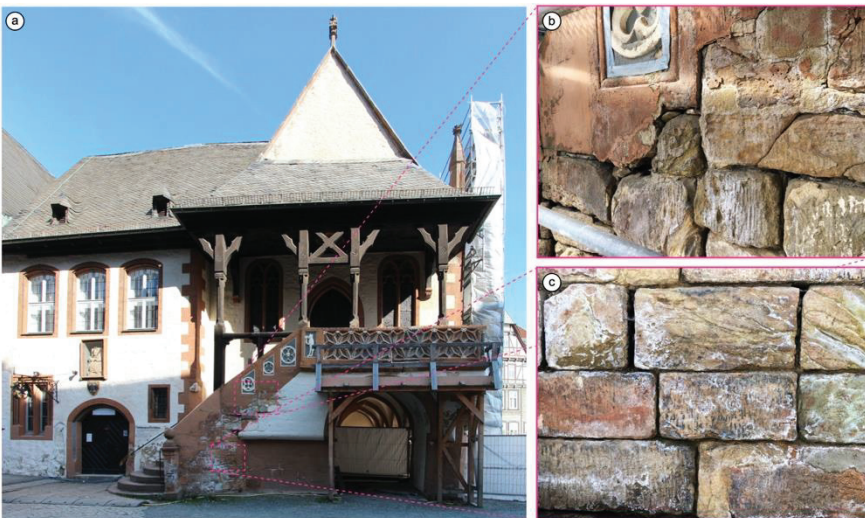
Figure 5: a) The staircase and balustrade in 2018 and b) and c) the stone elements right before desalination treatment.

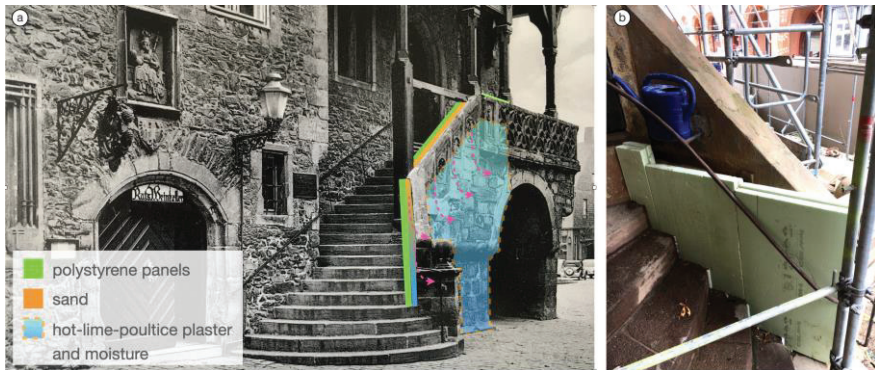
Figure 6: a) The design of the desalination procedure and b) a polystyrene panel behind the balustrade.

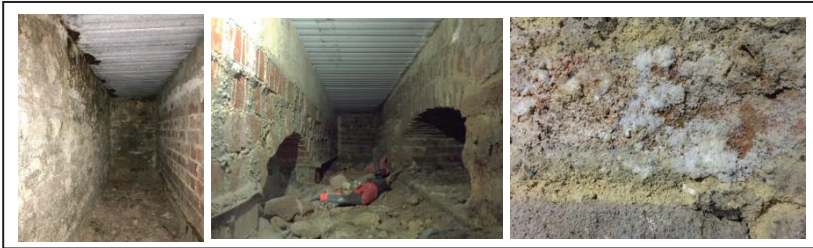
Figure 2: Typical view of a narrow space between the old and new masonry walls. Note also the corroded Bondek slab along the side with the historic masonry wall.

Through the pre-restoration inspection made to the sub-floor, signs of severe salt attack and moisture damage were evident on the surface of historic brick walls [1]. This led to the suspicion of prolonged rising dampness and salt attack. Other defects like corrosion were noticed on the Bondek system. There were also other walls with clay brick units in different dimensions and colour from those historic ones, remaining in good condition without any visual defect. These were latter-day added, likely to support the added Bondek slab system.

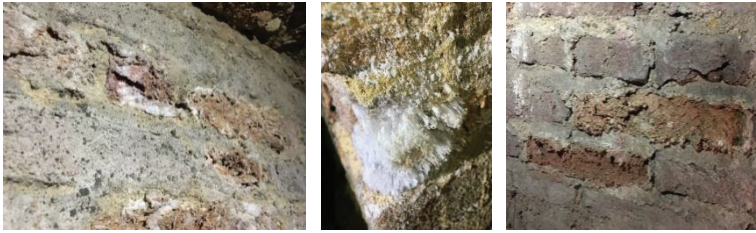
Figure 3: Left image - Efflorescence on the surface of the bricks accompanied by flaking or stratification of the surface layers. Middle image - Large crusts of salt crystals which have crystallized out from the surface of the bricks. Right image - Typical symptoms of friable clay and flaking of the bricks caused by salt crystallization.

During the visual inspection inside the sub-floor, efflorescence was evident on some bricks of the historic walls, as observed from the formation of whitish salt crystals on their surfaces. Such whitish salts mostly manifested as cluster or bundle of needle-like crystals, growing out of and breaking through the surface of clay bricks. As a result, the integrity of brick surface had been compromised with flaky and friable surfaces. This is often attributed to uprising dampness when moisture is transported from the ground upwards via capillary. In the process soluble salts from the ground are dissolved and carried up the wall which then re-crystallizes when water evaporates. The zone where water evaporates is governed by numerous factors which include, the pore characteristics of the substrate, surface finishes, environmental conditions. In this Hotel, the distribution of salt crystallization attack appeared to be random without a distinct pattern. They are found widespread in the sub-floor and at various heights and locations above the sub-floor. The micro climate in the sub-floor with ventilated air flow and yet at times humid condition as seen from the condensation depending the external weather could indeed have

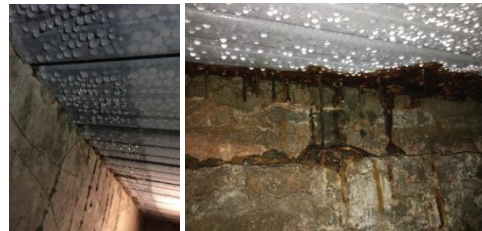
Figure 4: Left image shows condensation on the Bondek at the historic masonry wall side. The condensate water could lead to more water being absorbed by the historic wall. Right image shows the corrosion of the galvanised steel of the bondek especially where the deck butts the wall.

Condensation found on the underside of the Bondek are indications of humid environment within the sub-floor which impedes drying. However, the presence of efflorescence infers that there could have been local drying for salts with high equilibrium relative humidity, possibly contributed by a fluctuating microclimate in the sub-floor. Severe corrosion of the galvanized steel Bondek along the edges that is supported by the old masonry wall indicates prolonged dampness.

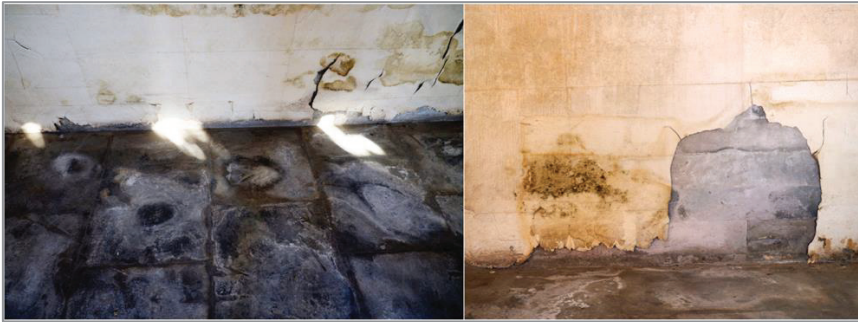
Figure 1: Indoor damages of building material: salt damage of floor bricks, cracking and mildew of wallpaper.

In the process of surveying and protecting the heritage buildings of the Palace Museum in Beijing, we found a kind of typical phenomenon of salt damage of indoor floor bricks, which showed seasonal regularity: it repeatedly appeared in the spring and autumn seasons every year, and in summer the floor bricks were very wet. Because there are precious cultural relics on display in the room, salt crystals on the ground will also erode the parts of the cultural relics in contact with the ground (figure 1).

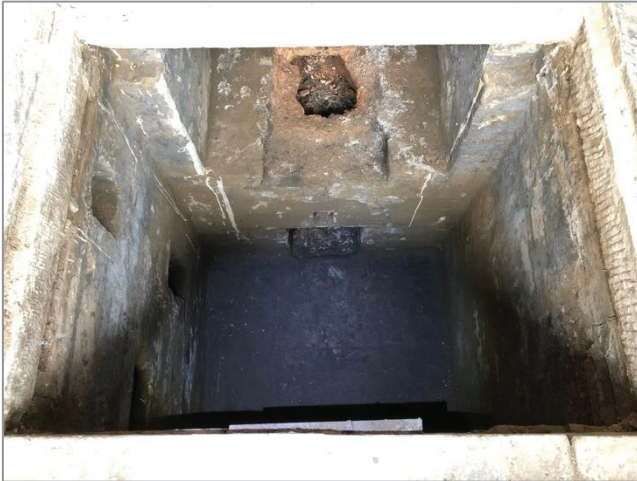
Figure 4: Photo of operation pit and the furnace.

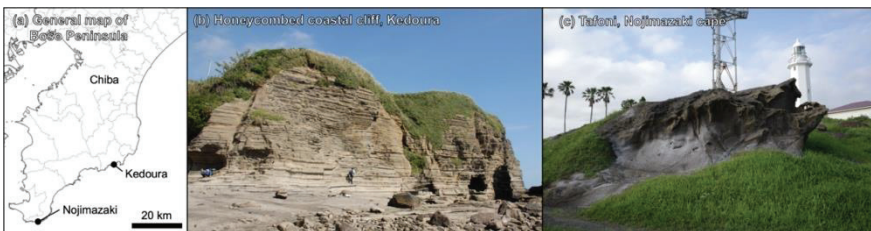
Figure 1: Targets of Three-dimensional modelling.

The targets for 3D modelling were tafoni and honeycombed coastal cliff, located on the south-east coast of the Boso Peninsula in central Japan. Marine terraces and rocky coasts formed by seismic uplift are widespread in the area. Kedoura, a rocky coast consists of a shelf platform with tens of meters wide and a rock cliff over ten meters high. The cliffs are composed of Neogene sandstones and mudstones, and honeycomb features have developed mainly on the sandstone layer. Another site is Nojimazaki, which located at the southern end of the Boso Peninsula. The small cape consists of a present-day shore-platform and several uplifted marine terraces. Tafoni of various sizes are found on the shore-platform and marine terraces [3].
