Preservation of murals with electrokinetic – with focus on desalination of single bricks

Ph.D. Thesis

Department of Civil Engineering
Technical University of Denmark

2008

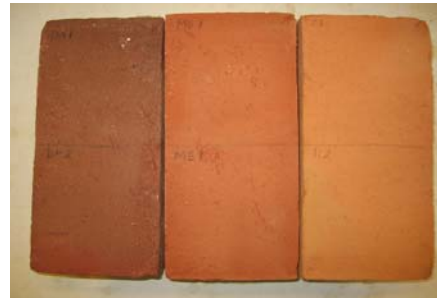
Figure 1. Dark, medium and bright colored bricks.

The total content of soluble ions verified both by the electrical conductivity measurements and as a sum of the actual anion and cation measurements clarified significant variations between bright, medium and dark colored new bricks (the color difference is shown in figure 1). Also significant differences in contents of soluble ions were found related to red/yellow color, location and age.

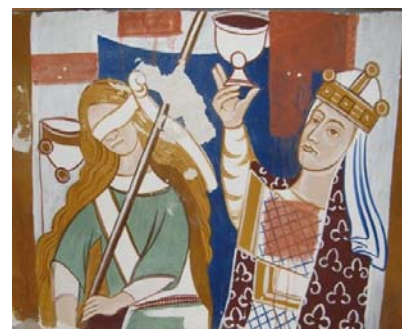
Figure 2. The wall section with murals. Height:88 cm, width:114.

The pH was measured in the wall section before and after treatment and no changes were observed. Pigments in murals have very low solubility at neutral pH, but some pigments have increased solubility in extreme acidic or alkali environments. Since only

dissolved pigments can be transported in an electric field, no changes in the pigments were expected after the treatment was ended, as the pH did not change after the electrokinetic treatment. Unfortunately, crumbling of the mortar below the cathode unit was observed during the treatment and further developments in the poultice type were needed.

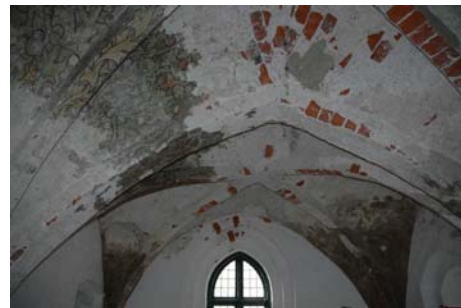
Figure 3. The vaults of the Birdsroom in the Carmelite Monastery, Helsingør, Denmark.

The investigations showed that the primary salt contaminant was sodium chloride used for preservation of perishable food in ancient preservation. Meanwhile, the most accepted theory for salt deterioration, crystallization pressure, does not justify damage from sodium chloride alone.

Besides sodium chloride, sulfur was found at all fractures originating from the vault by element mapping with (EDX) mappings. Overlapping EDX mappings with calcium, oxygen and sulfur made probable that gypsum was the determining deterioration factor. These SEM-EDX analyses underline the importance of individual evaluation of damaging ion concentrations related to the actual salt mixture since the study showed that the highest ion concentration not necessarily is the causes for the damage and since the combination of salts can result in another degree of damage than in the case for the single salts themselves. This has to be taken into account in future desalination treatments of existing structures for determination of a satisfying ion reduction will be obtained.

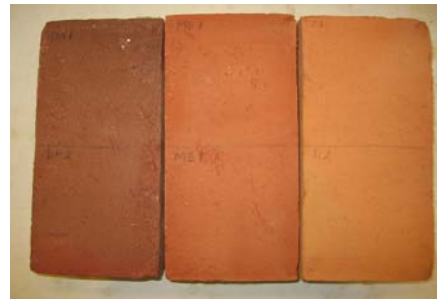
Figur 1. Mørk, mellem og lys farvede sten.

Den totale mængde af opløselige ioner, blev målt både ved den elektriske ledningsevne og som en sum af de aktuelt målte anioner og kationer. Den tydeliggjorde signifikante forskelle mellem lyse, medium og mørk farvede nye mursten (farve forskellene er vist i figur 1). Der blev også fundet signifikante forskelle mellem indholdet af opløselige ioner relateret til rød/gul farven, placering og alder.

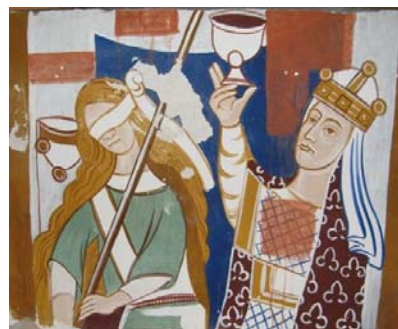
Figur 2. Væg udsnittet med kalkmaleri. Højde: 88 cm, bredde: 114 cm.

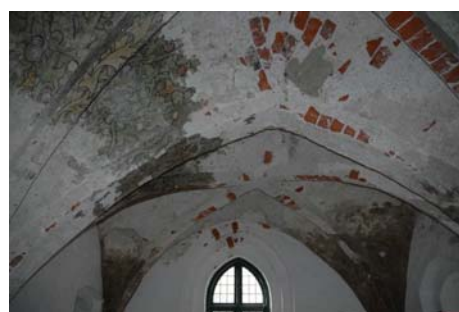
Figur 3. Hvælvene i Karmeliter klostrets Fugleværelset, Helsingør, Danmark.

Saltnedbrydning er afhængig af de aktuelt tilstedeværende ioner, blandinger og klima. Derfor blev nedbrydningsprocessen undersøgt på et sted, hvor den saltforårsagede overfladenedbrydning var omfattende. Stedet var et saltforurenset hvælv i det såkaldte Fugleværelse i Karmeliter klosteret (Vor Frue kloster) i Helsingør, Danmark. Et billede af hvælvene er

Undersøgelserne viste, at den primære årsag til saltforureningen var natriumklorid, som sandsynligvis tidligere blev brugt til konservering af fordærveligt mad. Imidlertid retfærdiggør den mest accepterede saltnedbrydningsteori, krystallisationstryk, ikke for skader alene forårsaget af natriumklorid. Udover natriumklorid, blev der også fundet sulfur i brudfladen, på alle de nedfaldne kalklag stammende fra hvælvet (vha. EDX element mapping). Overlappende EDX mappings med calcium, oxygen og sulfur sandsynliggjorde, at tilstedeværelse af gips var den afgørende nedbrydningsfaktor.

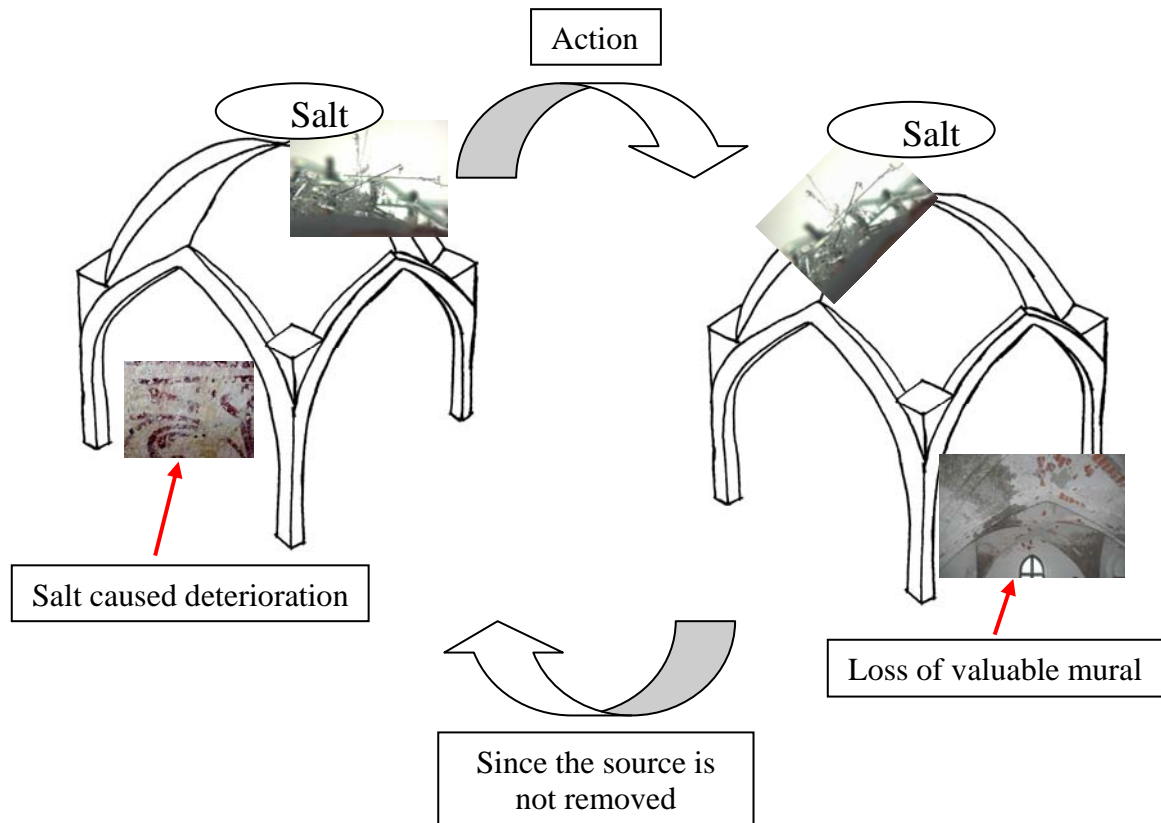
Figure 1. Present salt induced deterioration of murals. The salts are present in the brick masonry vault and in the lime layer and results in repulsion of small areas with paint. The murals are repainted when possible. However, since the source for the deterioration is not removed the deterioration-repainting cycle unfortunately continuous.

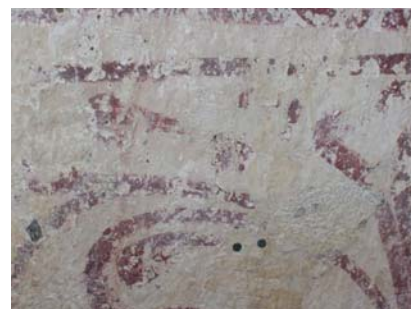
Figure 3. Close up of a partly deteriorated mural. Rørby Church, Denmark

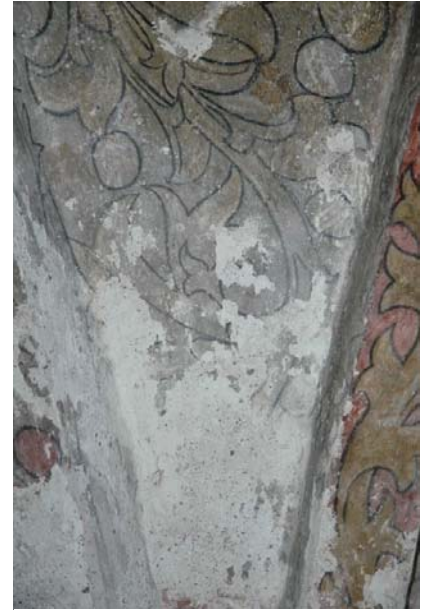
Figure 4. Deterioration of the murals in the Carmelite Monastery in Helsingør, Denmark.

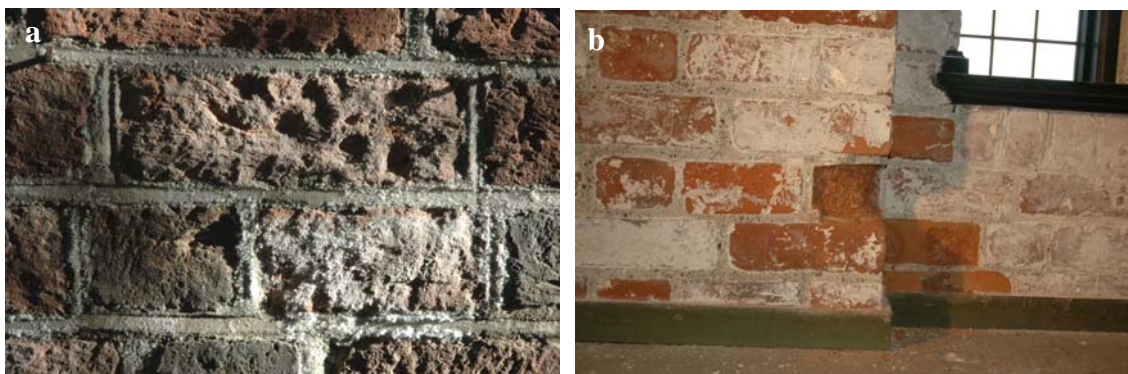
Figure 1. (a) Harmless salt effluences at the surface of non plastered brick masonry from where the salts can be removed by use of a brush. (b) Material damaging subeffluences (salt crystallization inside the pores).

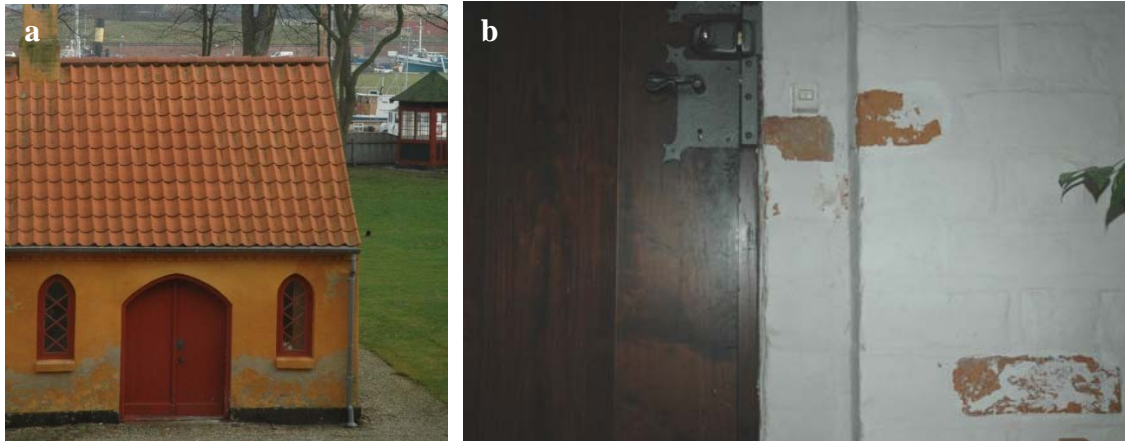
Figure 2. Plaster peeling (a) Traditional salt induced plaster peeling in a belt at approximately the same distance from the ground (b) Peeling of the lime wash in front of some specific bricks. In both cases the result is increased maintenance.

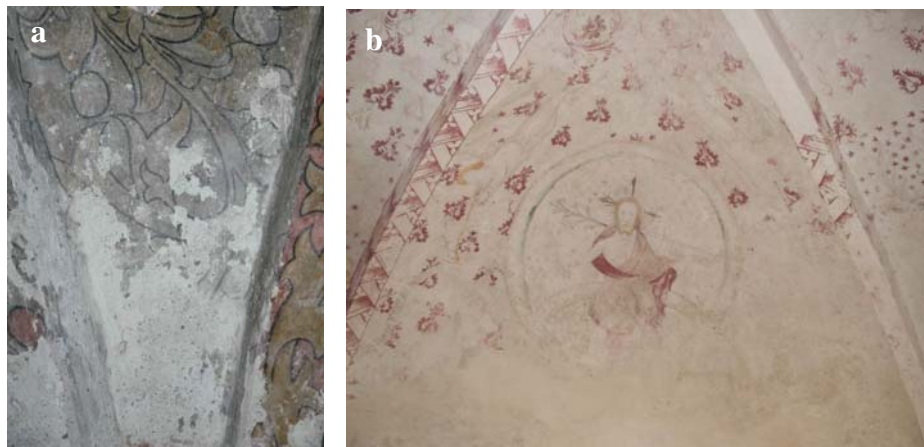
Figure 3. Salt induced deterioration of murals (a) From a monastery vault (b) From a church vault.

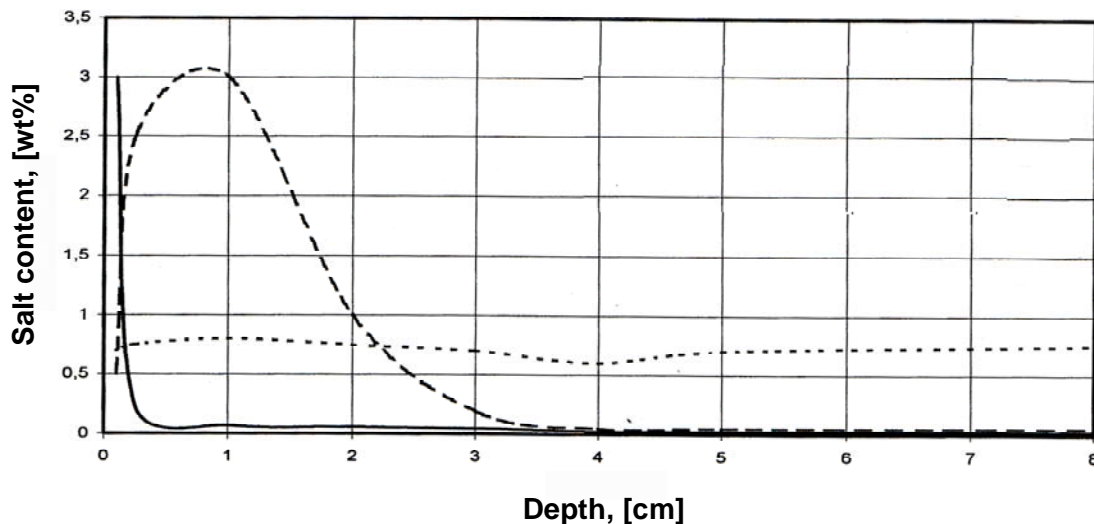
Figure 4. Typical salt distribution in an external wall from [Auras & Melisa, 2002]. The solid line represents salt-crust at the surface, the big dotted line salt accumulation near the surface and the small dotted line the salt contamination of the cross section.

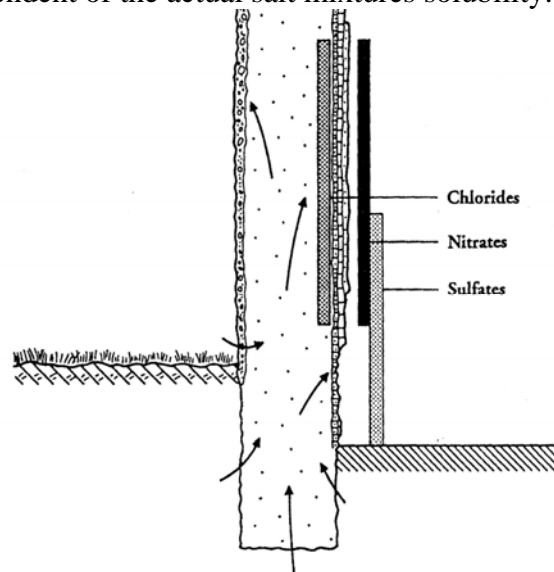
Figure 5. Model of the evolution of salt systems in relation to capillary rise of moisture from [Arnold & Zehnder, 1987].

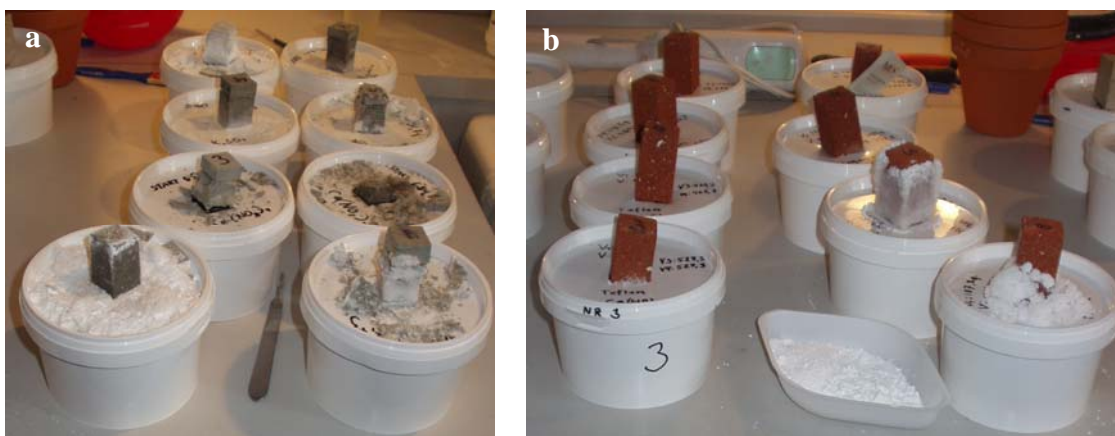
Figure 6. The effect of salt in sandstones and brick specimens (a) Salt induced deterioration of the sandstone specimens mainly crystallization inside the material (b) Visible salt precipitation at the brick specimens surface mainly crystallization on the surface of the material.

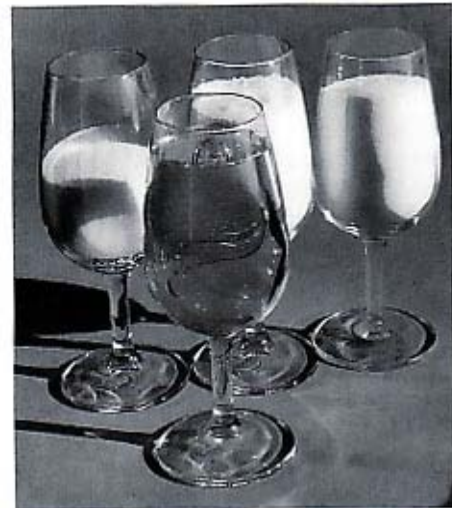
Figure 7. $\text{Ca}(\text{NO}_3)_2 \cdot 4\text{H}_2\text{O}$ The volume difference from nucleated state to dissolved state. $2 \frac{1}{2}$ glasses of the nucleated salt fits into 1 glass when dissolved in water [Arendt & Seele, 2001]

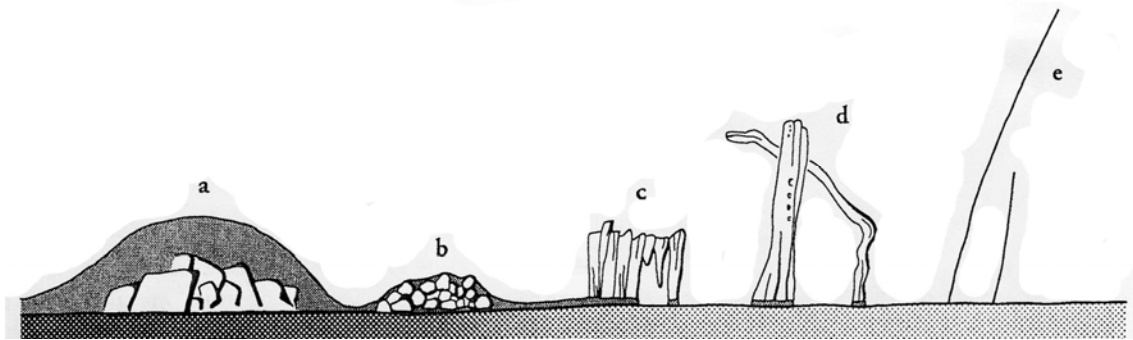
Figure 8. The relationship between crystal morphology and the substrate humidity of a porous material (a) Large crystals, displaying their specific equilibrium forms, grow completely immersed in a solution film on a wet substrate (b) A granular crust made up of smaller and isometric crystals on a wet substrate. The crystals are just covered by a solution film (c) A fibrous crust grows into the air from a substrate surface covered by a thin solution film (d) Columnar and thick whisker crystals grow from a slightly humid substrate; the solution film still forms small spots (e) Very thin whisker crystals grow into the air from the nearly dry surface with a localized solution supply [from Arnold & Zehnder, 1987].

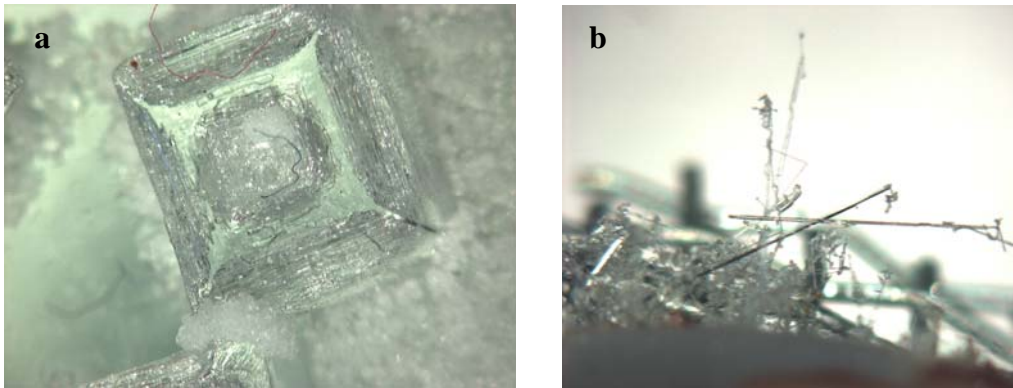
Figure 9. (a) Isometric NaCl formation below a water film (b) NaCH₃COO Whisker crystals formation at a nearly dry surface with a localized solution supply.

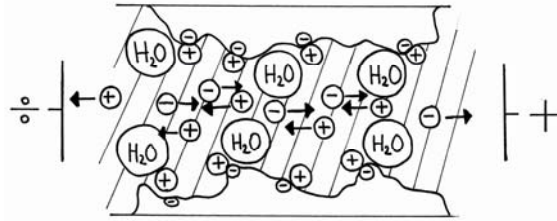
Figure 2. High ionic concentration in the electrolyte shown as a principle for a single pore (the electrolyte is indicated as the hatched area). The ions are attracted towards the opposite charged electrodes in the electric DC field.

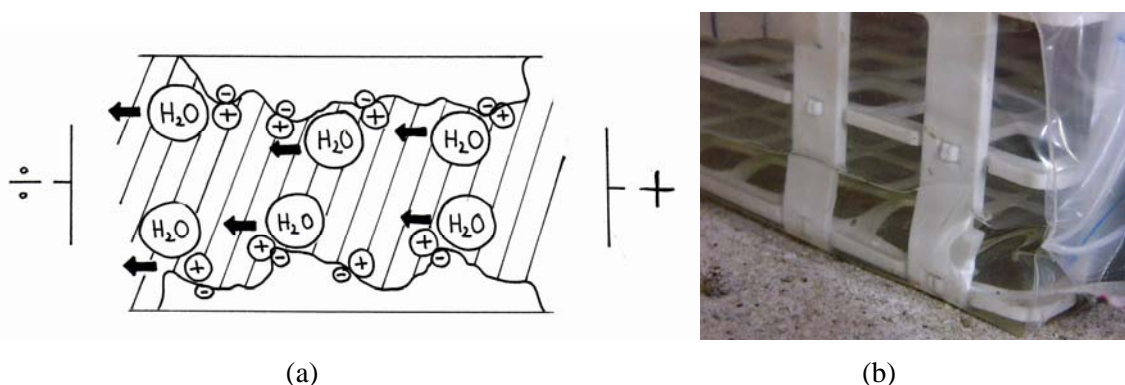
Figure 4. Low ionic concentration in the electrolyte. By application of an electric DC field water transport is initiated close to the material surfaces (in the diffuse part of the electric double layer). (a) A principle sketch (the electrolyte is indicated as the hatched area) (b) The electroosmotic water transport effect shown in pilot scale. The collecting unit with water below the cathode [Ottosen & Rörig-Dalgaard, 2006].

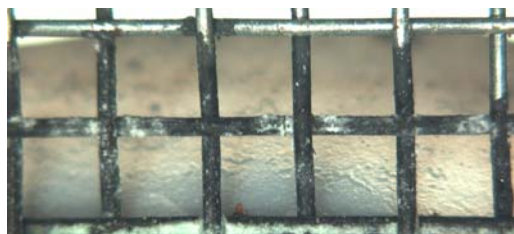
Figure 5. Decomposition of the anode mesh made of stainless steel. The original metallic gray color is during the decomposition changed to black and later green and the metal mesh will subsequently get so deteriorated that it breaks. Stainless steel is surface coated iron.

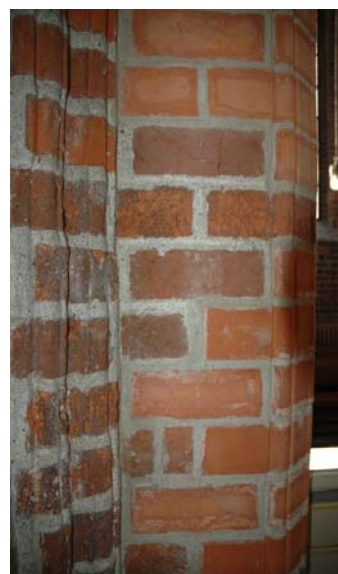
Figure 1. Picture of the pillar to the right of the altar in Sct. Mariæ Church, Helsingør, Denmark. Replacement with Falkenløwe bricks of deteriorated bricks have been carried out. Color variation is visible.

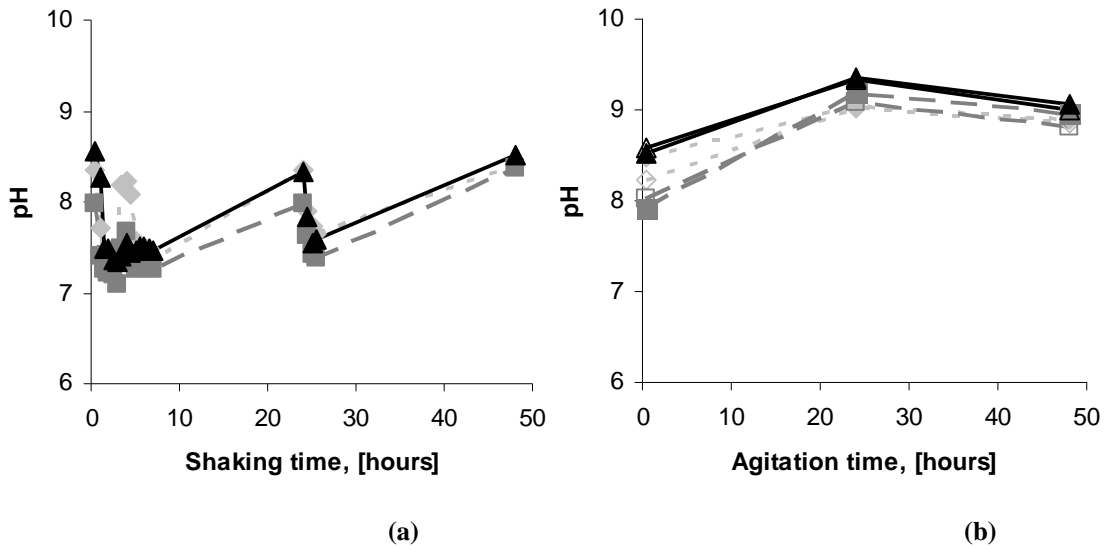
Figure 3. Double determination of pH measured in the bright \diamond , medium \blacksquare and dark colored brick \blacktriangle (a) with opening/closing of samples (air supply) and (b) without opening/closing of samples (air supply).

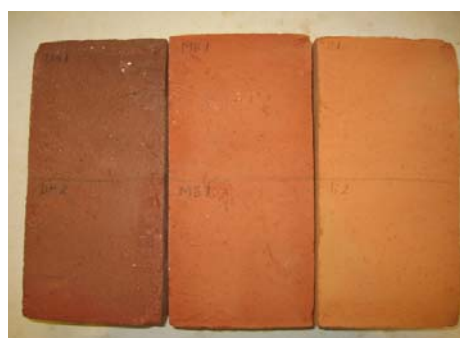
Figure 4. Color variation from a pale of Falkenløve bricks: Dark, medium and bright.

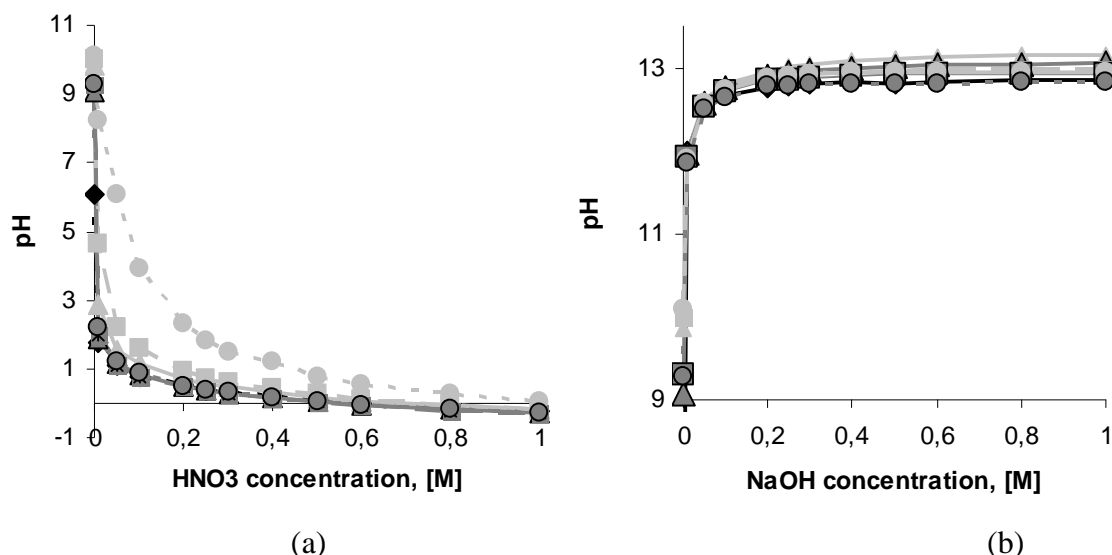
Figure 5. (a) Acid resistance and (b) alkali resistance. pH in \blacklozenge solution. Falkenløwe medium agitation time \blacktriangle 1 hour \blacksquare 5 hours \bullet 24 hours. Wewers yellow agitation time \blacktriangle 1 hour \blacksquare 5 hours \bullet 24 hours.

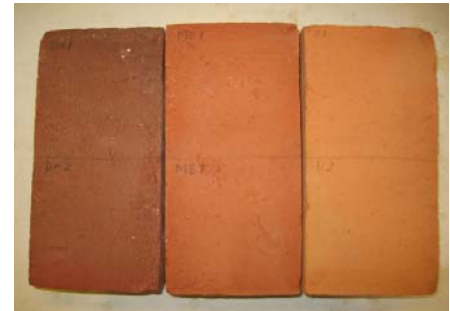
Figure 1. The dark, medium and bright colored bricks.

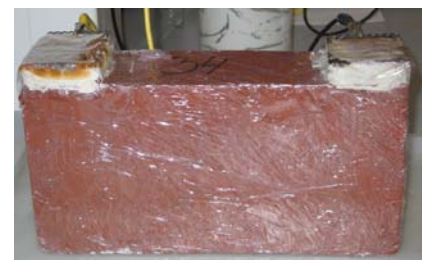
Figure 2. Laboratory setup where the poultice with electrodes is placed on the long, narrow side of the brick.

The electric resistance and effective diffusion coefficient investigations were made with whole bricks in order to minimize the source of errors originating from the edges and obtain general results in case of variations throughout the bricks. In the electrokinetic salt removal experiments the electrical DC field was applied with two electrode units. They were placed on the long, narrow side of the brick in two holes that were cut in the plastic film, see figure 2. The electrode units each had an area of 5.5 cm × 7.0 cm and a special clay poultice was applied between the brick surface and the two metallic electrodes. Flexible plastic forms were placed around the poultice to ensure the same amount of poultice in all the experiments. The forms had a height of 1.7 cm which corresponds to the height of the poultice between metallic electrodes and brick.

To obtain an effective desalination, a newly developed poultice was used. The poultice consisted of kaolinite clay, buffer component and distilled water and is described in details in Rörig-Dalgaard & Ottosen (2008 C) with the possibility to obtain a high desalination effect.

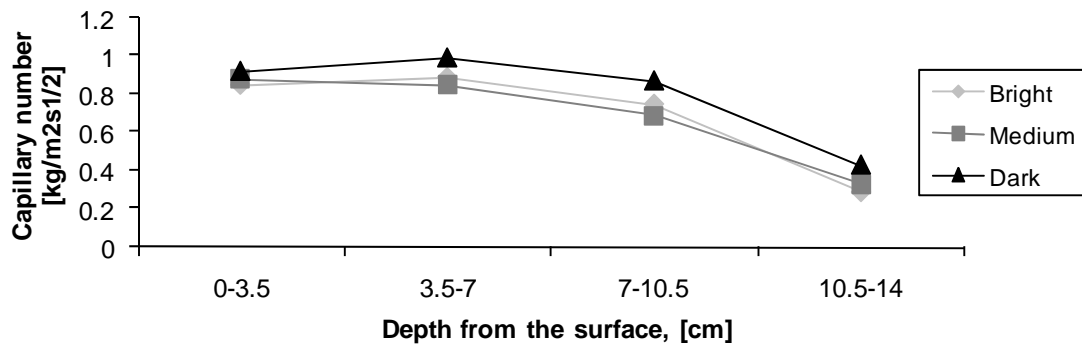
Figure 3. Water absorption coefficient of bricks as function of distance from the outer surface. The last measurement correspond to the center of the brick.

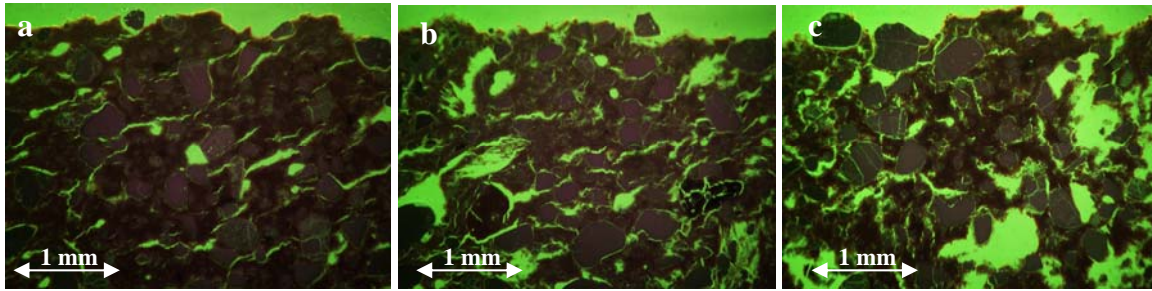
Figure 4. PFM pictures from the border of the cross section where the border is at the top of the picture (a) The bright colored brick (b) The medium colored brick and (c) The dark colored brick.

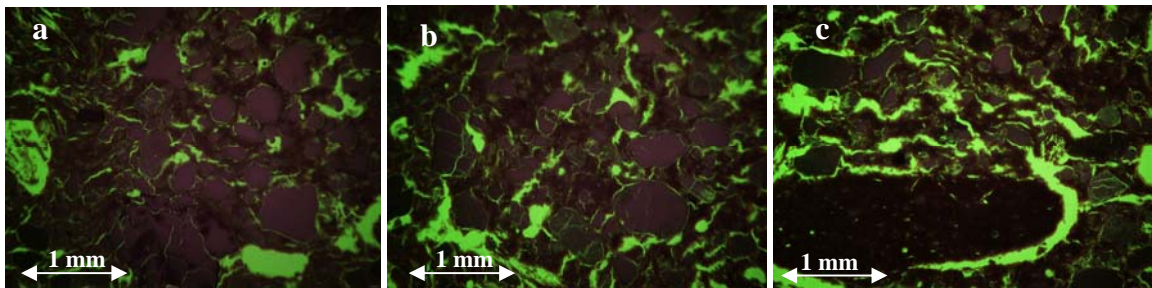
Figure 5. PFM pictures from the middle of the cross section. (a) The bright colored brick (b) The medium colored brick (c) The dark colored brick.

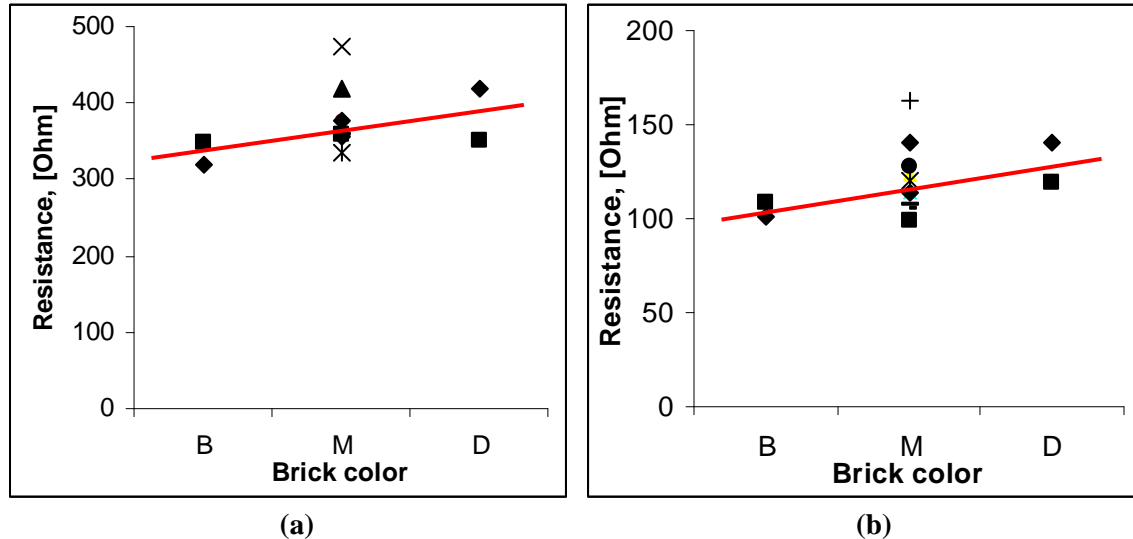
Figure 6. The initial resistance across the setup (a) and the resistance after 24 hours duration (b) as a function of the colors: bright (B), medium (M) and dark (D) colored bricks. Each dot represents a measurement of the total resistance across the setup and the solid lines show tendencies.

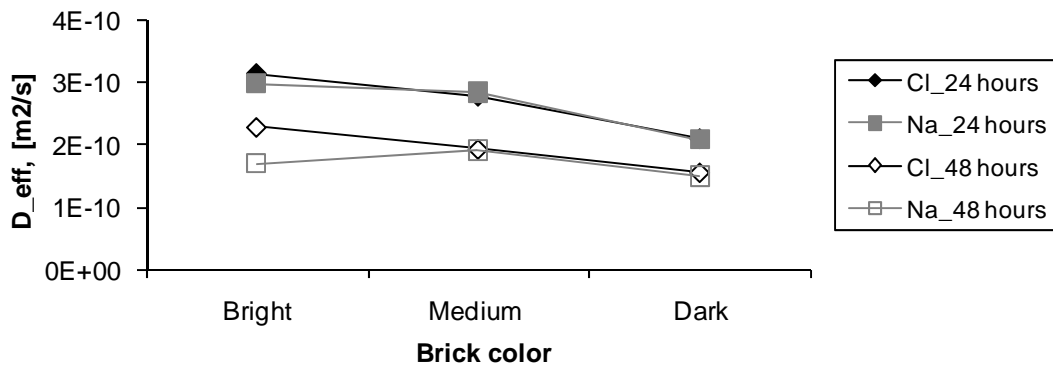
Figure 7. Calculated effective diffusion coefficients according to equation IV for the bright, medium and dark colored bricks after 24 and 48 hours. For the calculation is the resistance across the electrode surfaces and the clay neglected.

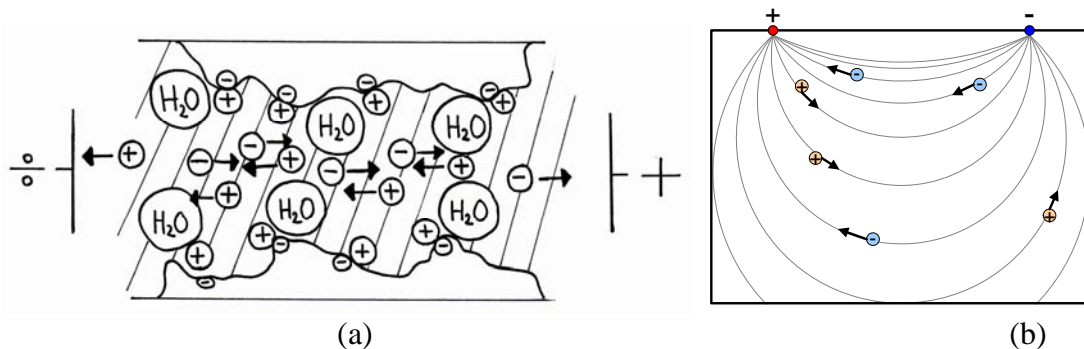
Figure 1. Effects at a high ionic concentration in the electrolyte, by application of an electric DC field. (a) Shown for a single pore (the electrolyte is indicated as the hatched area). The ions are attracted towards the oppositely charged electrodes in the electric DC field (b) Principal sketch of current distribution in a vertical plane along the line of electrodes. Freely after van Nostrand & Cook [1966].

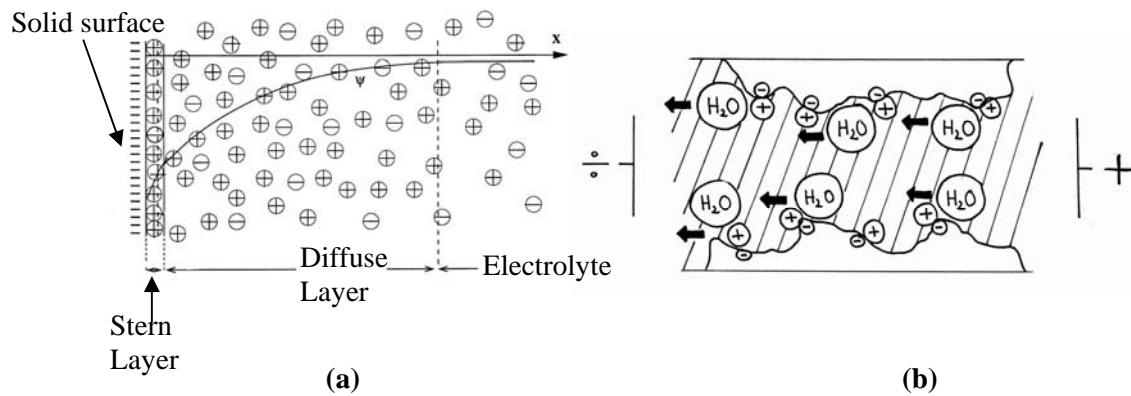
Figure 2. Low electrolyte concentration. (a) Principle illustration of the area close to the matrix-fluid interface adapted from [Gupta et al., 2007] (b) The effect of applying an electric potential across a moist, porous material (the electrolyte is indicated as the hatched area), water transport towards the negative electrode.

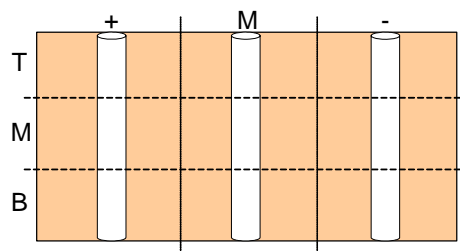
Figure 3. Principle drawing of the sampling. Each brick is divided into 3 pieces both horizontally and vertically. The upper third closest to the electrodes is called top piece and the brick pieces just below the positive electrode is called + e.g. upper left piece is called +T.

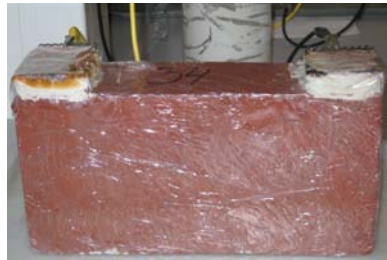
Figure 4. Laboratory setup where the electrodes (and poultices) both are placed on the bricks long, narrow side.

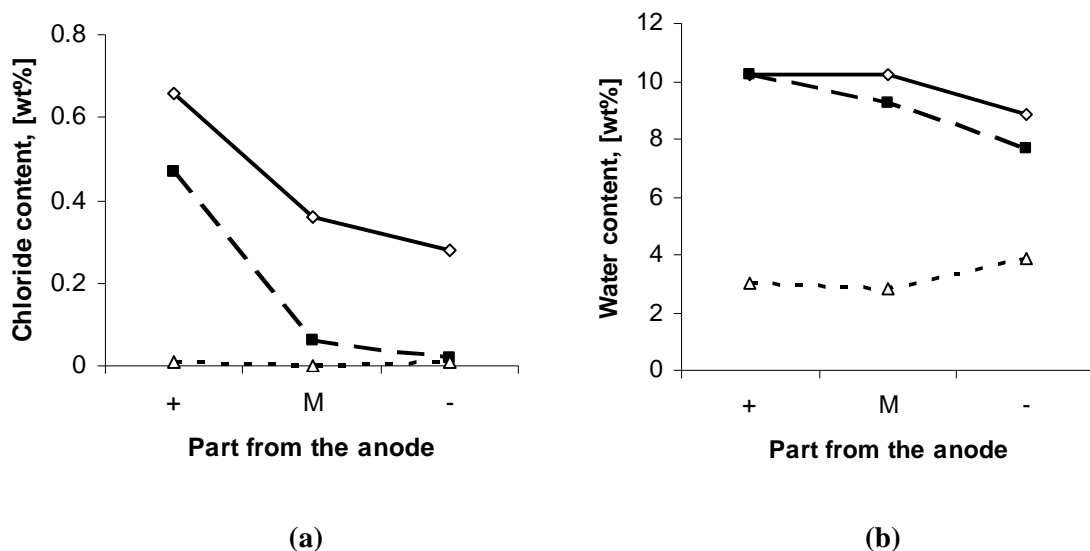
Figure 5. (a) Remaining chloride content (b) Water content after \diamond 1 week (W1) \blacksquare 2 weeks (W2) \triangle 3 weeks (W3). Each point is an average of three vertical taken samples either: below the anode (+), the middle (M) or below the cathode (-).

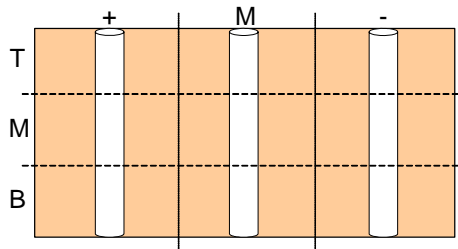
Figure 3. Sampling. Each brick was divided into 3 pieces both horizontally and vertically. The upper third closest to the electrodes is called top piece and the brick pieces just below the positive electrode is called + e.g. upper left piece is called +T.

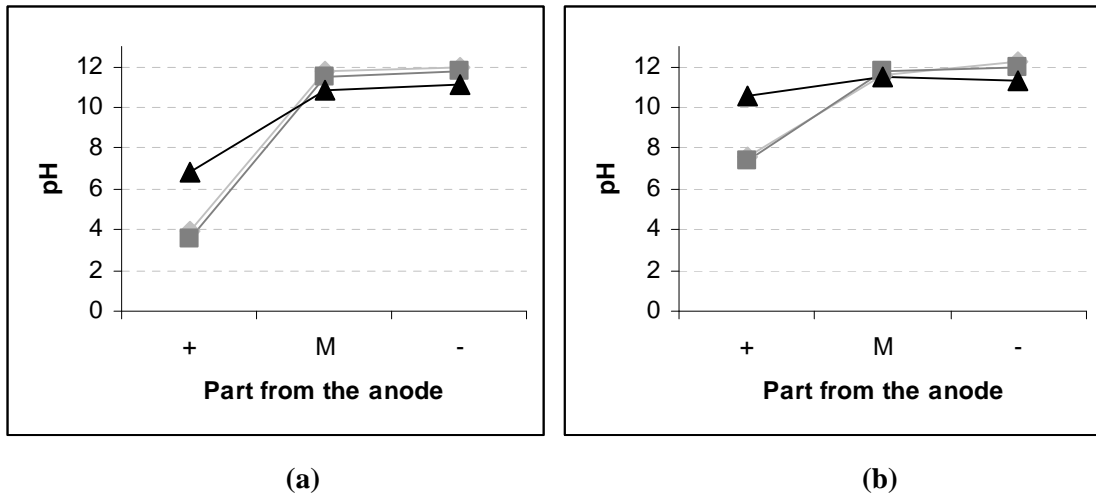
Figure 4. ♦ The upper 5 cm, top ■ the middle 5 cm ▲ and the lowest 5 cm, bottom (a). Extend of pH changes in series KK4 with no added buffering capacity at the electrodes.(b) Extend of pH changes in series CK4 with added buffering capacity at the anode. The initial pH was 8.6 +/- 0.1.

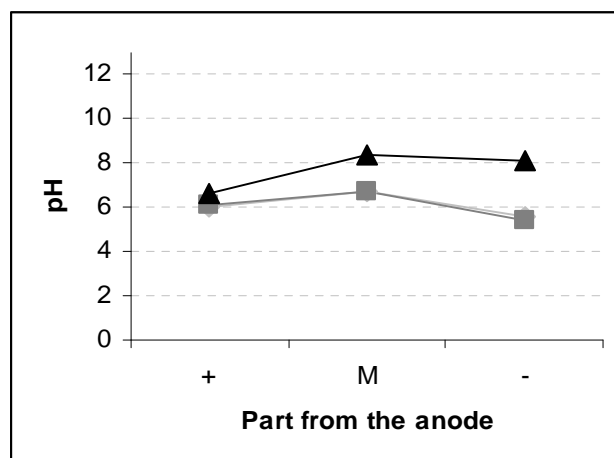
Figure 5. ♦ The upper 5 cm, top ■ the middle 5 cm ▲ and the lowest 5 cm, bottom. pH in the substrate after ended experiment CA 6 (pH control at both anode and cathode).

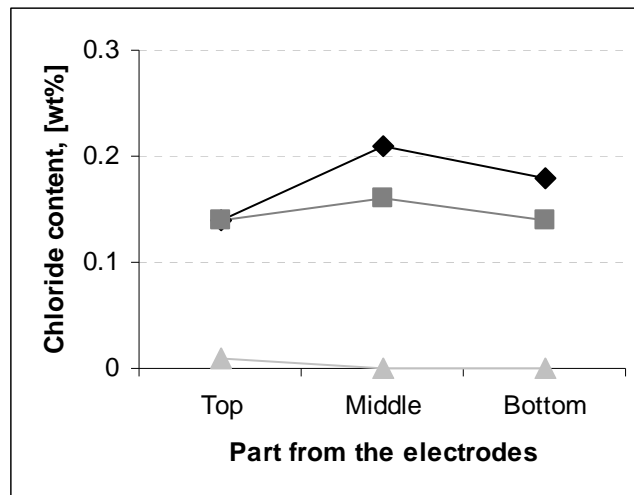
Figure 8. Remaining chloride content in the brick after ended experiment of: ◆ KK4 ■ CK4 ▲ CA6.

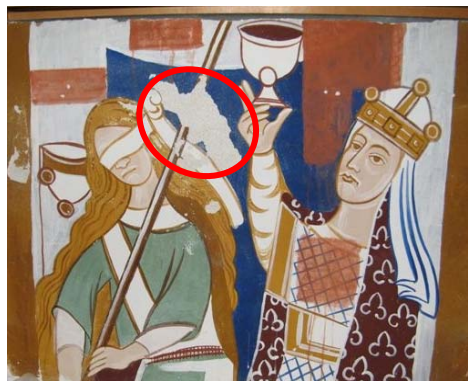
Figure 2. The wall section. Severe salt damage inside the red ring.

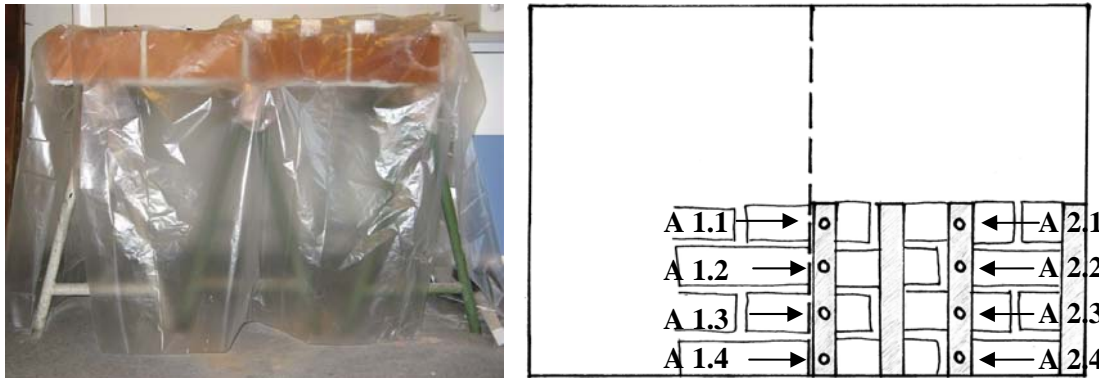
Figure 4. Left: the whole wall section and the plastic covering to minimize evaporation. Right: Numbering of the spot checks from the poultice taken above each brick (e.g. A 1.1 means anode setup one, spot check number one).

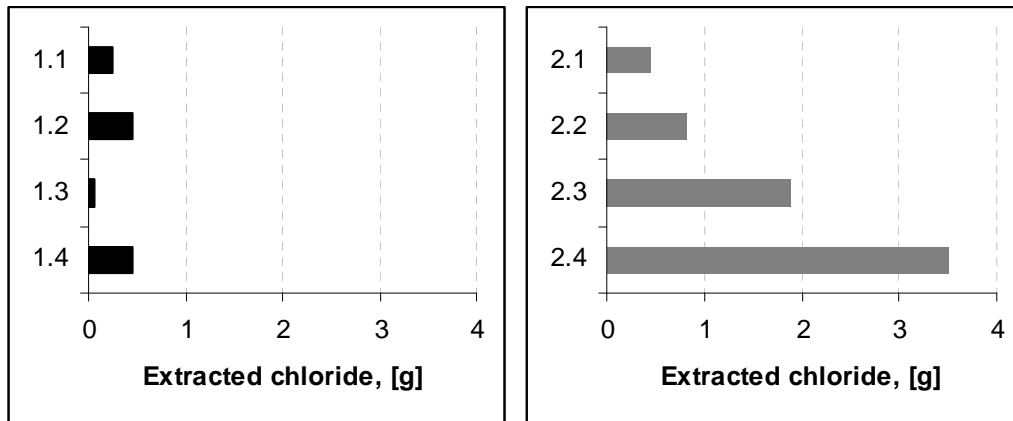
Figure 5. Accumulated chloride in the poultice by anode set 1 and 2 in each of 4 positions.

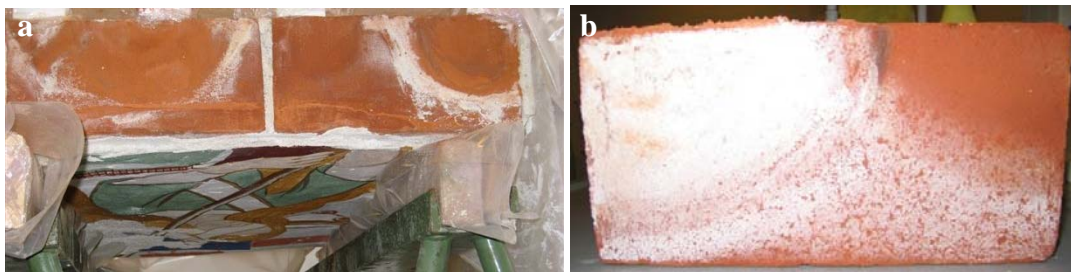
Figure 7 (a) Picture of ion movement after 2 weeks treatment crystallized as salts after evaporation, corresponding to the measured values in figure 6. (b) Similar visible salts on a single brick.

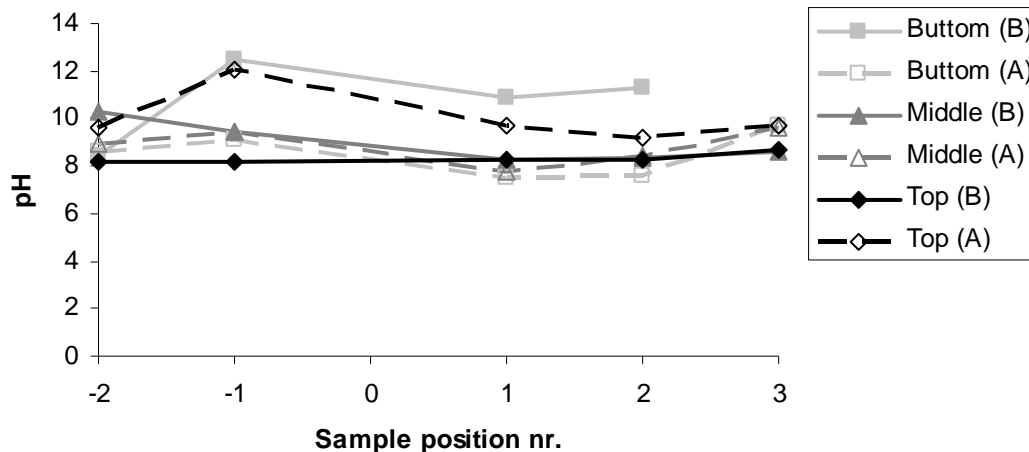
Figure 8. pH measurements at position: -2, -1, 1, 2, 3 before (B) and after (A) treatment. Sample positions below zero are from the area without an applied electric DC field contrary the sample positions above zero.

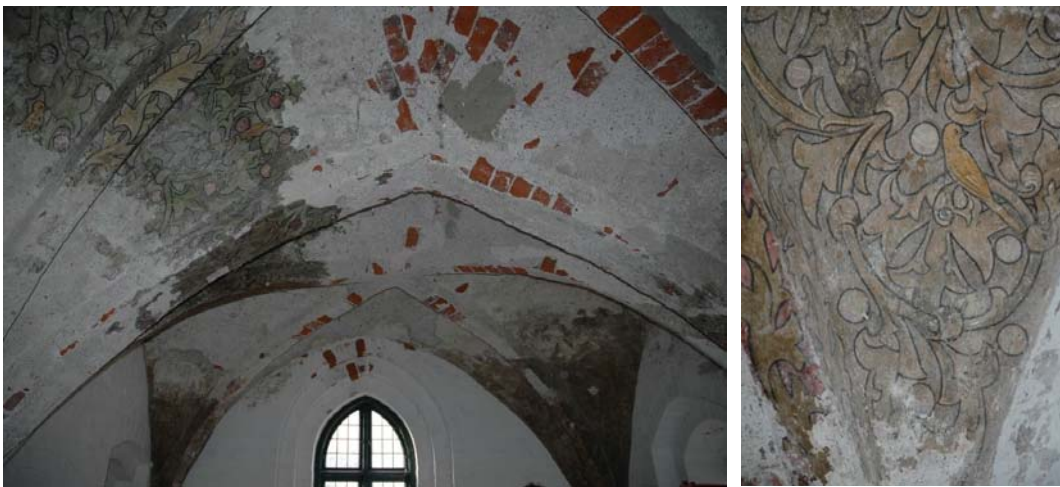
Figure 1. Extensive deterioration of the painted vault in the so-called Birds room in Vor Frue Monastery, Helsingør, Denmark. (Left) an overview (Right) a detail.

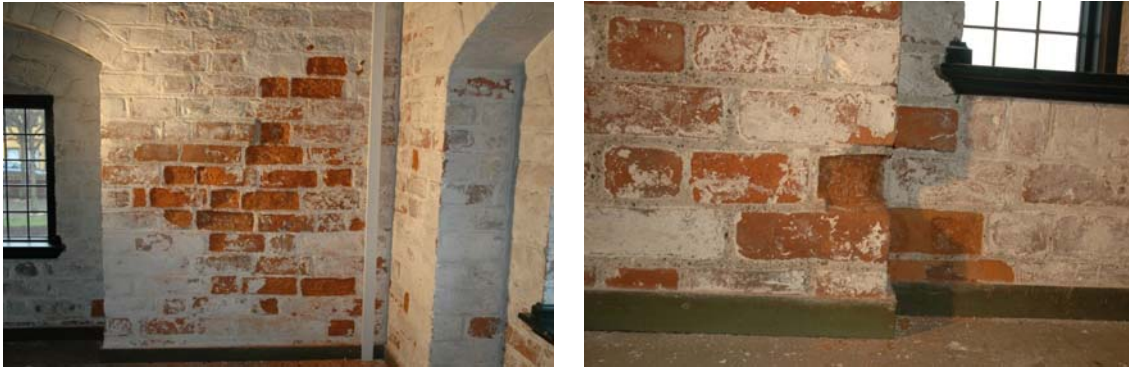
Figure 4. Deteriorated corner above the birds room. (a) Direction south-west (b) Direction north-west.

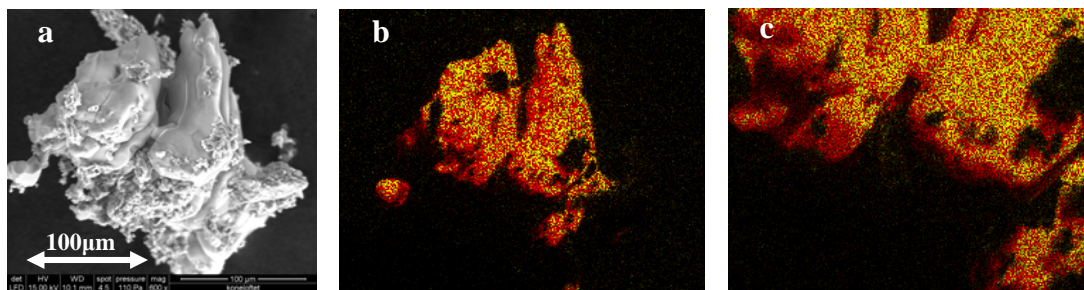
Figure 5. (a) ESEM picture of position 1.1. EDX mapping, chloride (red) and sodium (yellow): (b) in position 1.1. (c) in position 1.2.

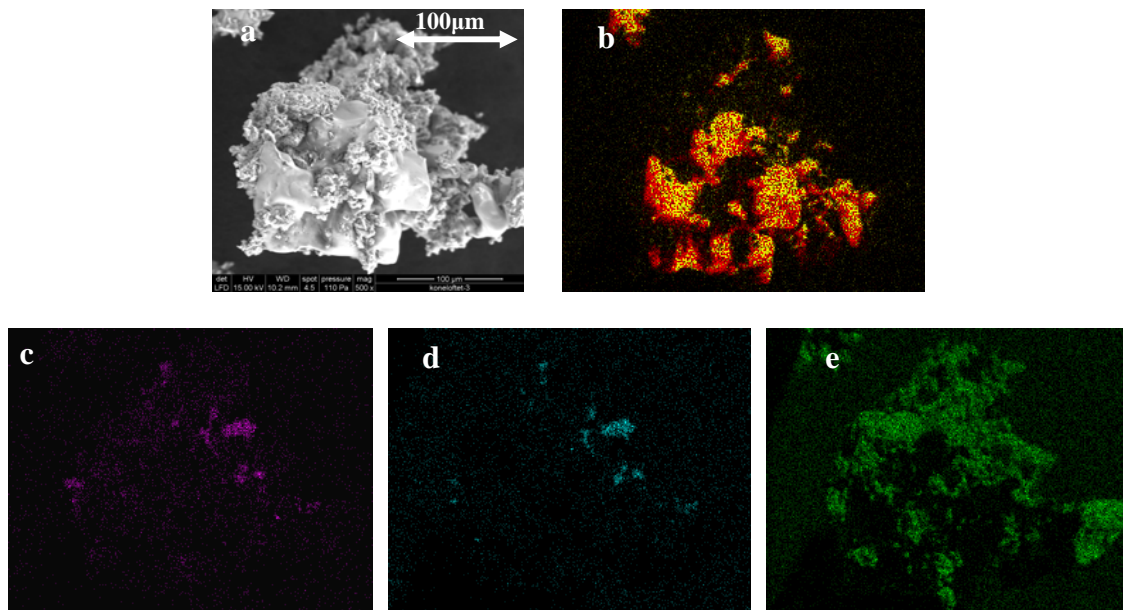
Figure 6. (a) SEM picture in position 1.3, SEM-EDX mappings: (b) chloride (red) and sodium (yellow) (c) calcium (d) sulfur (e) oxide.

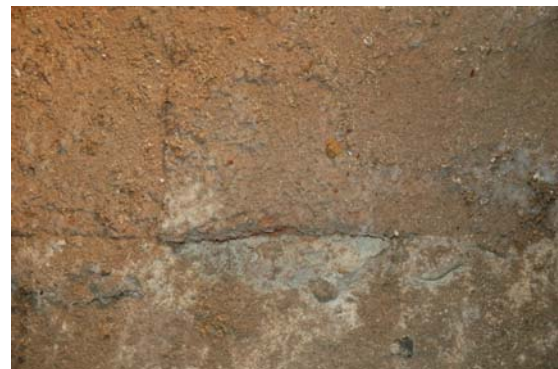
Figure 7. Visible efflorescence at the upper side of the vault.

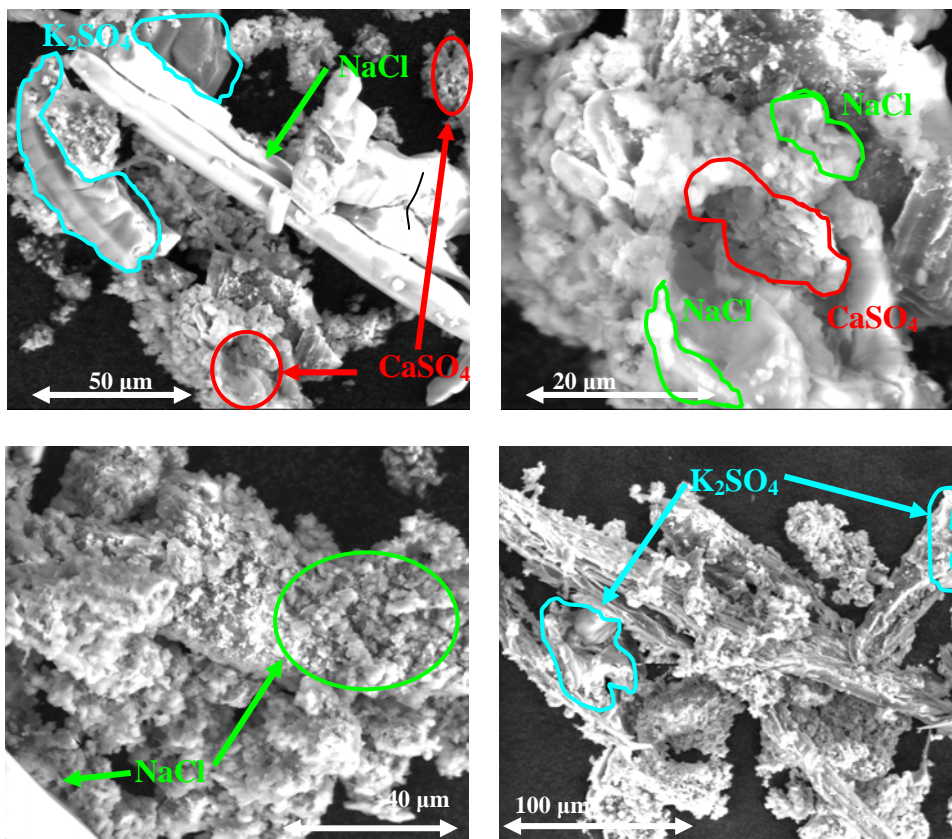
Figure 8. The salt crystal distribution and composition in four different positions. **Position 2.1 (upper left):** Long Sodium chloride crystal, smooth surfaces (dense crust) K_2SO_4 , bubbled (cuttum balls) $CaSO_4$ (S:0.5 wt%). **Position 2.2 (upper right):** Blurry salt crystals by presence of higher sulfate content (S: 3.0 wt%), outside the marked areas evenly K, Ca and S distribution was detected. **Position 2.3 (lower left):** NaCl bar at the lower left corner, evenly K, Ca and S distribution throughout the rest of the section. **Position 4 (lower right):** NaCl skeleton, two K_2SO_4 areas and the rest of the white areas where identified as $CaSO_4$.
