Preservation of murals with electrokinetic – with focus on desalination of single bricks

Ph.D. Thesis

Department of Civil Engineering
Technical University of Denmark

2008

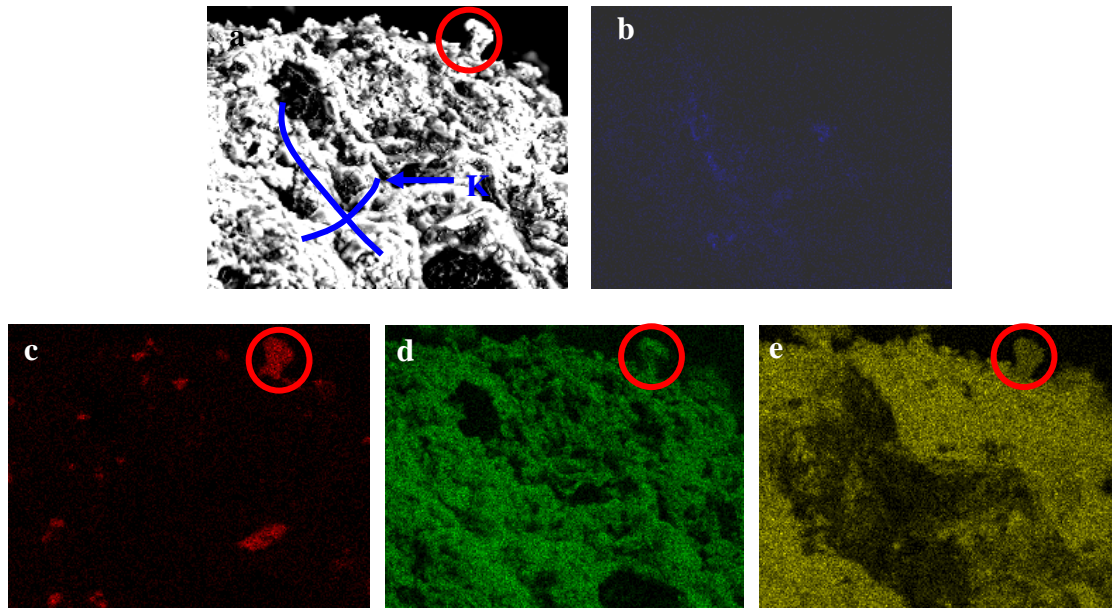
Figure 9. (a) The sample with potassium from position 3.2. Potassium is marked as the blue lines (b) potassium element distribution. Coincidence of sulfur (c), oxygen (d) and calcium (e) in some areas e.g. along the fracture and inside the red ring. The fracture is at the top of the picture.

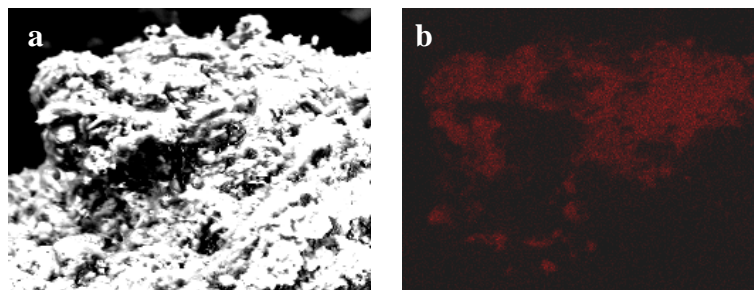
Figure 10. (a) Sample picture from position 3.1. The fracture is at the top of the picture (b) sulfur distribution.

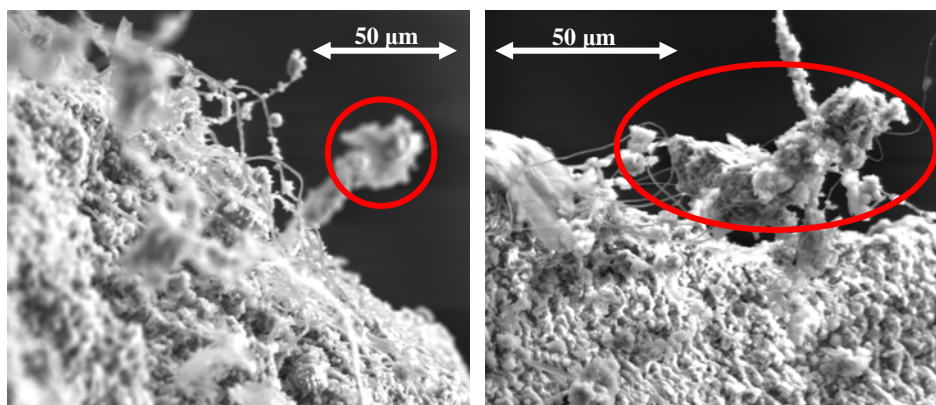
Figure 11. Position 4.1 (left) Inside the red ring a bar with a ball in the end as seen in figure 9 due to gypsum formation. Position 4.2 (right) An area is just about to be pushed of (cross section not analysed in EDX).

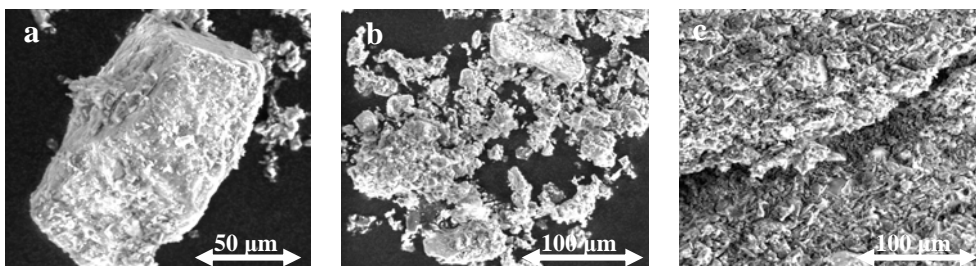
Figure 12. Three SEM pictures from the found lime piece in the windowsill. (a) Position 5.1 (b) Position 5.2 and (c) Position 5.3.

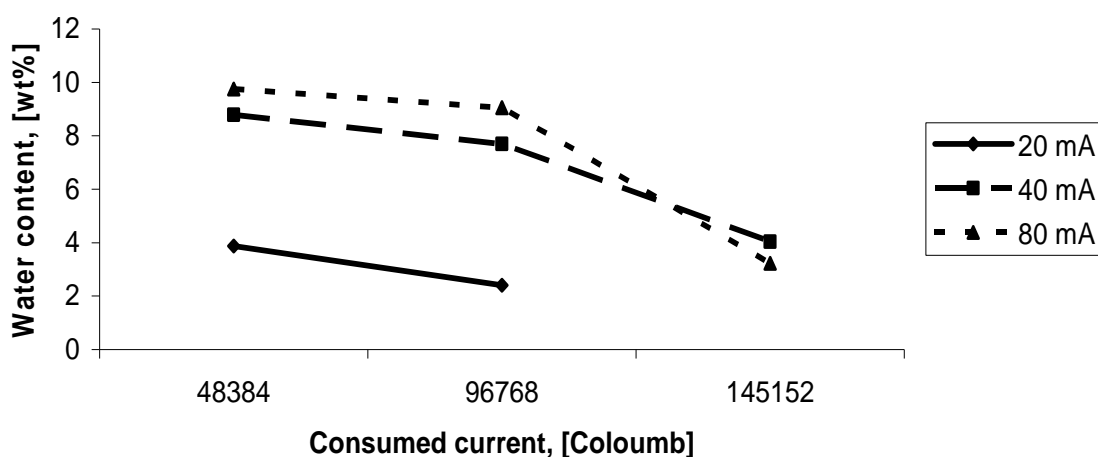
Figure 1. The influence of the duration time on the water content after the same consumed current, at the end of the experiment. The initial water content was approximately 13 wt%

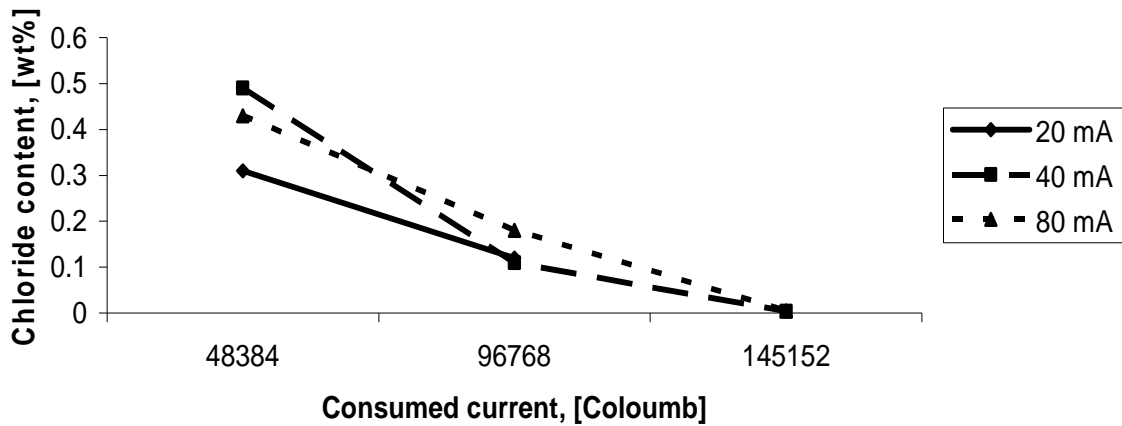
Figure 2. Remaining chloride content in the brick, as a function of current consumption. The initial chloride content was 1.0 wt%.

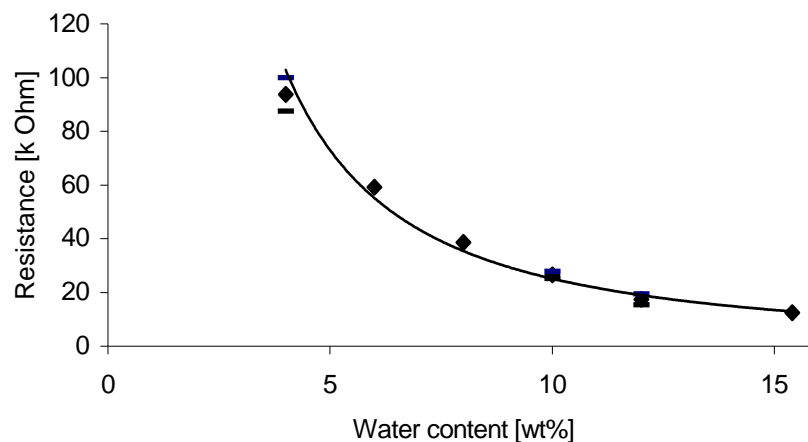
Figure 3. Measured total resistance across the brick type “Wewers red” at varying tap water contents, [Rørig-Dalgaard, 2002].

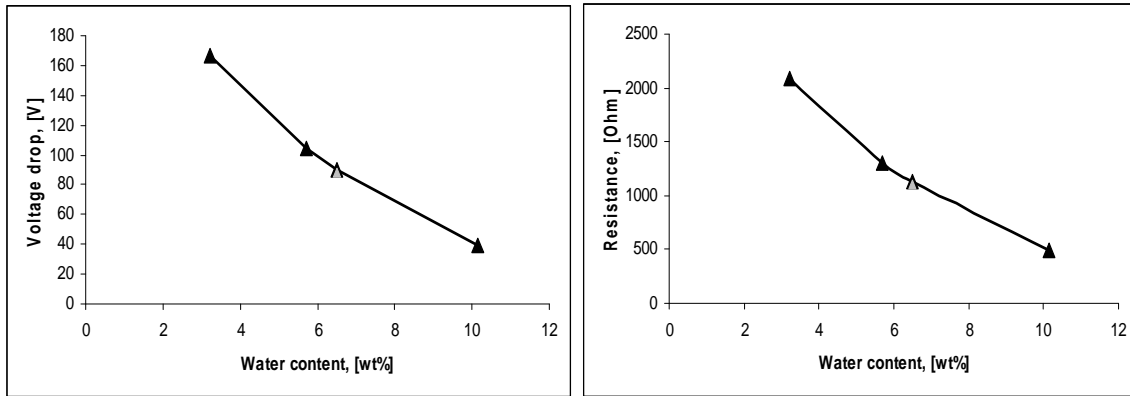
Figure 4. The coherence between final water content and voltage/resistance in Falkenløve. The gray marks are from additional measurements showing good repeatability of the results.

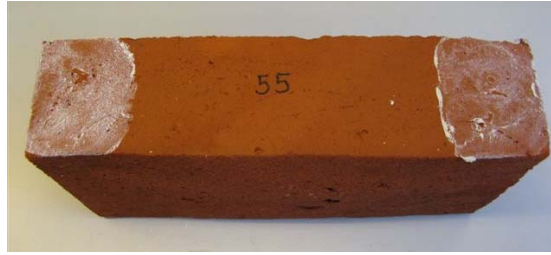
Figure 5. Brick after use of an oxide coated titanium anode. No visible discoloring from the anode. The white areas are kaolin clay and can be minimized by use of e.g. porous paper between the brick and the kaolin clay.

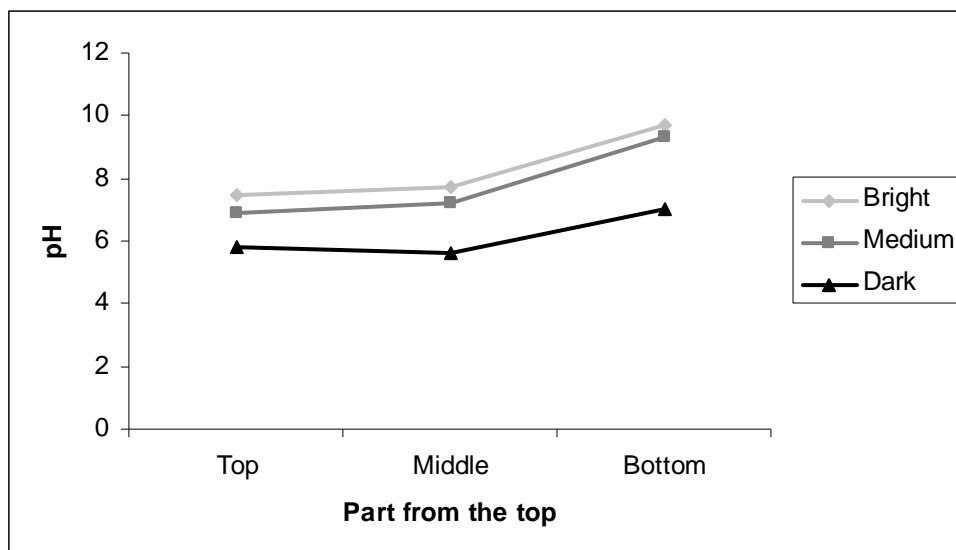
Figure 6. pH in the bricks after ended desalination treatment as a function of color (Bright, Medium and Dark) and distance to the electrodes (Top, Middle, Bottom). The initial pH was 8.5 ± 0.4 .

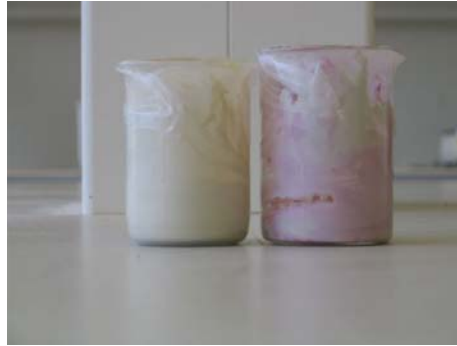
Figure 1. The acid-base color indicator change in kaolin clay from beige (left) at pH above 6.3 to red (right) at pH below 6.3.

The effect of the acid-base color indicators on kaolin clay was tried before the acid-diffusion experiments were initiated, figure 1.

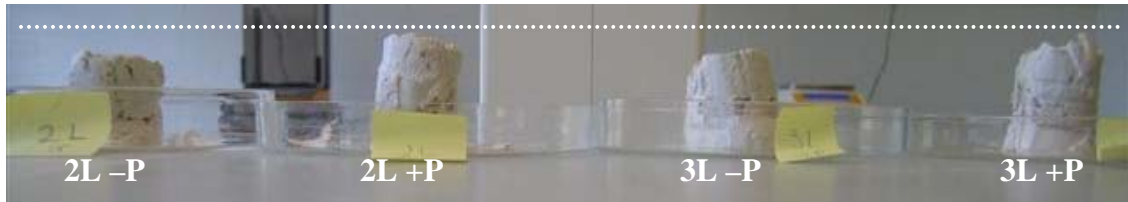
Figure 3. Visible variation in the height after ended tests (11 days). The highest volume decrease was seen left (2L-P) and the lowest right (3L+P). The dotted white line indicates the initial height, however minor visual changes happened during the plastic tubes were removed.

Air voids were present to varying extends. Such disconnections will have a negative influence on the electrokinetic treatment as air voids results in increased resistance. The total volume of the air voids were estimated for the different tests by pressing the clay together from the top and measuring the volume reduction. A reduction in the total poultice layers was seen (figure 3) and measured before the plastic tubes were removed from the clay poultice to:

- 2L -P: 1-1 ½ cm
- 2L +P: ½ cm
- 3L -P: 3 mm
- 3L +P: 1mm

Due to small color variations between the alkaline, neutral and acidic clays it was possible to see, that the volume reduction mainly occurred in the alkaline layer, most probably during the neutralization of the diffused acid. The observed differences with and without paper between the layers indicates, that direct contact between the acidic and the alkaline clay results in increased reaction between the layers.
