The Treatment of Wall Paintings affected by Salts: An Interdisciplinary Task as seen from a Conservator's Perspective

H. Leitner

Hochschule für Bildende Künste Dresden, Germany

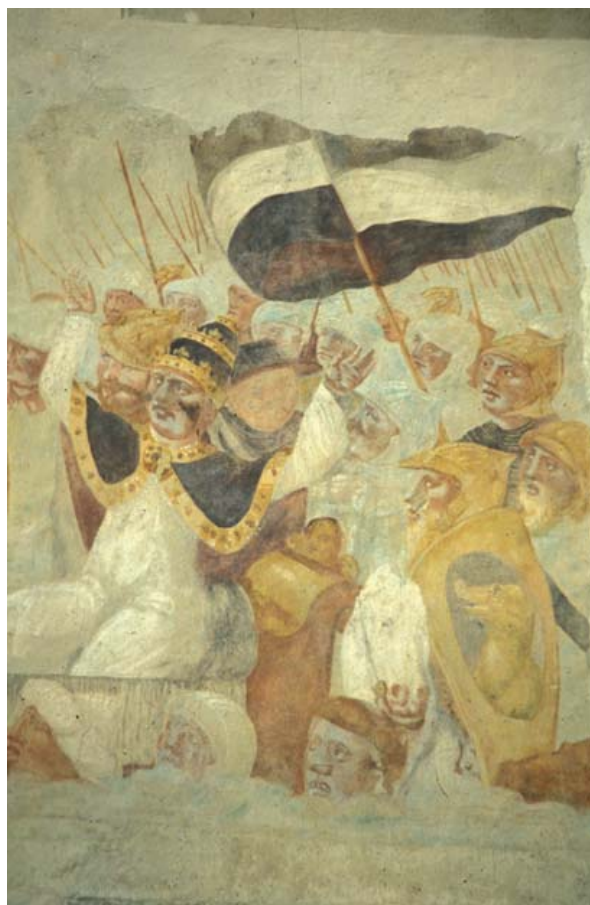
Figure 1: Façade paintings of Parz, Mosè guides his people through the Red Sea, detail representing the pope as "Antichrist".

The extensive painted façade (over 600 m²) represents a rare case of painting from the time of the Reformation movement. Due to its political subject, it was covered during the Counter-Reformation, shortly after its execution around 1580. These covering layers, applied continuously during subsequent centuries, have saved the painting from extensive damage. (Figure 1).

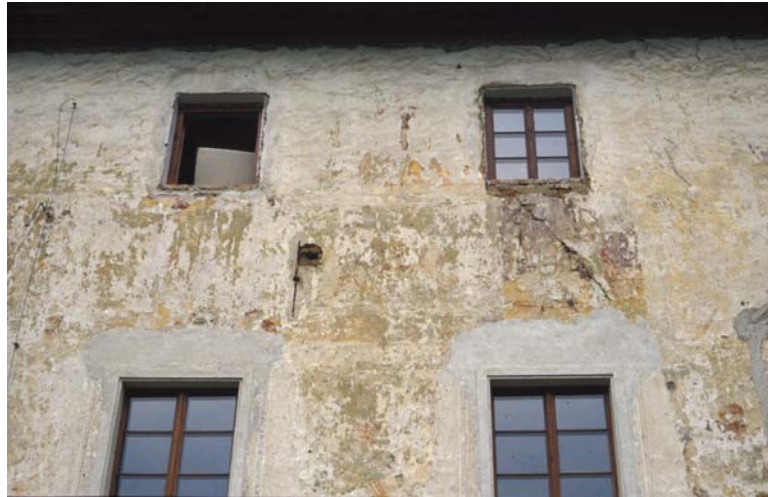
Figure 2: Facade paintings of Parz, the covering of the paintings by limewash, during the counterreformation (around 1600) was meant as destruction, but acted as protection layer. Because of lack of maintenance the covering limewash layers have been partly fallen off by the weathering activity exposing the paint layer. The dark areas indicate a heavy sulfatation.

However, lack of maintenance during the 20th century resulted in the weathering of the covering layers and the partial exposure of the painting. Due to its location, climatic conditions and air pollution, the painting was at extreme risk of sulfation (Figure 2-4).

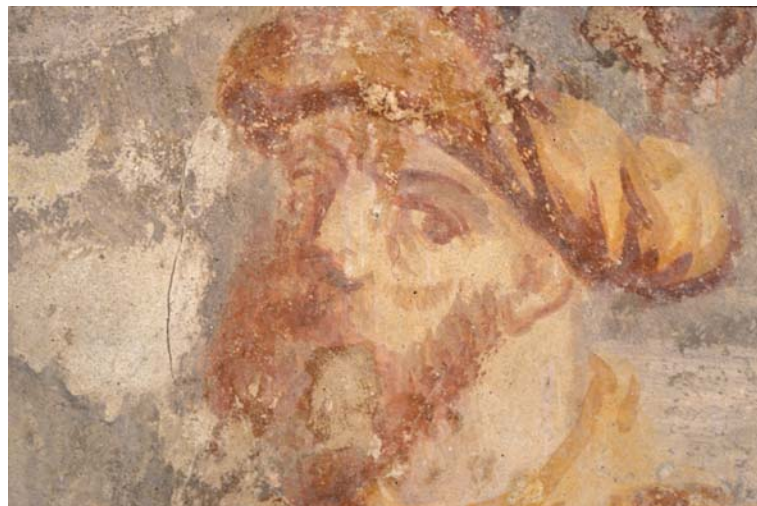
Figure 3: Facade paintings of Parz, detail of sulfatated area with progressive corrosion

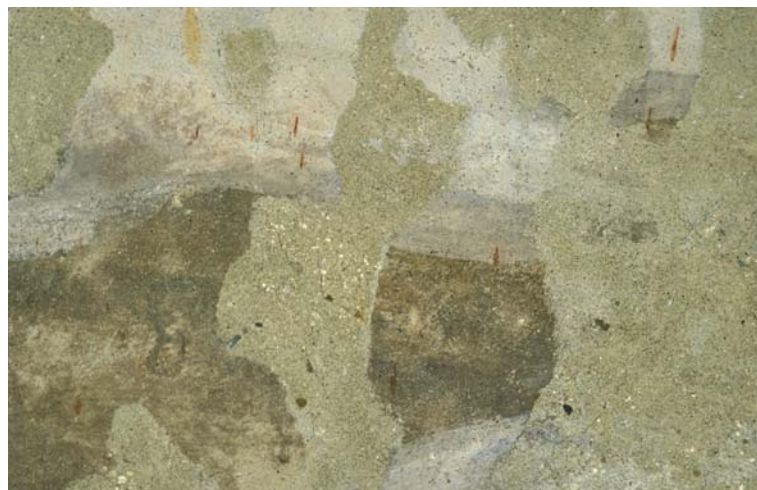
Figure 4: Facade paintings of Parz, detail with complete loss of the painted surface corroded into the plaster-layer

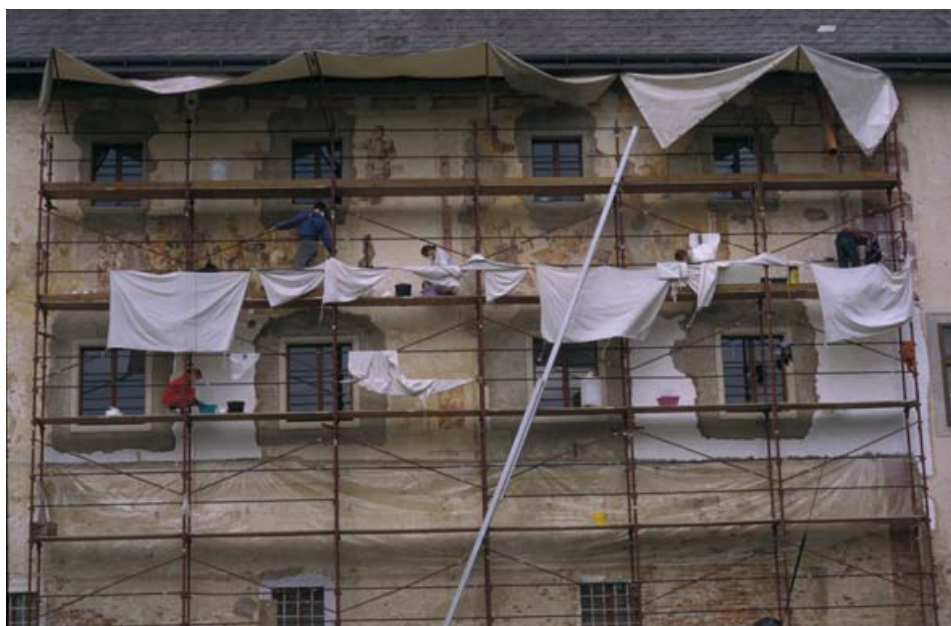
Figure 5: Facade paintings of Parz, during the application of the Florentine treatment

veloped in the 1960s by the Florentine scientist Enzo Ferroni. This new treatment concept introduced the application of ammonium carbonate solution as the first step, followed then by the Bariumhydroxid treatment. The practical application of this theoretical concept—converting the calcium sulfate to barium sulfate, while at the same time producing barium carbonate and calcium carbonate—was only possible with the development of a specific application technique by conservator Dino Dini. He introduced the reactive materials by means of cellulose pulp poultice. The positive results by this technique over the last 35 years are the consequence of a fruitful collaboration between scientist and conservator.

The application of this method on the paintings of Parz was carried out in close collaboration with the staff of the Opificio delle Pietre Dure, comprising both scientists (Mauro Matteini and Arcangelo Moles) and a conservator (Sabino Giovannoni). Local knowledge about the object itself, combined with the experience of the Florentine specialists

provided the possibility to develop a specific application technique for the object with all its individual characteristics (painting technique, specific local climate, condition of the painting, etc.). In particular, the variables in the methods of application (devised on the basis of specific experiences of the conservator) were essential for a positive result in consolidating the surface to the extent that now, after more than ten years after the intervention, it

can still be characterized as unchanged.¹ (Figures 5-6).

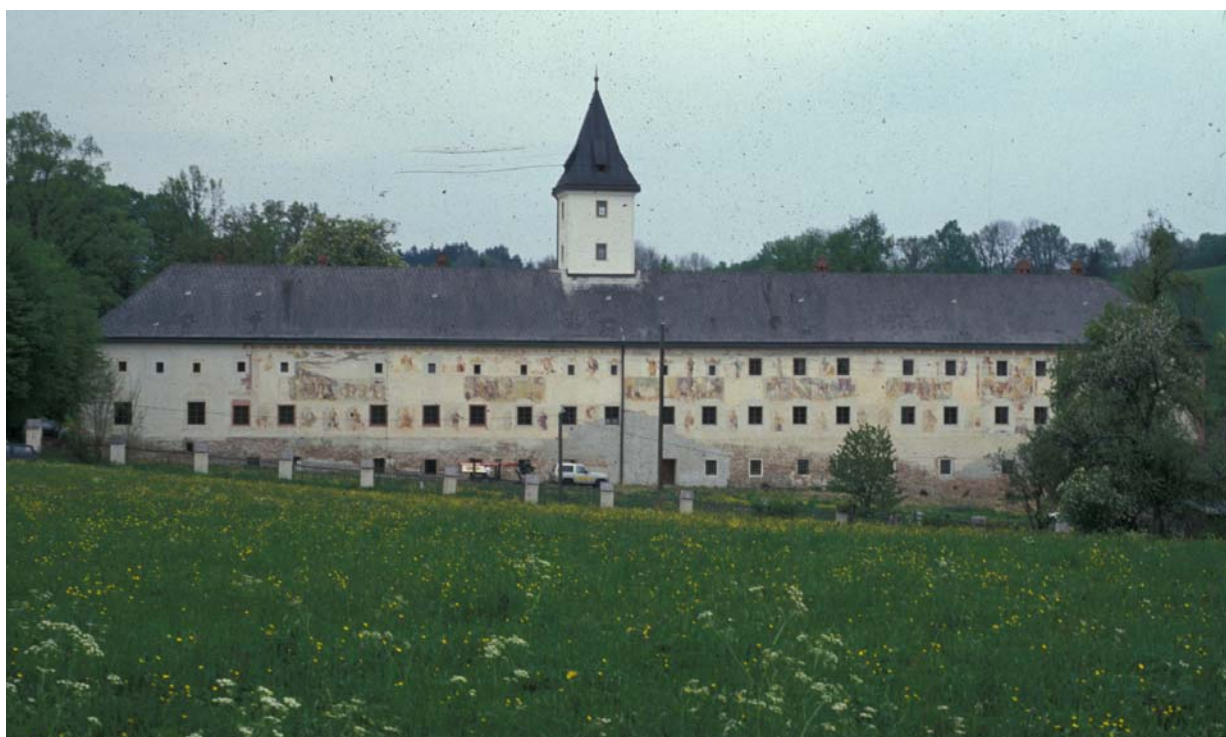
Figure 6: Facade paintings of Parz, general view after the treatment of the remaining painted areas

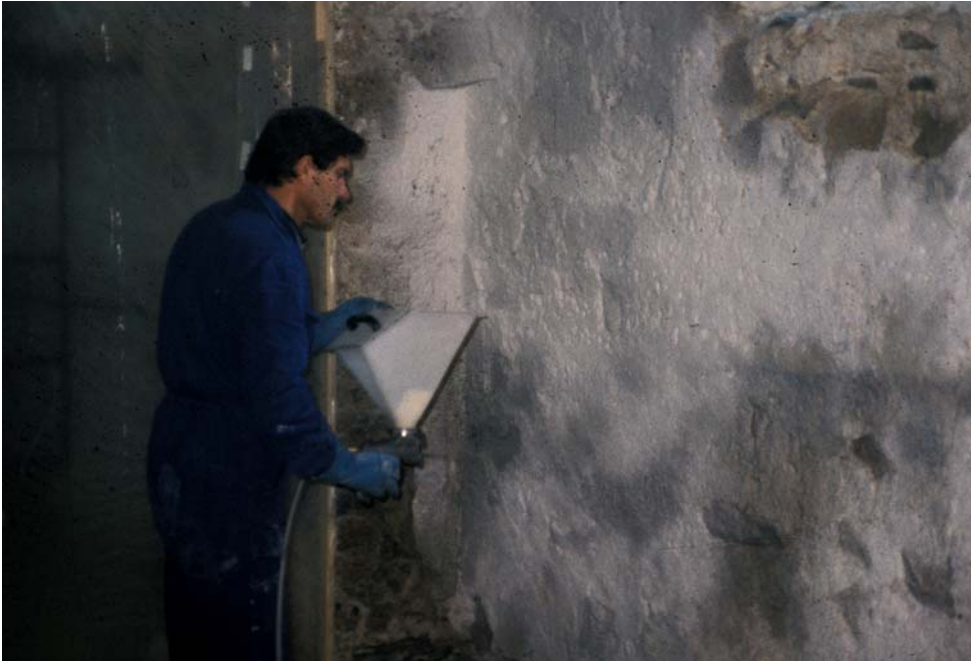
Figure 10: St. Georgen, salt reducing treatment

However, the lower part—presenting all the problems due to rising damp and salt activity—required further interventions. A first intervention of reducing the soluble salt content was executed by the application of a long-term cellulose pulp poultice applied with deionized water. The poultice,

consisting of Arbocel BWW 40, was sprayed on the surface to a height of about 3.5 m, with a thickness of about 3 mm, in order to achieve some salt reduction (Fig.10, 11).

This poulticing technique was developed some years before and used quite often in Austria, even though the results and the actual functioning of this method were not yet clear. Because of this lack of assessment of this empirical treatment, it was decided to investigate it further with help from a scientific team. Therefore, after drying, a grid was drawn on the poultice, dividing it into squares of 50 cm. These squares were removed individually;

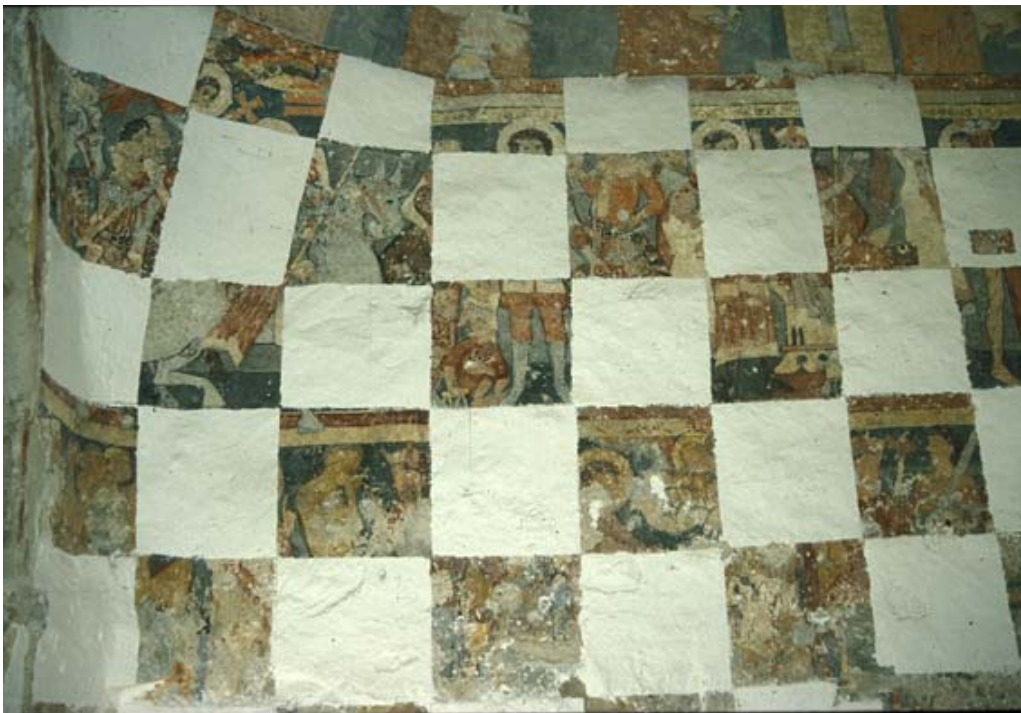
Figure 11: St. Georgen, during the removal of the salt reducing poultice

the intention was to be able to analyze the amount of relevant salt ions taken up by the poultice squares in relation to their positions on the wall. The methodology and results of these procedures were presented in a paper by the responsible scientist in 1993 [2].

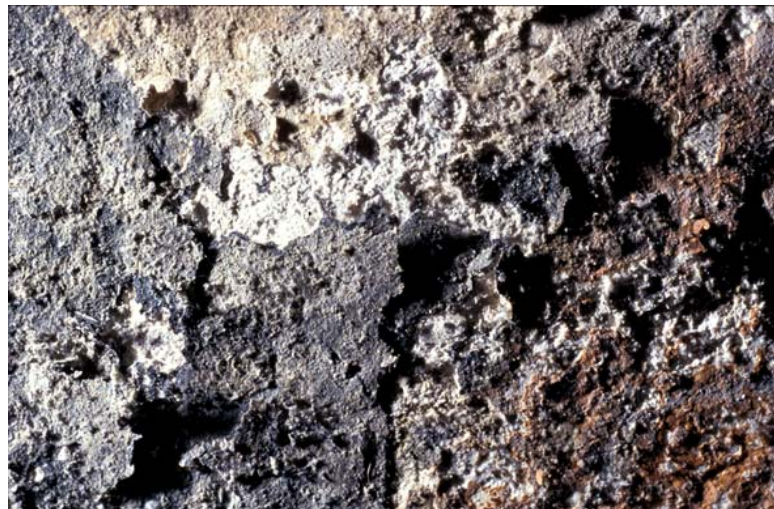
Figure 12: St. Georgen, scaling of the paint layer by the dynamic of salt crystallization

fully investigated and revealed new flaking phenomena in some areas of the northern wall connected with salt efflorescence (Fig. 12). The affected zones were at a level of approximately 2.5 m from the ground, and the salts proved to be mainly magnesium sulfate, in a whisker-like form, while on the reverse of the flakes this salt was accompanied by gypsum. The gypsum also crystal-

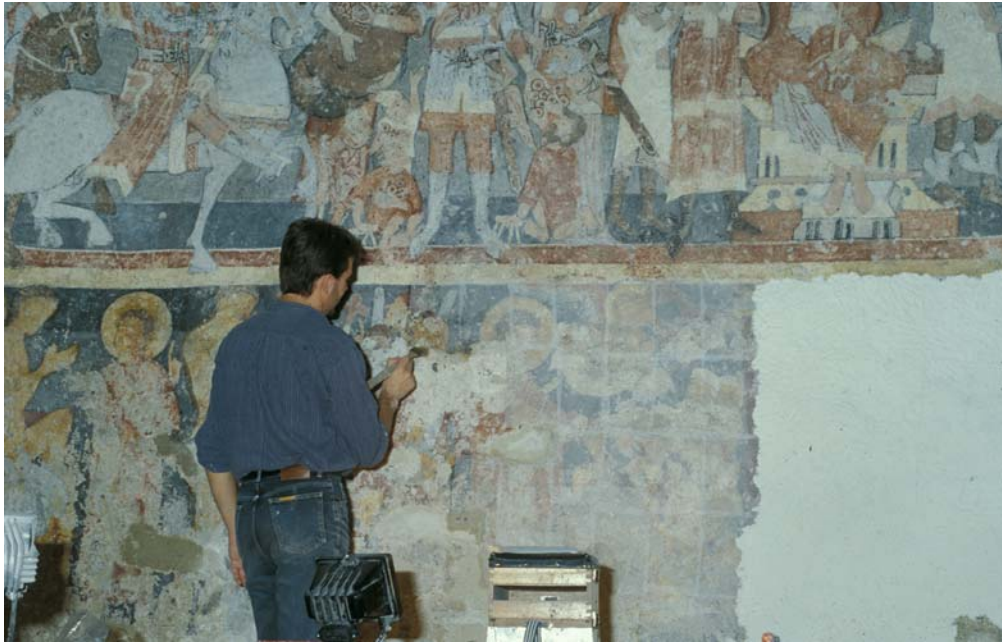
Figure 14: St. Georgen, steps of treatment with ammoniumcarbonatsolution and barium hydroxide

- Areas of flaking paint with preparation layer were re-adhered using silicate ester; a fast hydrolisation was obtained by the use of lithium waterglass.
- Surface incrustations and pustules of gypsum were reduced by the use of an anionic ion exchange resin, applied through Japanese tissue and cleaned off with deionized water. Up to this stage a minimum of water was introduced.
- The next step was to apply a poultice of cellulose pulp mixed with barium hydroxide as preconsolidation. The poultice with a 7 % solution of barium hydroxide was applied over Japanese tissue and removed after

8 hours. This step was first applied to a limited area of minor importance. Analyses and control of the reaction were verified using SEM.

- This poultice application using a low concentration of barium was successful as a preconsolidation and provided sufficient resistance to allow the application of a subsequent poultice with ammonium carbonate (20 %).
- Following analytical control of the effect (using SEM) and a waiting time of two weeks, the area was once more treated with a barium hydroxide poultice (15 %).

The situation after these consolidations—by transforming the gypsum into the insoluble barite and introducing additional barium carbonate—gave a satisfying result (Fig. 14).
