Field and Laboratory Investigations to Examine the Damage Category of Monumental Sandstone in Arid Regions: Seti I Temple, Upper Egypt; a Case Study

G. M. E. Kamh¹ and R. Azzam²

Abstract

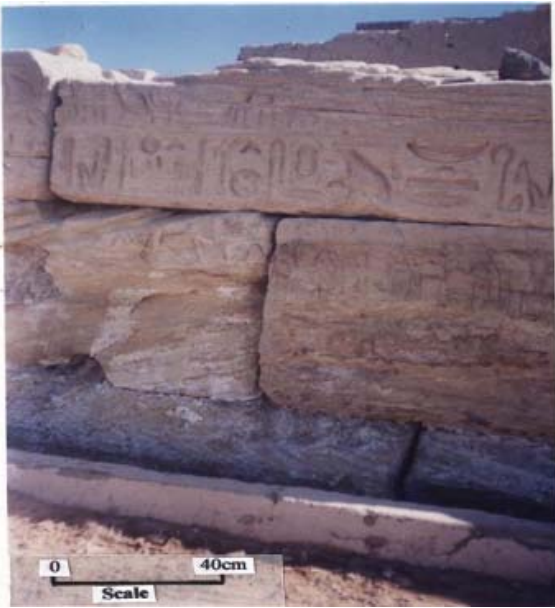
Figure 4: Severely weathered sandstone basal courses at West facing wall side of the first pylon (parts of investigation numbers 1 and 2), Seti I Temple.

All result in a conclusion that damage category at some parts of Seti I Temple reaches up to severe and very severe damage (as areas including parts number 1, 2, 3 and 4 regarding granular disintegration that ends by obliteration of engravings and clearing out of stone components, table 2) and down to slight and very slight damage category (as areas including parts number 5, 6, 7, 8 and 9 regarding break out and fissures, table 2). The overall damage category for this temple based on field investigation considering all weathering forms is found to be very severe damage category (Fig. 10).

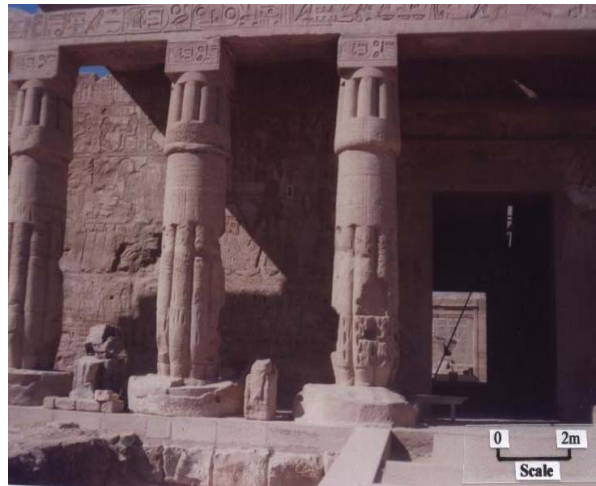
Figure 6: Moderately weathered East facing wall side of the Temple (parts of investigation numbers 5 and 6).

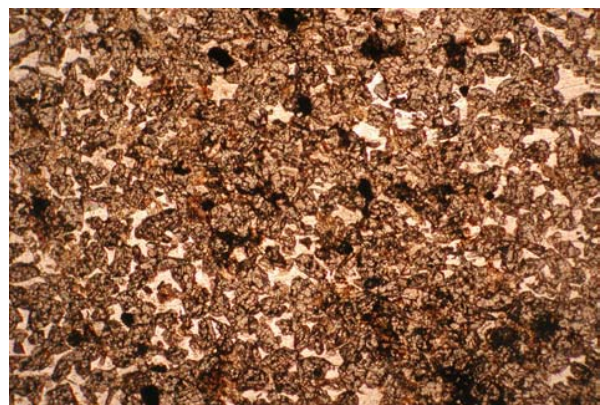
S.S. (40x mag., plane polarized light)

Figure 12: Thin section photo-micrograph presenting rock texture of fine grained sandstone of Seti I Temple.

It has been conducted for the sandstone samples collected from Seti I Temple using a transmitting polarizing microscope. It revealed that this sandstone has arenite texture of quartz arenite to arkose in composition. It is light brown spotted sandstone as noted at the study area and it is very similar and highly matching sandstone type 1 of Gebel El-Silsila. The sandstone blocks in this temple are heterogeneous regarding grain size as examined and measured by a graticule eye-piece at the same magnification power using a transmitting polarizing microscope. One type has quartz grains moderately sorted, sub-rounded to sub-angular with an average grain size of 0.25 mm (i.e. medium size sandstone), mostly with point contacts and few with grain contacts. Silica overgrowth can hardly be noted on some quartz grains. Its average pore size is 0.18 mm, mostly as inter-connected pores of irregular shape involving brown color spots of iron oxide (Fig. 11). The other type of sandstone constituting Seti I Temple has also arenite texture, its quartz grains have an average grain size of 0.11mm i.e. fine grained sandstone, moderately to well sorted, point grain contacts dominates, noticeable porosity with concentric to irregular shape pores having an average diameter of 0.07 mm involving dark brown iron oxide spots (Fig. 12).
