# Salt-induced flaking of wall paintings at the Mogao Grottoes, China

Lori Wong<sup>1\*</sup>, Su Bomin<sup>2</sup>, Wang Xiaowei<sup>2</sup>, Amarilli Rava<sup>3</sup> and Neville Agnew<sup>1</sup>

<sup>1</sup> The Getty Conservation Institute, USA

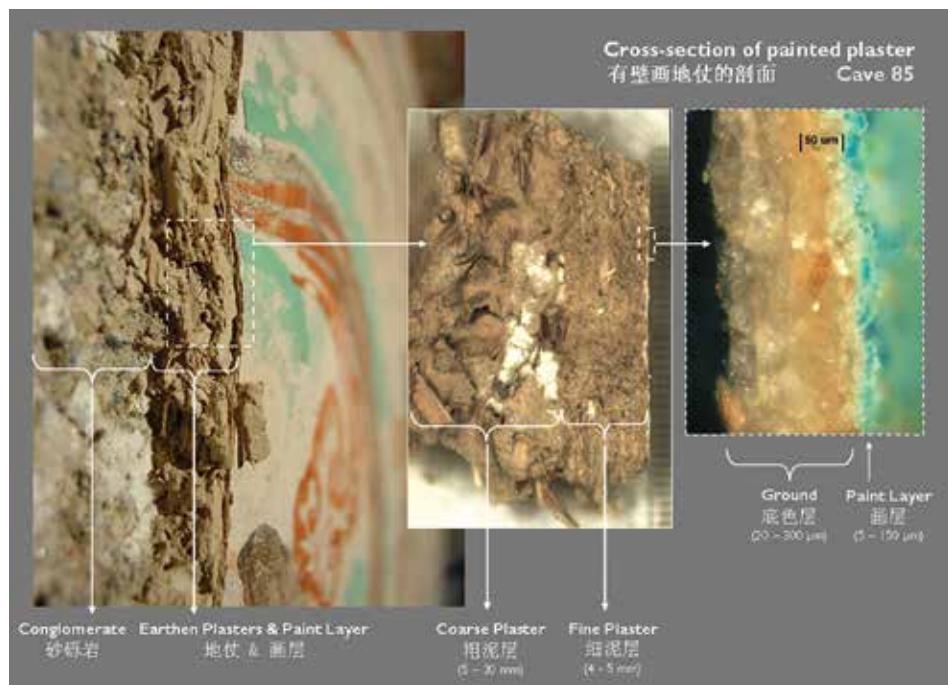
Figure 3: Stratigraphy of the painted plaster in Cave 85.

excavated, the roughly carved rock walls and ceilings were plastered and smoothed with a coarse leveling plaster of variable thickness (5-30 mm) and finished with a fine plaster (4-5 mm) (*Figure 3*). The composition of the plasters were found to be a close match to the riverbed silt from the Daquan River that runs through the site with additional sand and plant fibers mixed in to prevent shrinkage and cracking. The plasters are bound with clay and contain 19% clay-sized fraction including illite, chlorite and the mixed-layer mineral, illite/smectite.<sup>1</sup>
