Drying of porous building materials possibly contaminated with soluble salts: summary and findings of the DRYMASS research project

The DRYMASS project aimed at improving the current understanding of drying and of how soluble salts can influence it. It also had the objective of verifying if drying can be accelerated by means of surface layers such as coatings, which would be of high technical interest for conservation.

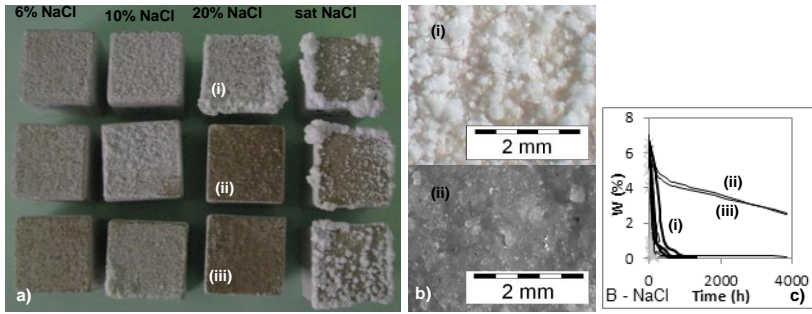
Figure 1: Decay patterns and drying kinetics of Bentheimer sandstone with NaCl solutions of different concentration: (a) vitreous salt crusts were observed on two out of three specimens tested with 20% NaCl solution; (b) details of the two types of efflorescence obtained with the 20% NaCl solution; (c) drying curves showing that the vitreous NaCl crusts on specimens (ii) and (iii) correspond to a much slower drying kinetics.

The results of drying test c revealed two main facts: (i) the higher the salt concentration the slower the drying, which agrees with what is usually observed in practice and in lab; (ii) some isolated specimens arbitrarily deviated from the general behaviour, depicting even slower drying kinetics (Figure 1). The arbitrary deviations in drying kinetics correspond to (also apparently random) variations in the morphology of the efflorescence formed during drying (test d), as also seen in Figure 1.

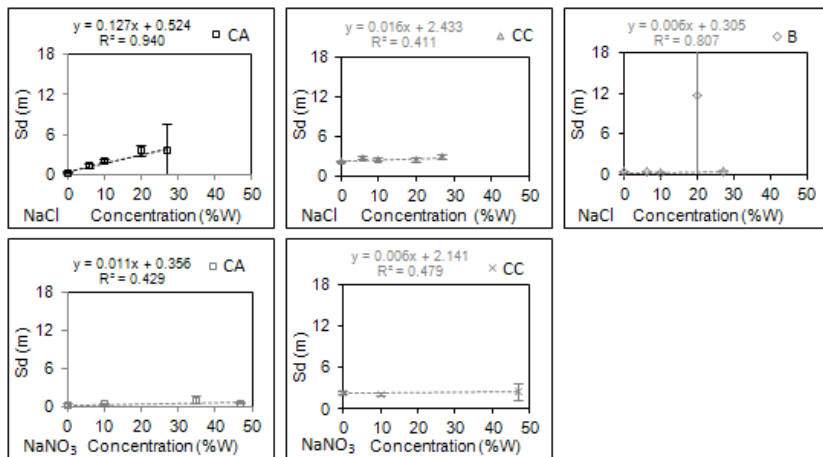
Figure 2: Equivalent air layer thickness (S_d) of the efflorescence-covered specimens as a function of the initial concentration of the salt solution [5]

The results of the vapour conductivity test (test e) are given in Figure 2 in terms of equivalent air layer thickness S_d . As seen, the S_d of the efflorescence-covered specimens is, in most cases, similar to that of the blank specimens. This means that no significant blocking of vapour transport by the efflorescence took place in these cases.

By crossing these results with those of test d, it was verified that the deviant drying kinetics correspond to dense salt deposits, namely the mentioned vitreous NaCl crusts formed on Bentheimer specimens ii and iii (Figure 1) and compact NaCl efflorescence formed on the Ançã specimens [5]. The rest corresponds to porous efflorescence. Therefore, it was concluded that only dense salt layers effectively hinder the transport of vapour.

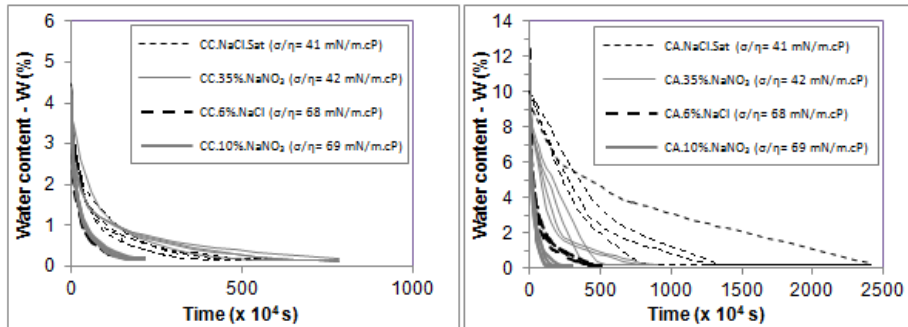
Figure 3: Drying kinetics, for solutions with similar σ/η ratio, of specimens depicting either: (i) only porous efflorescence (on the left, CC stone); (ii) porous efflorescence and compact salt crusts, respectively (on the right, CA stone) [5]

In fact, when the efflorescence present on the surface was porous and, therefore, had no relevant blocking effect in relation to vapour transport, the drying kinetics is similar for solutions with similar σ/η ratio (Figure 3, on

the left). This indicates that, in these cases, the differences in drying kinetics are due to the changes salts induce on sorptivity.

Differently, when compact salt crusts which hinder vapour transport are present, there is an additional decrease in drying kinetics, as seen for the CA limestone with NaCl (Figure 3, on the right). This indicates that compact salt crusts can further slowdown the drying kinetics.

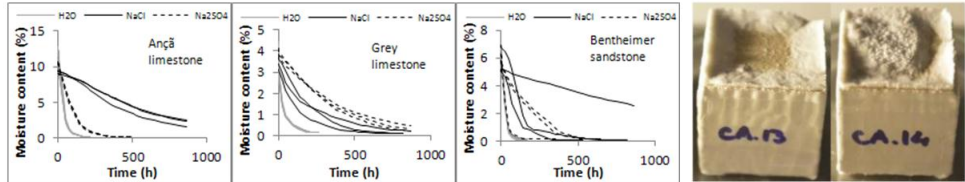
Figure 4: On the left: drying kinetics of the three tested stones. On the right: variation in the decay patterns of two specimens of Ançã limestone tested simultaneously and under similar conditions with saturated NaCl solution [7]

This kind of uncertainty was observed also in a second experimental study of the project carried out with NaCl and Na₂SO₄ [7]. Figure 4 shows some of the results. As seen, the drying kinetics are not only slower, but also more irregular showing higher dispersion for the salt solutions than for pure water. Also, it sometimes diverges among specimens of the same material subjected to similar experimental conditions. These chaotic features [14] are in agreement with the decay patterns and suggest that soluble salts amplify the effects of the natural heterogeneity of porous materials.

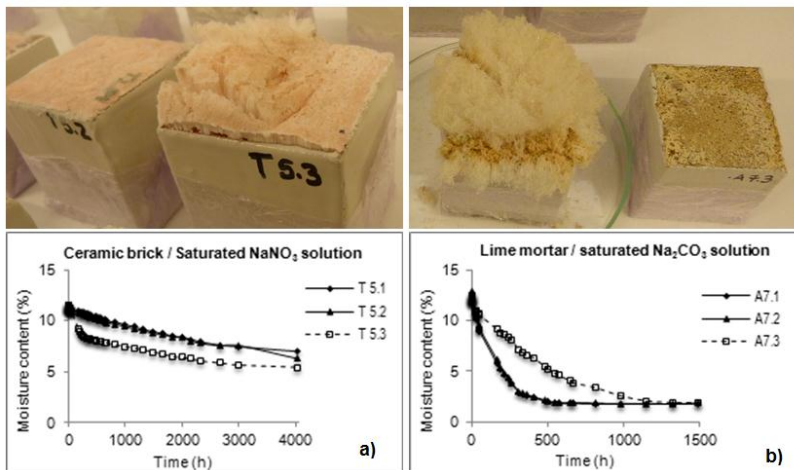
Figure 5: Variations in the decay patterns and drying kinetics of brick and mortar laden with NaNO₃ and Na₂CO₃: (a) one brick specimen depicted fluffy efflorescence while the other two developed compact salt crusts and had slower drying kinetics; (b) two lime mortar specimens showed abundant efflorescence that caused material disintegration and was accompanied by faster drying kinetics, while the other did not [8].

Figure 5 shows variations in the decay patterns and drying kinetics of brick and mortar with NaNO₃ and Na₂CO₃.

This figure illustrates that also in this study the degradation patterns varied occasionally for similar materials subjected to the same experimental conditions. And, again, the drying kinetics varied accordingly: in this case, the more altered the material the faster the drying.

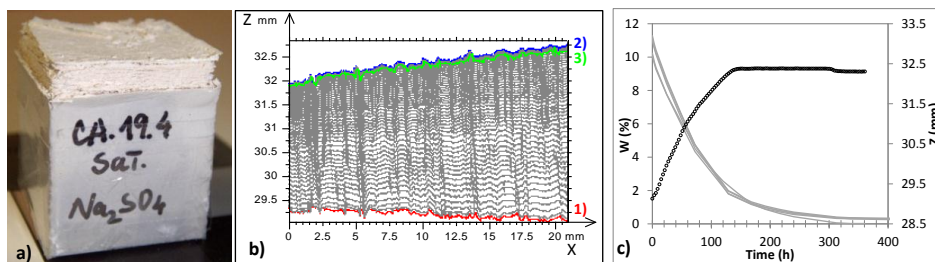
Figure 6: Delamination of Ançã limestone: (a) image of a test specimen at the end of drying; (b) topographic profiles obtained every 3 h during drying: 1) first profile; 2) uppermost profile after 305 h of drying; 3) last profile after 320 h of drying; (c) alteration kinetics curves in black, and drying kinetics curves in grey [6]

The results showed that, under these less radical conditions, Na_2SO_4 can develop decay patterns similar to those observed in buildings. Ançã limestone, for example, developed a typical delamination pattern (Figure 6). As shown, the alteration process was successfully monitored by optical profilometry and, afterwards, characterized by the alteration curve [6].

NMR experiments showed that the Na_2SO_4 phase causing the damage seen in Figures 6 and 7 was mirabilite [9]. Indeed, the two Na_2SO_4 hydrated phases, mirabilite and the metastable heptahydrate, can form under a wide range of conditions, including the present (20°C / 50% RH).

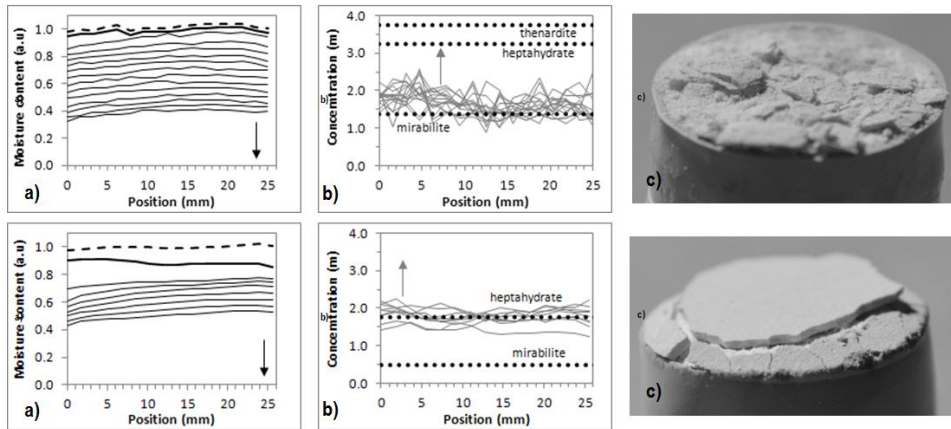
Figure 7: NMR-monitored drying experiments on Ançã limestone specimens at 20°C / 50% RH (left) and 7.5°C/0% RH with pre-heating (right): (a) moisture profiles, (b) ion concentration profiles, (c) test specimens after the experiment [9]

The conclusions were that both mirabilite and heptahydrate can be responsible for this type of decay, as seen in Figure 7. The heptahydrate tends to crystallize first when there is no previous presence of mirabilite crystals in the porous material [9].

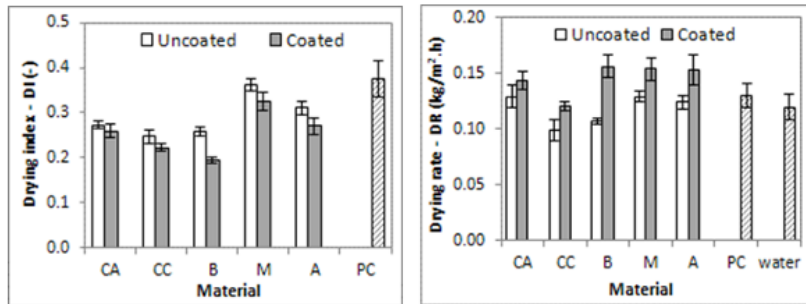
Figure 8: Results of the drying test with pure water on lime coated materials given in terms of: drying index (on the left) and Stage I drying rate (on the right) [7]

The results obtained with pure water were extremely interesting. They showed that the lime coating not only does not hinder drying, but it is also able to accelerate it (Figure 8).

The increase in drying rate was very significant under Stage I conditions (Figure 8, on the right), i.e., when the moisture content of the substrate is high, as it often happens at the base of walls suffering from rising damp. It has, therefore, nothing to do with the vapour permeability of the coating, because during Stage I the drying front is at the surface of the material.

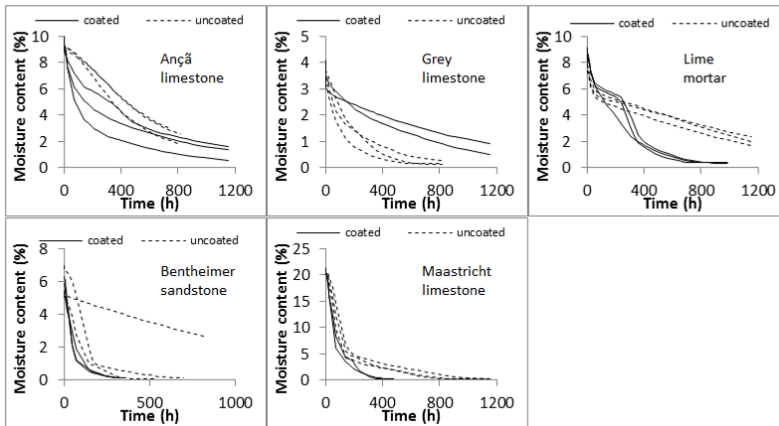
Figure 9: Drying kinetics of coated and uncoated materials contaminated with NaCl [8]

As seen in Figure 9, the coating can still, in few cases, enhance drying when soluble salts are present. However, in comparison to pure water, the drying kinetics are slower. The drying behaviour is also more irregular and has higher dispersion, which suggests that salt decay processes have a high sensitivity to the initial conditions. This means that small changes in the microstructure of the materials may result in large differences in terms of decay patterns and, consequently, of drying kinetics. That explains why, as previously, the drying kinetics occasionally diverged between specimens of the same material subjected to similar experimental conditions.
